**From:** [Mekhala Kariyawasam](#)  
**To:** [Bryan Hudson](#)  
**Cc:** [Michael Kulpa](#), [Will Pank](#), [Andrew Ball](#)  
**Sent:** 14/8/2018 at 5:14 PM  
**Received:** 14/8/2018 at 5:15 PM  
**Subject:** Waipa DC - Victoria Bridge (Cambridge) Resilience Review Report

Report

Prepared by Beca Limited

14 August 2018

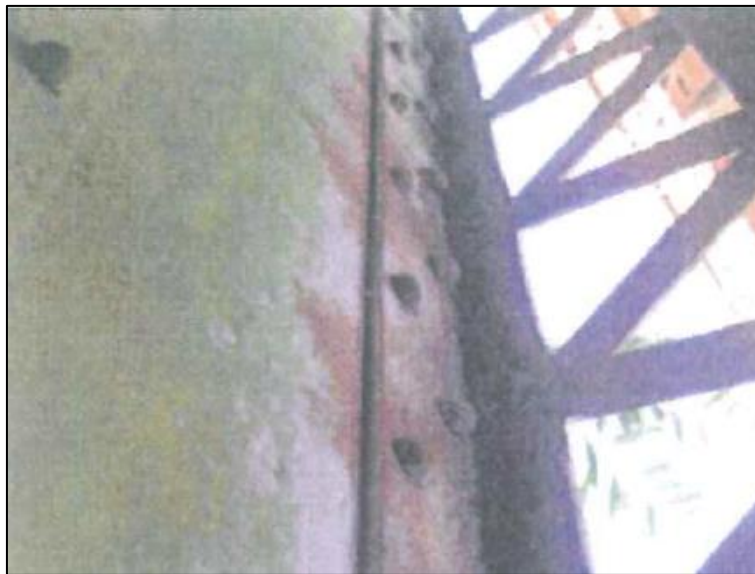
Figure A- 1: Surface corrosion inside lattice column at Pier C (2012).

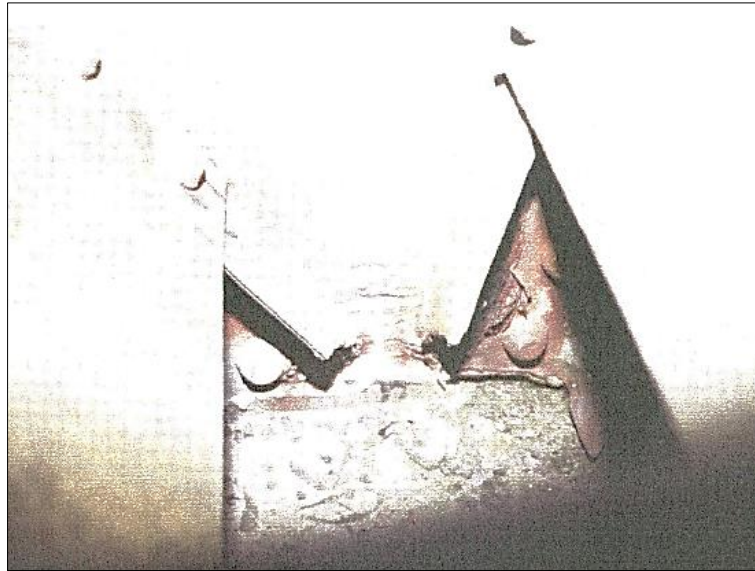
On the arch members the 1996 report identifies that the nodes are the areas of highest corrosion as they are not exposed to the washing influence of the weather (Figure A- 2). Section loss inside of these node areas is common and extensive parent material replacement has been carried out previously. Material replacement between the lower angle sections and the webs is thought to have been carried out in the 1950's.

Figure A- 2: Corrosion of members inside node area on arch (1996).

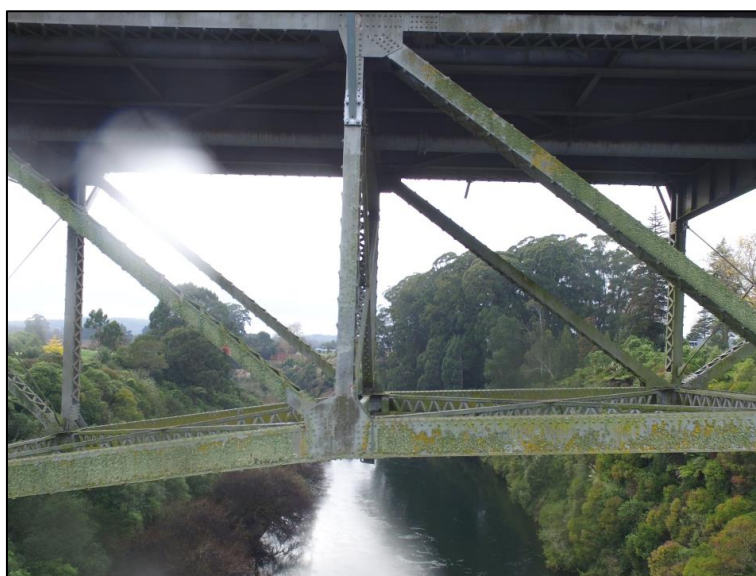
A noticeable amount of algae and lichen build up was observed from the photos (Figure A- 3). The lichen growth tends to be more pronounced at the bottom chord and diagonal members' on the upstream and downstream faces.

Figure A- 3: Drone photography showing algae build-up (2016).

- A Bioshield spray was applied in 2016 to kill off the lichen and algae. Now that time has been allowed for this to take effect, the residue should be washed off, any remaining algae and detritus removed and a full Principal Inspection should be undertaken on the cleaned structure. This should identify any areas of corrosion and deformation of the steel work.
- Geotechnical investigations should be carried out and an assessment completed of the underlying materials.
- Concrete and paint investigations should also be carried out at this stage.

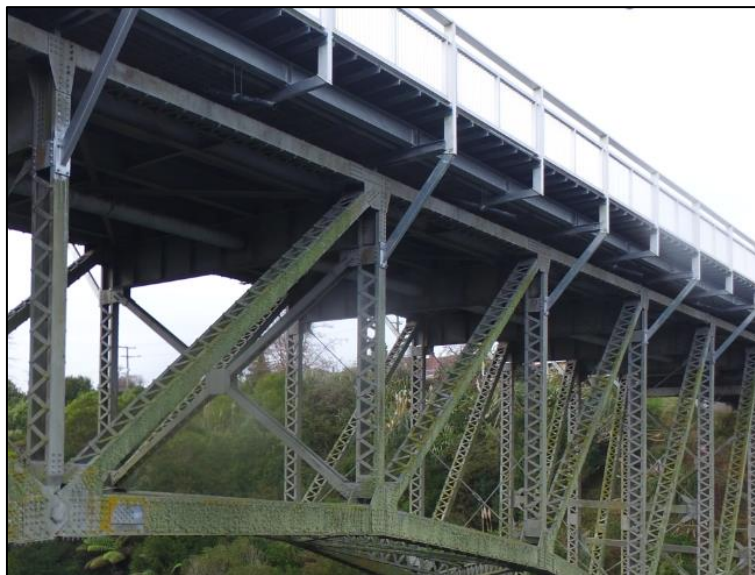
For the lacing bar deflections, BS5400-6 Table 8 specifies a limit to the out-of-straightness deviation at right angles to a plate surface of  $L/165$  or 3mm whichever is greater. It was noted that the bar measured in 2016 with high deflections were generally only in discrete locations and majority of bars were observed to be straight or with deflections in the order of 3 to 5mm. Future monitoring was recommended.

Figure A- 4: Drone photo showing lattice elements (2016).

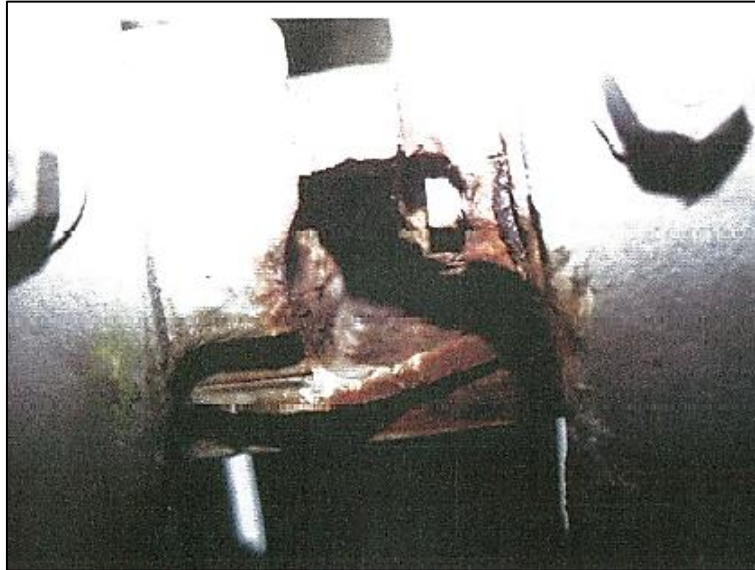
The last inspection of the central pins is thought to be in the 1996 inspection, it was noted that the level of corrosion had increased since 1990 and that additional bearing surfaces were recommended due to the ongoing corrosion and lack of maintenance access (Figure A- 5). It is not known if this was carried out as part of the subsequent works.

Figure A- 5: Corrosion to bearing plates at central pin from beneath pin area (1996).

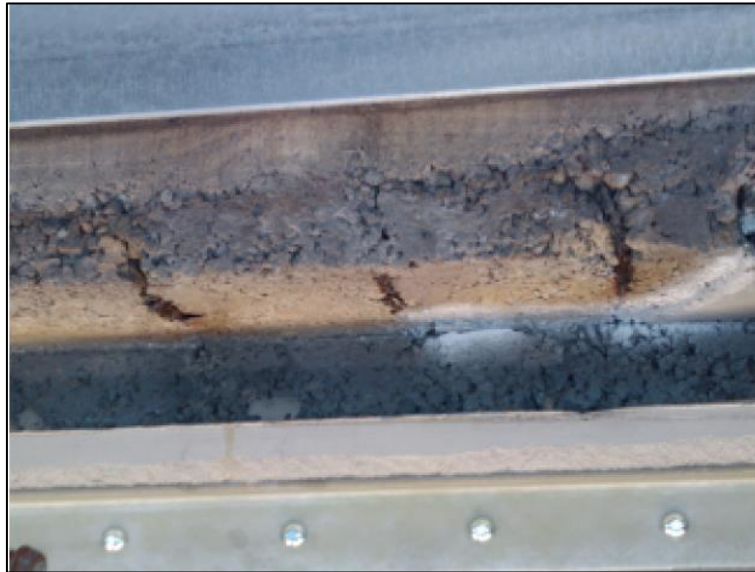
The 2011 inspection marks the deck as extensively cracked and recommends monitoring. The 2014 inspection identified honeycombing in many areas. Cope reinforcement has been identified as severely corroded (Figure A- 7). The 1996 inspection identified transverse cracking at the same spacing as the asbestos sheeting approx. 1.5m centres. The inspection also noted longitudinal cracking which would correspond with overstressing of the deck. It was not thought that the cracking had deteriorated between the 1990 and 1996 inspections.

Figure A- 7: Exposed reinforcement and honeycombing in deck (2014).

The honeycombing, cracking and reinforcement corrosion observed in the concrete deck are highlighted as a potential risk and need to be investigated further. The concrete investigations should include the removal of asbestos sheets over a land span to allow for future observation as well as crack mapping and concrete coring to the deck to determine strength and to examine for evidence of defects.

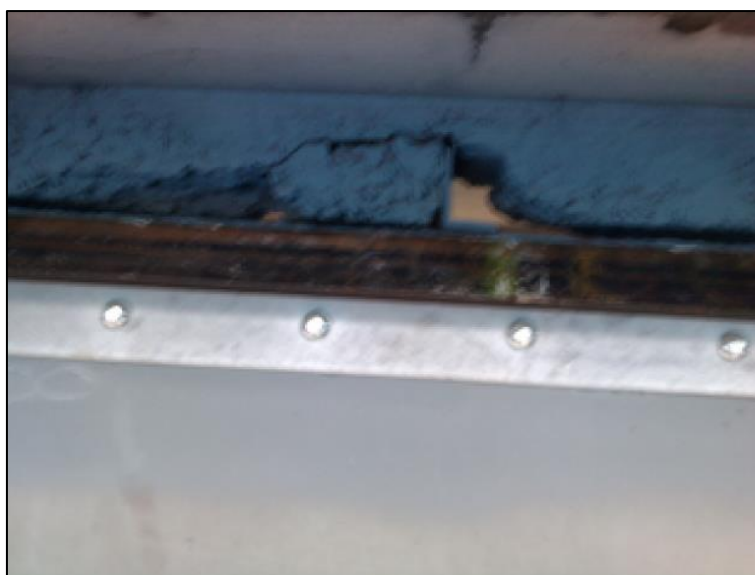
Due to corrosion of the stringers top flanges there has been some separation between the steel superstructure and the concrete deck, this includes concrete broken around the shear connections effectively reducing the transfer of shear between the elements (Figure A- 8). This was also noted in the 1996 inspection and poor deck waterproofing was suggested as a cause.

Figure A- 8: Concrete breakdown around shear connectors (2014)

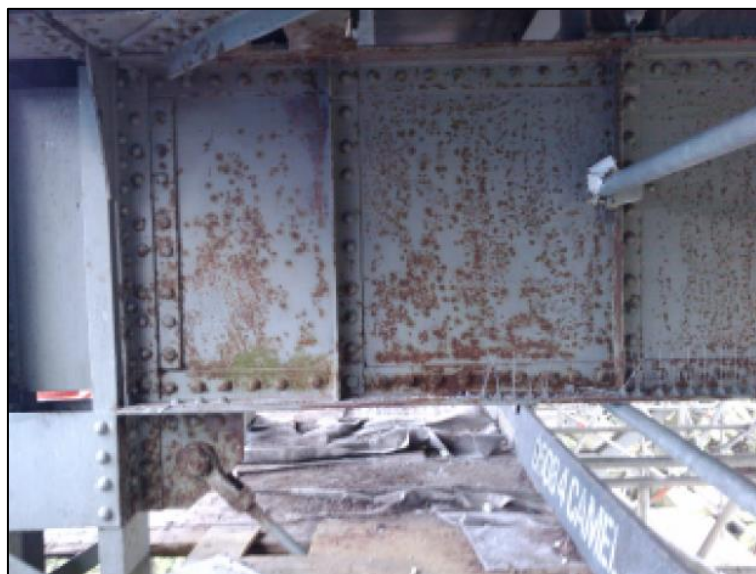
The 2014 survey of the upper beams noted a breakdown of the paintwork and spot corrosion blistering on the webs and beams (Figure A- 9). It was highlighted that this was present on many of the beams at this level and that general corrosion was also present.

Figure A- 9: Typical corrosion blistering on transverse beam (2014).
