# Victoria Street Bridge (Cambridge) Condition Assessment Report

Prepared for Waipa District Council

Prepared by Beca Limited

10 August 2020

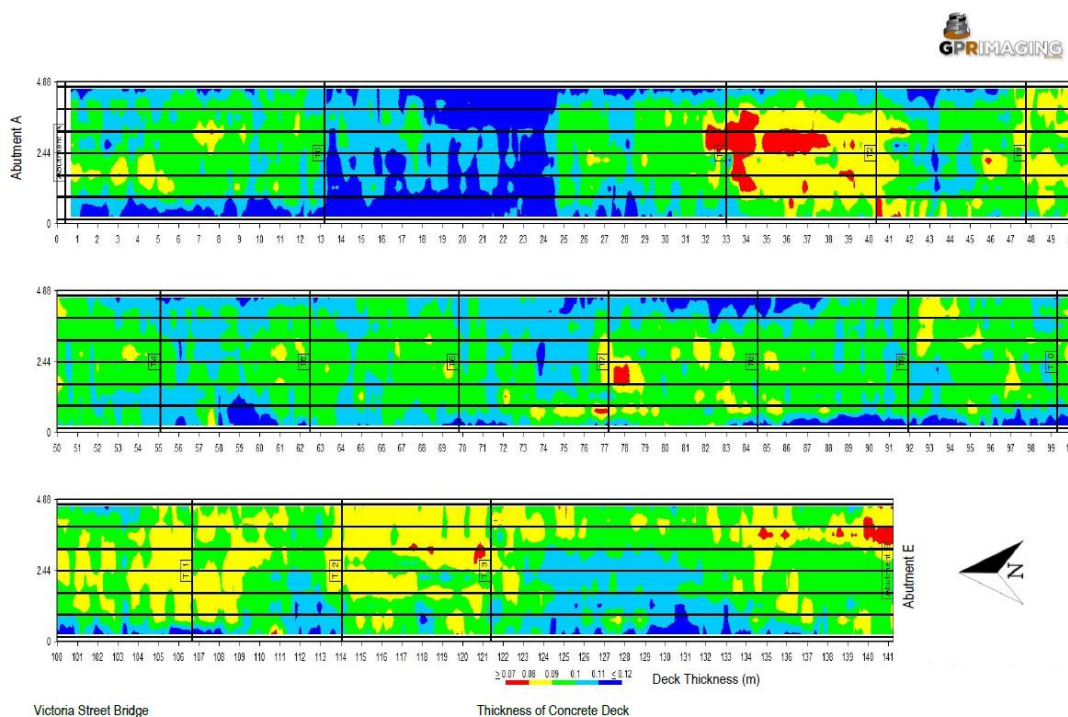
Figure 5-1 Deck thickness mapping

A new assessment may be appropriate. It can be seen in the maps below that the critical area of low deck thickness is in Span 01-02. A reasonable approach to analysis may be to take the average thickness under a patch equivalent to the size of patch used for a punching failure check. As an initial approximation an average of the deck thickness beneath a circa 1m square located at chainage 33.5 is 70mm. Confirmation of cover and deck thickness in Span 01-02 is recommended as part of the intrusive investigations.

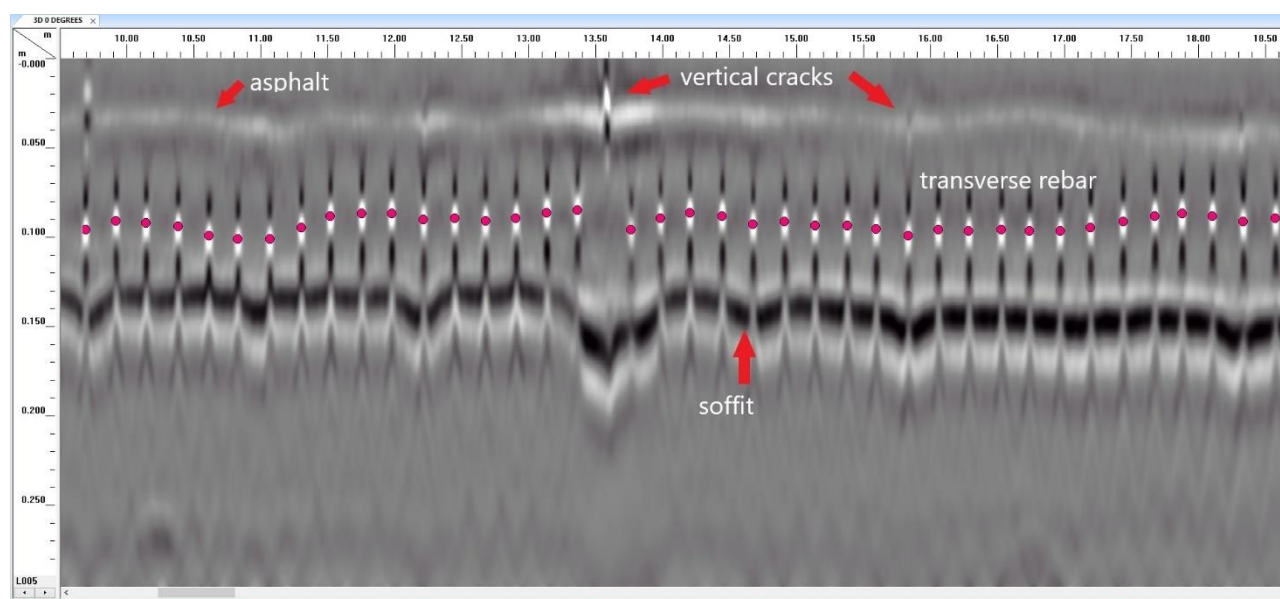
Figure 5-2 - Missing bar at Chainage 13.5

The image below shows the location on the missing bar at Ch.13.5 it can be seen that a vertical crack has developed directly over the location of the missing bar, this is also the case at Ch. 24.5. Both cracks are across the full width of the deck and the crack at Ch13.5 is larger.

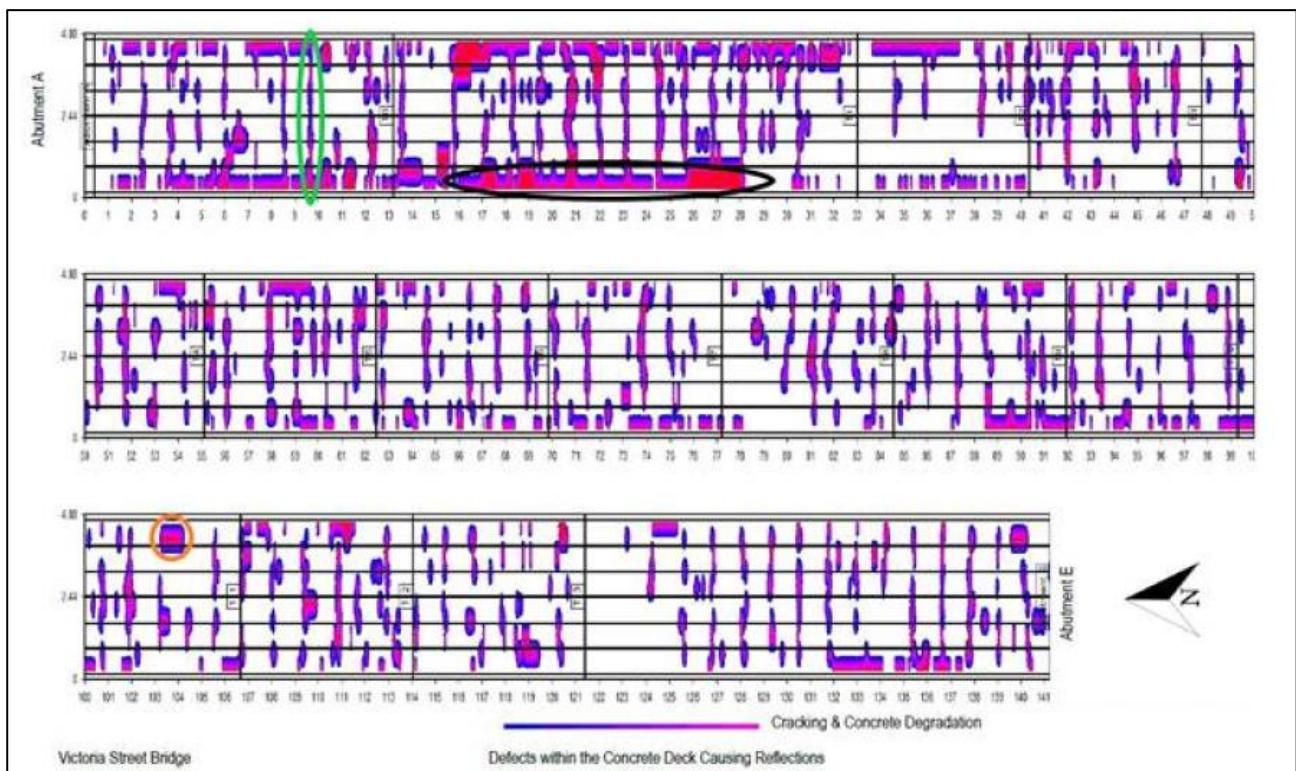
Figure 5-3 GPR scan image showing possible locations of defects causing reflections

It can be seen that there are areas of poor-quality concrete towards each kerb. There are many defects spanning across the deck that may be indicators of full width vertical cracking. This is of particular concern as if these are full depth cracks then the distribution of load longitudinally through the slab may be reduced. Investigations into several of these cracks are recommended to determine their depth and width.

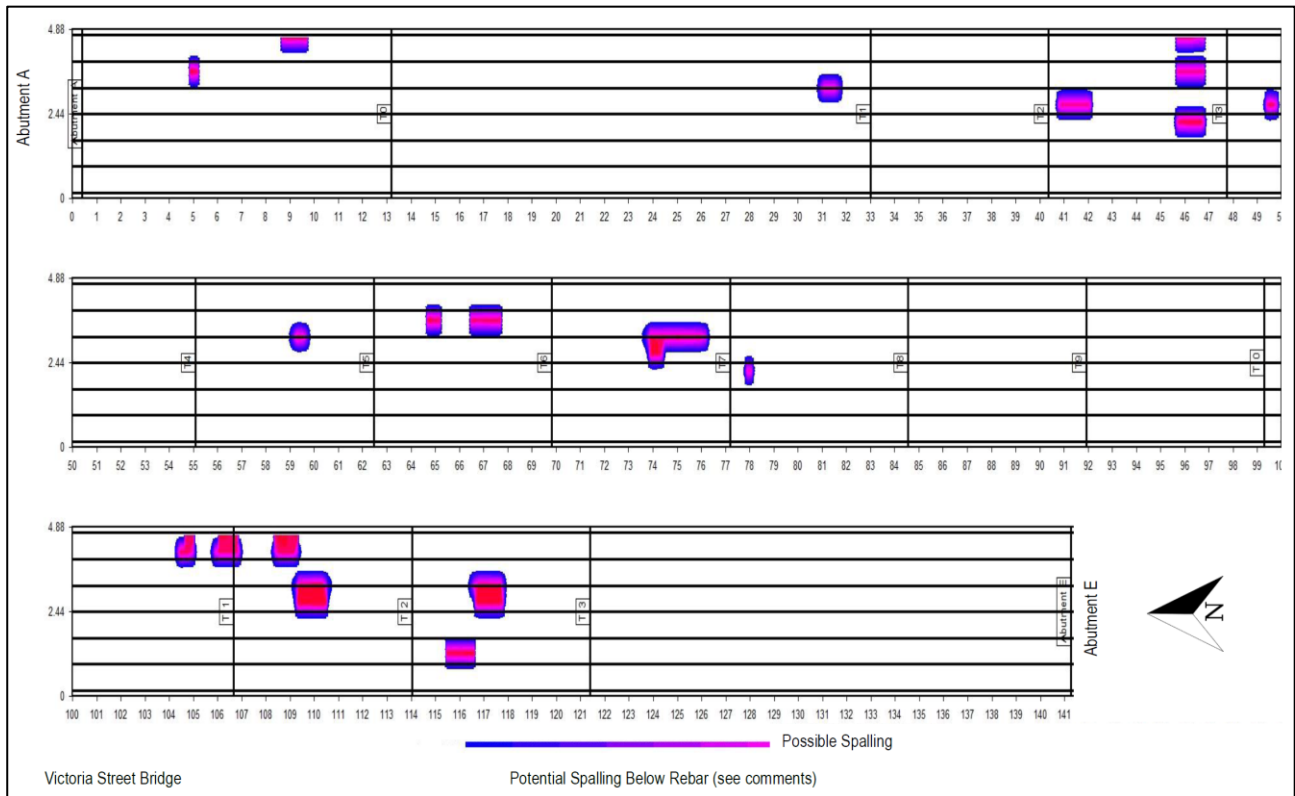
Figure 5-4 GPR scan image showing locations with potential spalling below rebar

Figure 5-4 below identifies areas of potential spalling to the soffit. The vehicle mounted scanner is a good screening tool for identifying areas of concern however a more accurate handheld device should be used prior to carrying out exploratory cores on these locations. One possibility is that the permanent formwork has fallen away from the soffit which the scanner may have identified as spalling, the investigations should identify if this is the case.

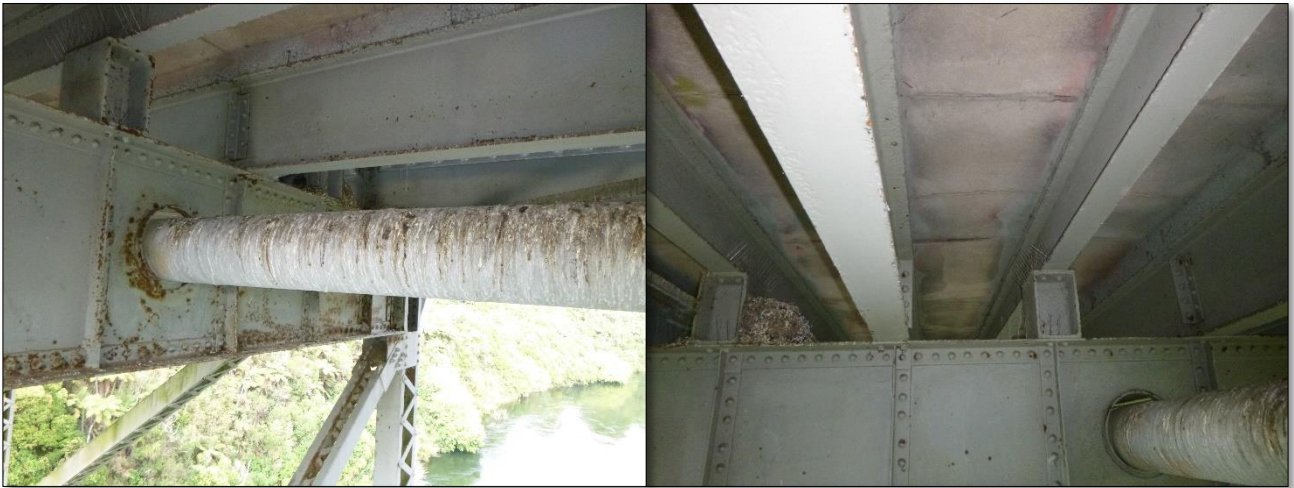
Figure 6-4 - Example of birds nesting.

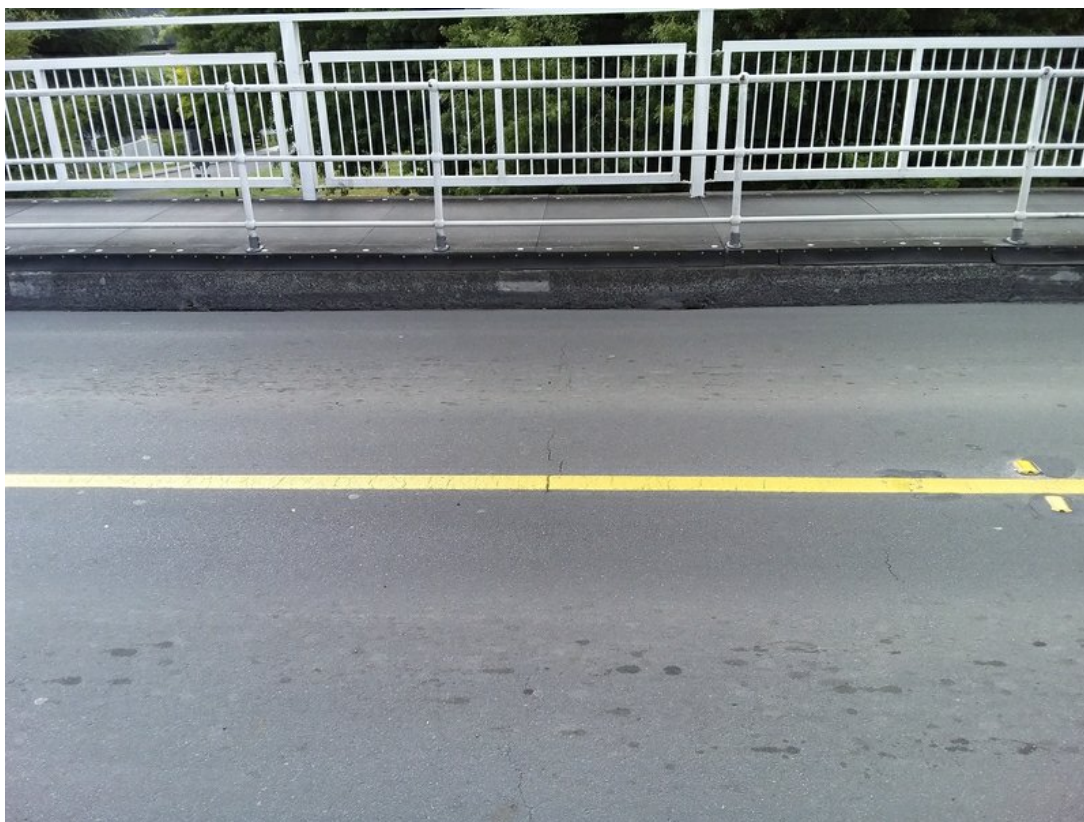
Carriageway Surfacing (Element 23): Transverse cracking on surfacing at 5m from Abutment A.

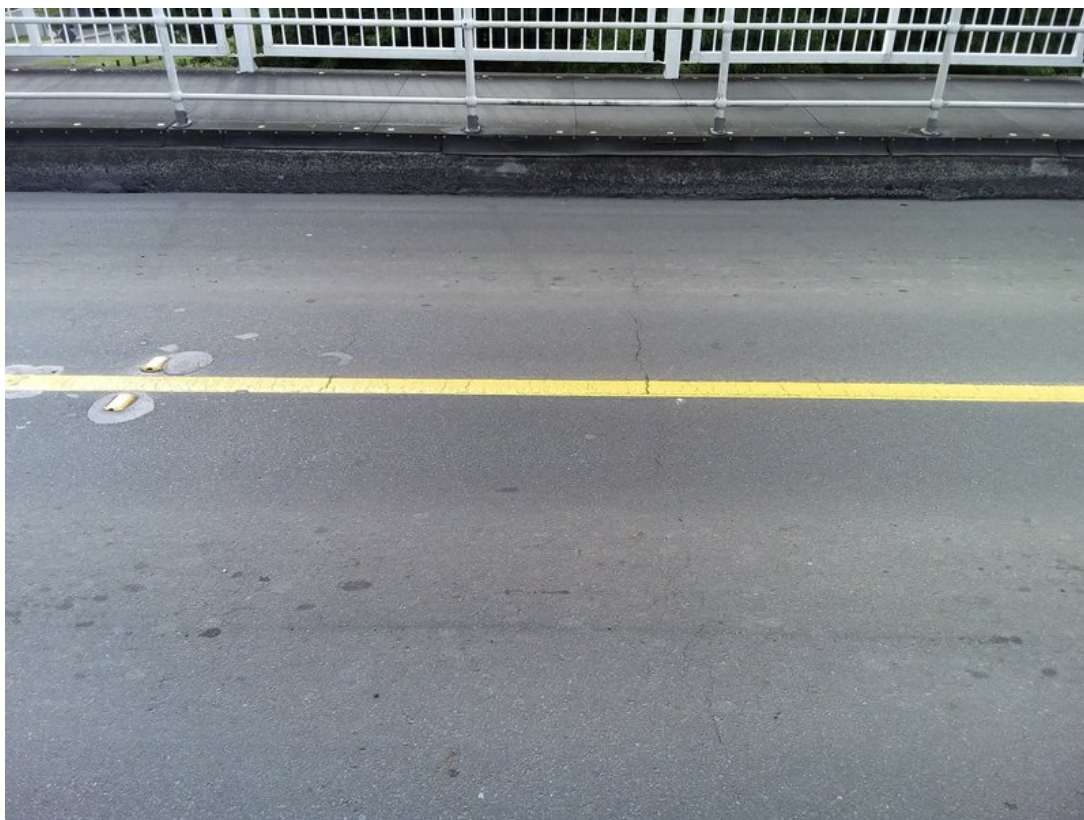
Carriageway Surfacing (Element 23): Transverse cracking on surfacing at 2m from Abutment A.

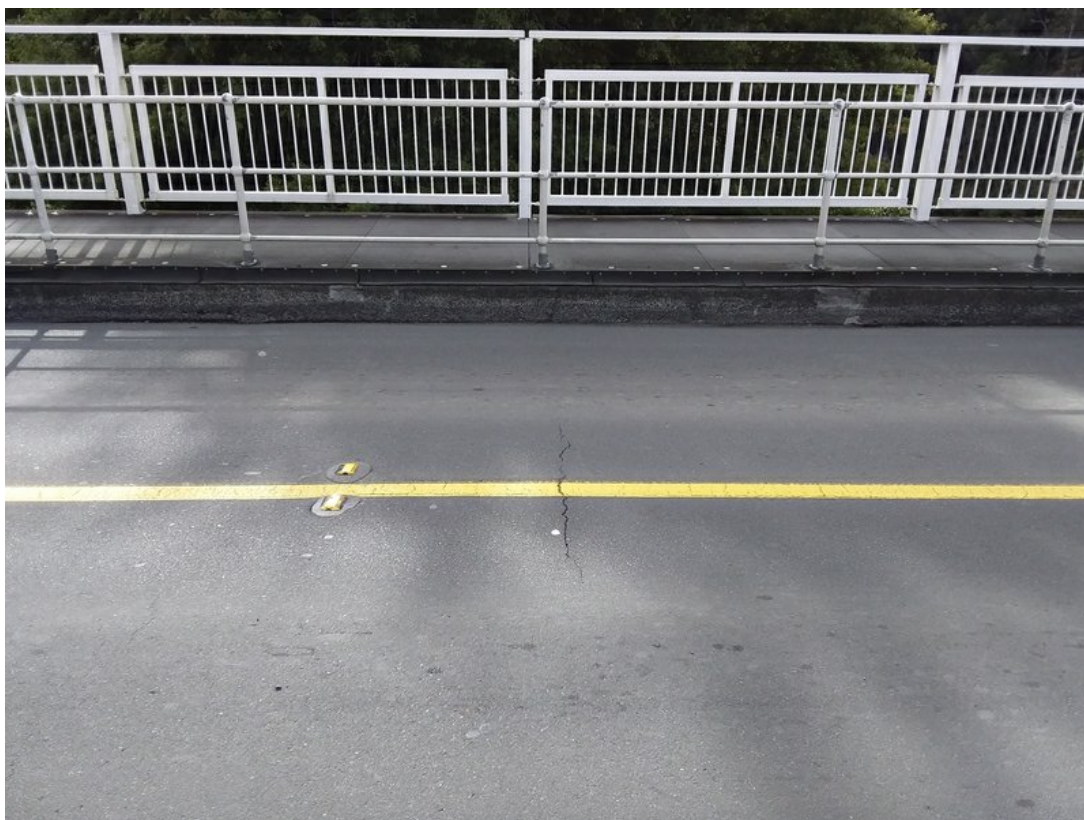
Carriageway Surfacing (Element 23): Transverse cracking on surfacing at 12m from Abutment A.

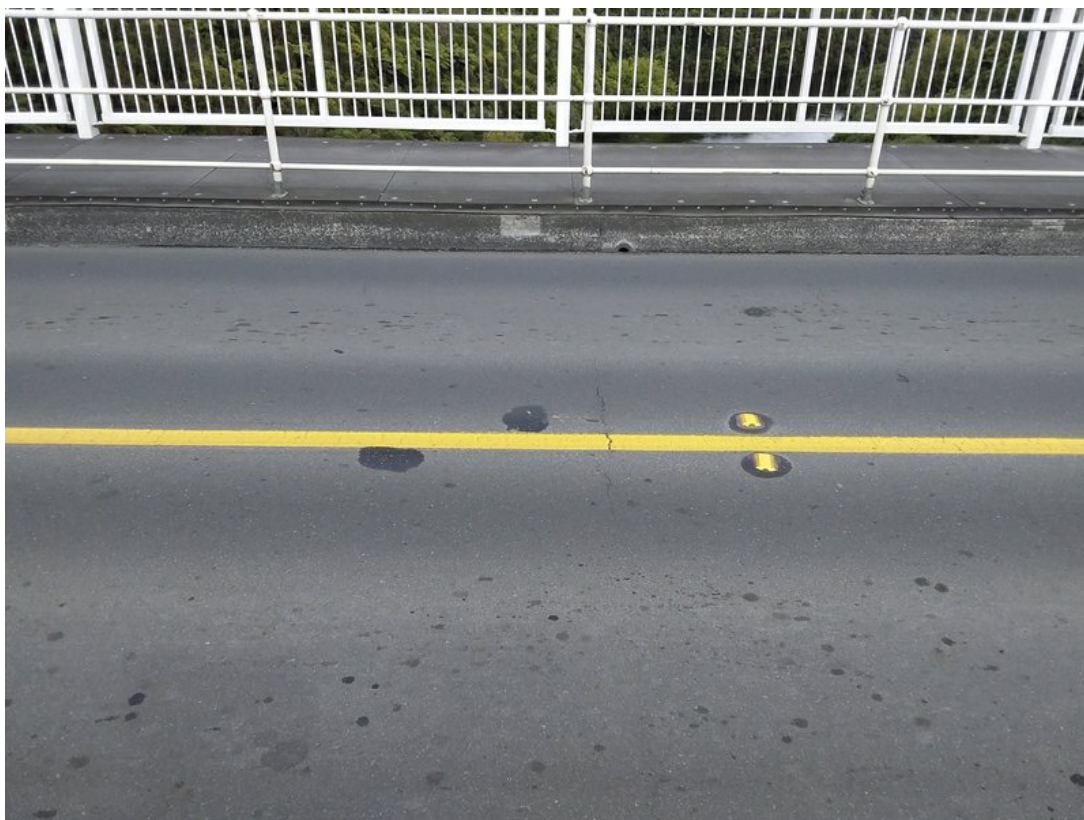
Carriageway Surfacing (Element 23): Transverse cracking on surfacing at 30m from Abutment B.

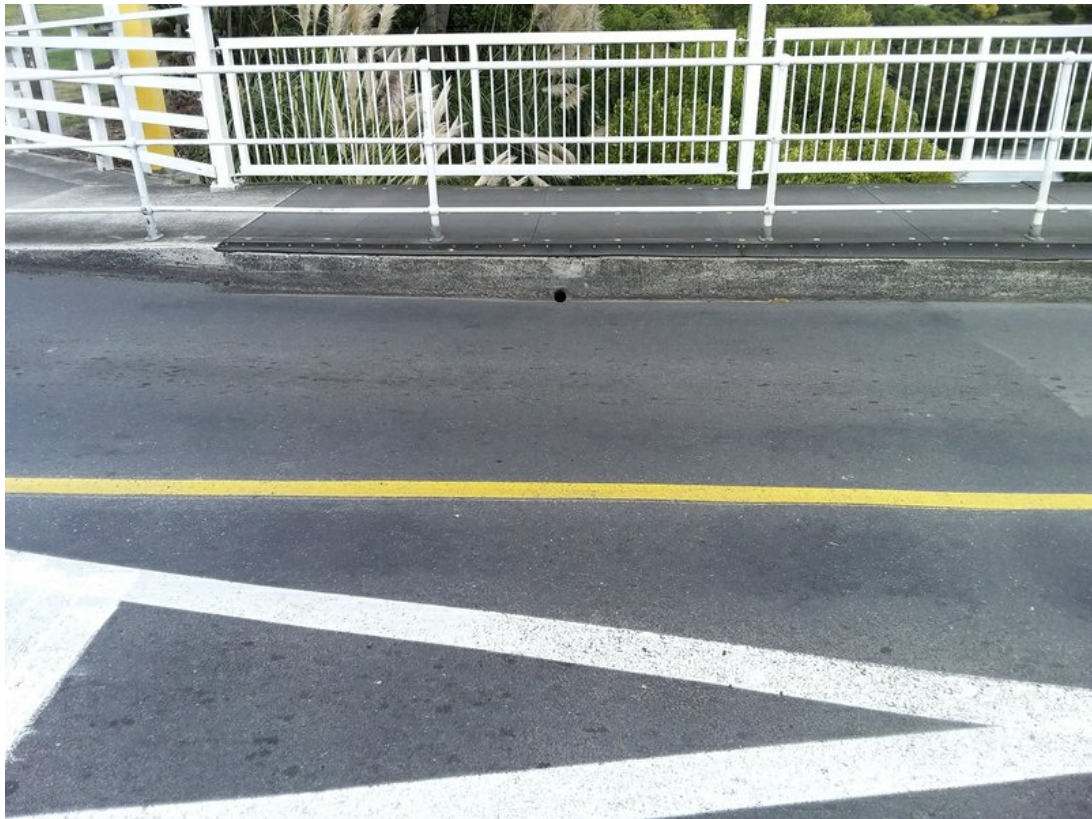
Superstructure Drainage (Element 15): Clear drain hole on kerb.

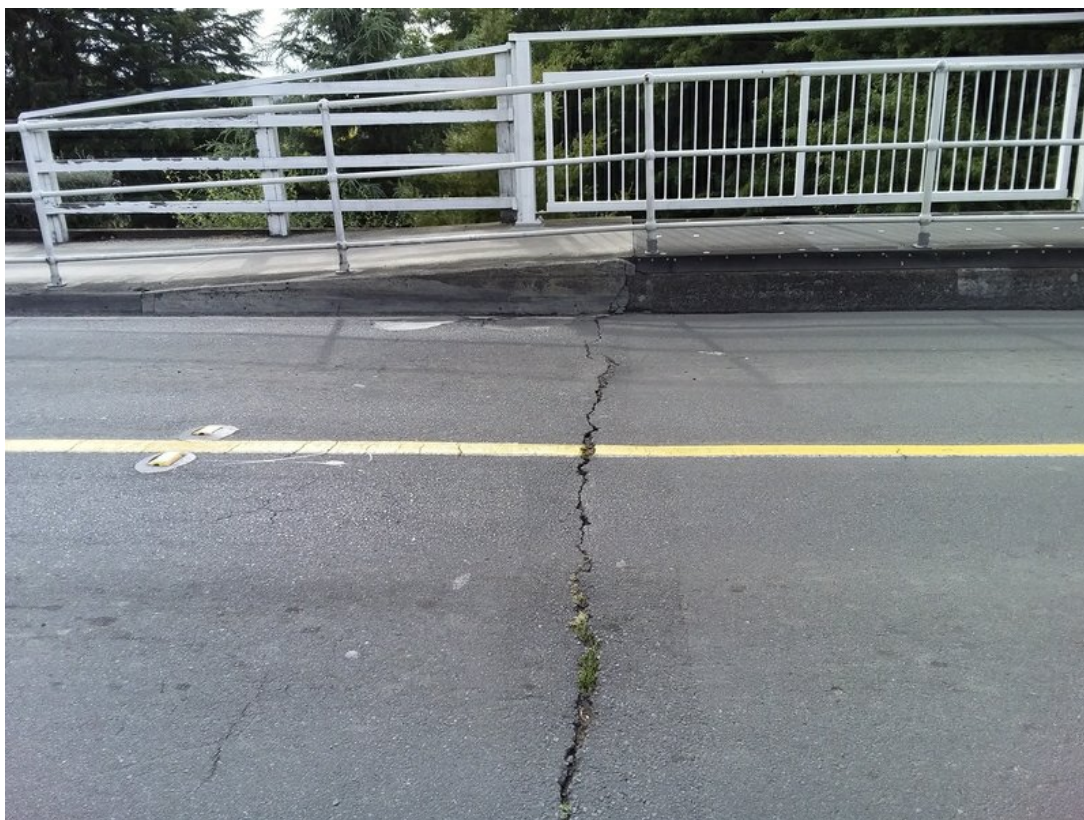
Movement / Expansion Joints (Element 17): Crack to surfacing above Abutment A.

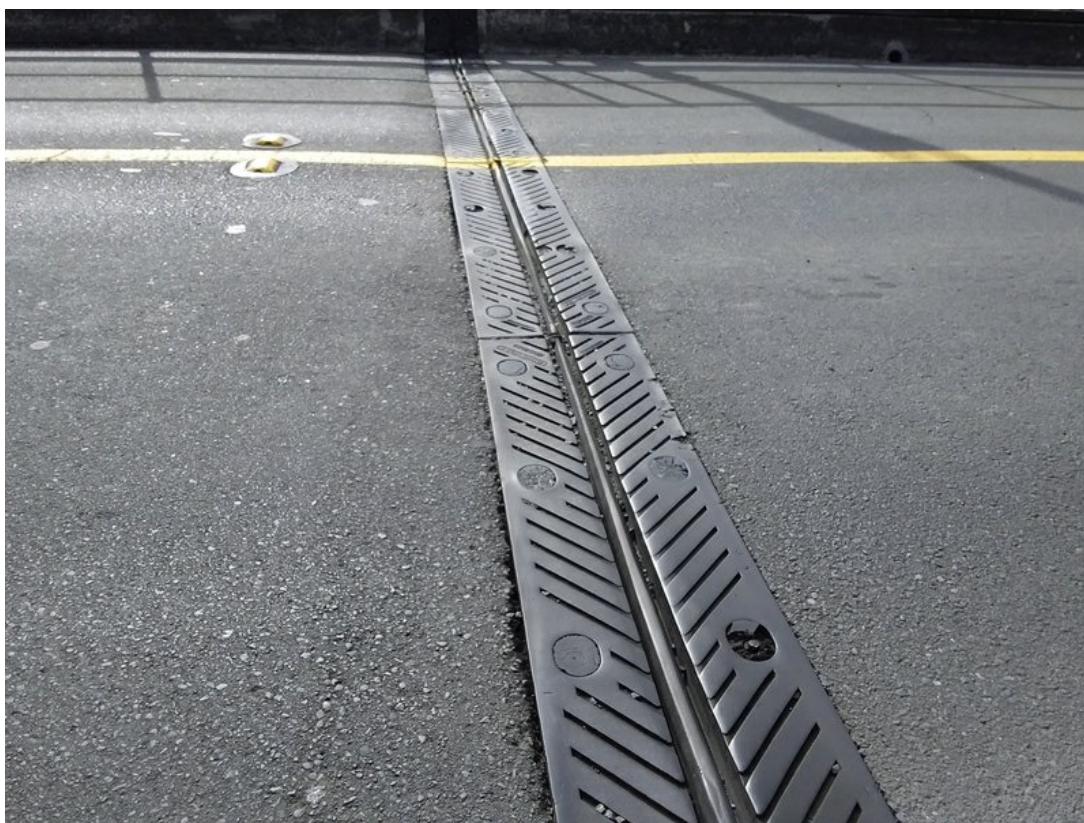
Movement / Expansion Joints (Element 17): Some debris in and around expansion joint.

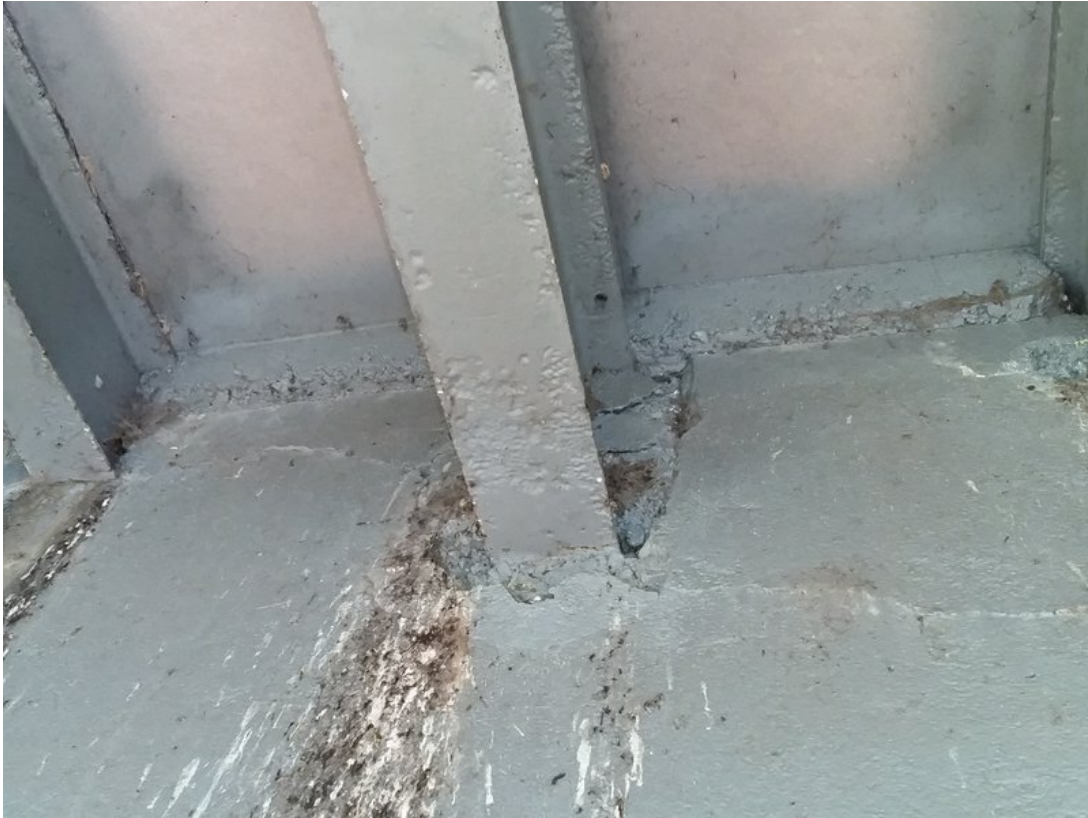
Abutments (Element 9): Loose concrete on face of Abutment B at ends of Stringer 2.

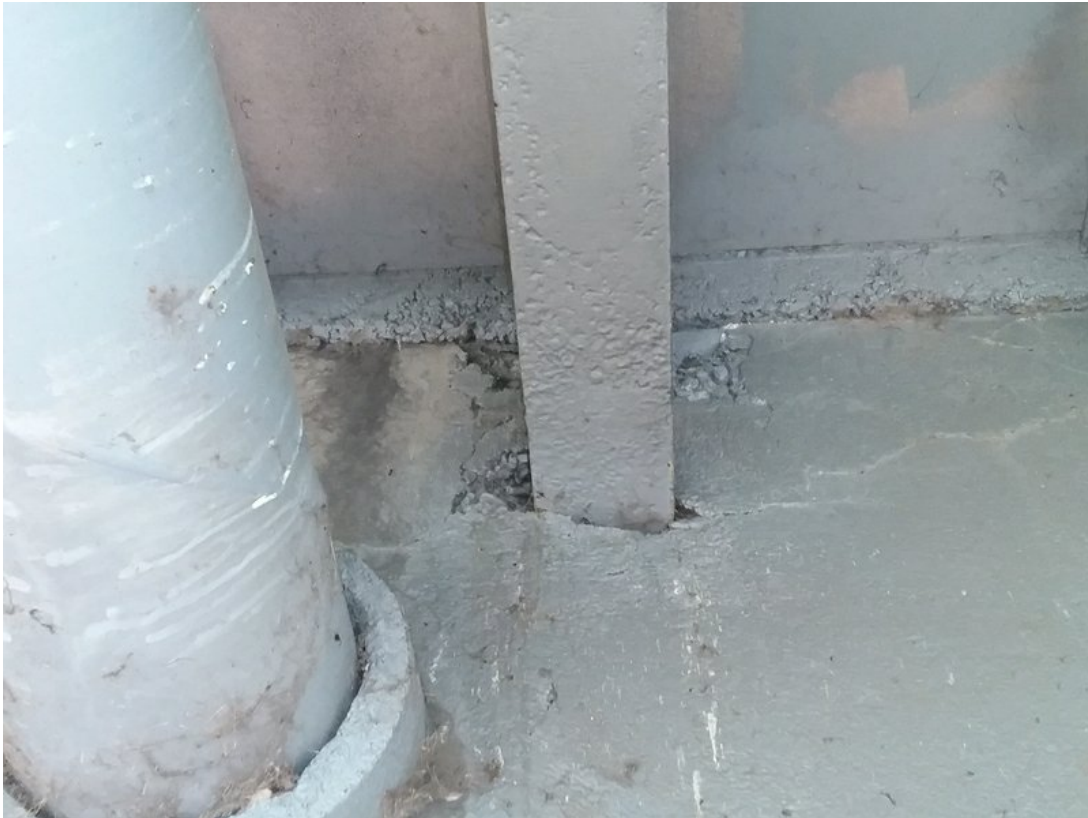
Abutments (Element 9): Loose concrete on face of Abutment B at ends of Stringer 4.

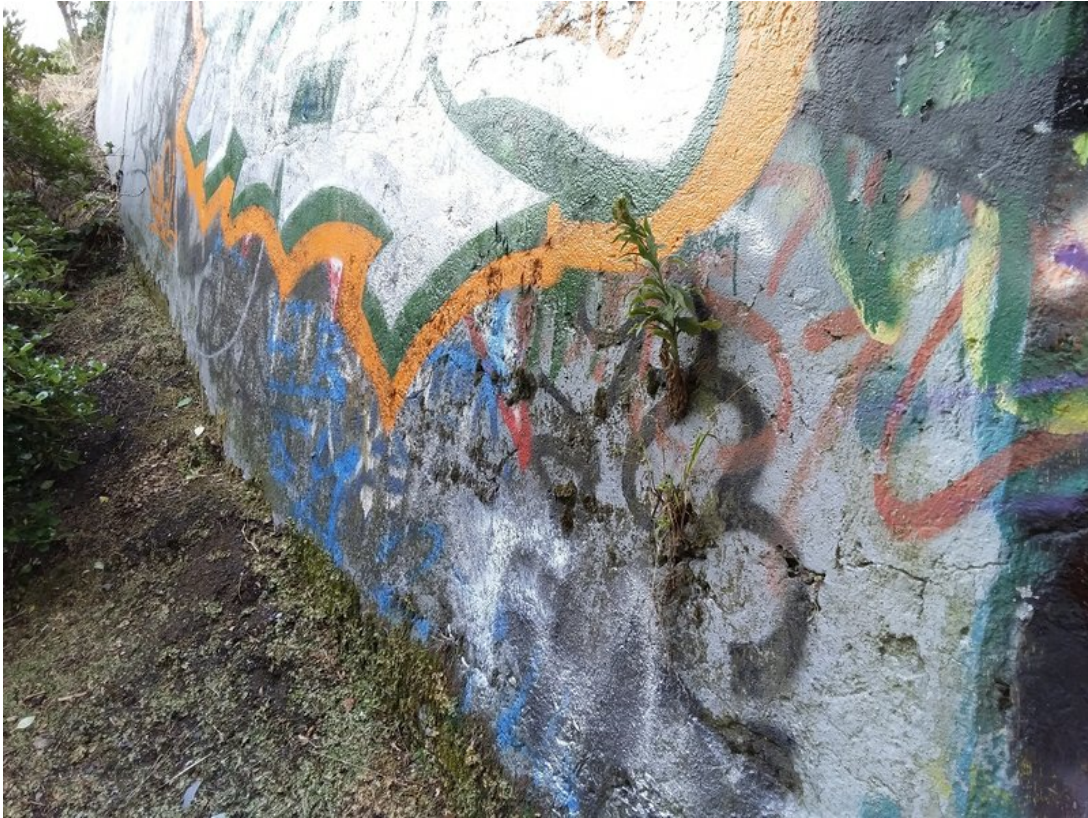
Wing Wall (Element 32): Small shallow void on Approach A downstream wing wall with vegetation growing out of the void.

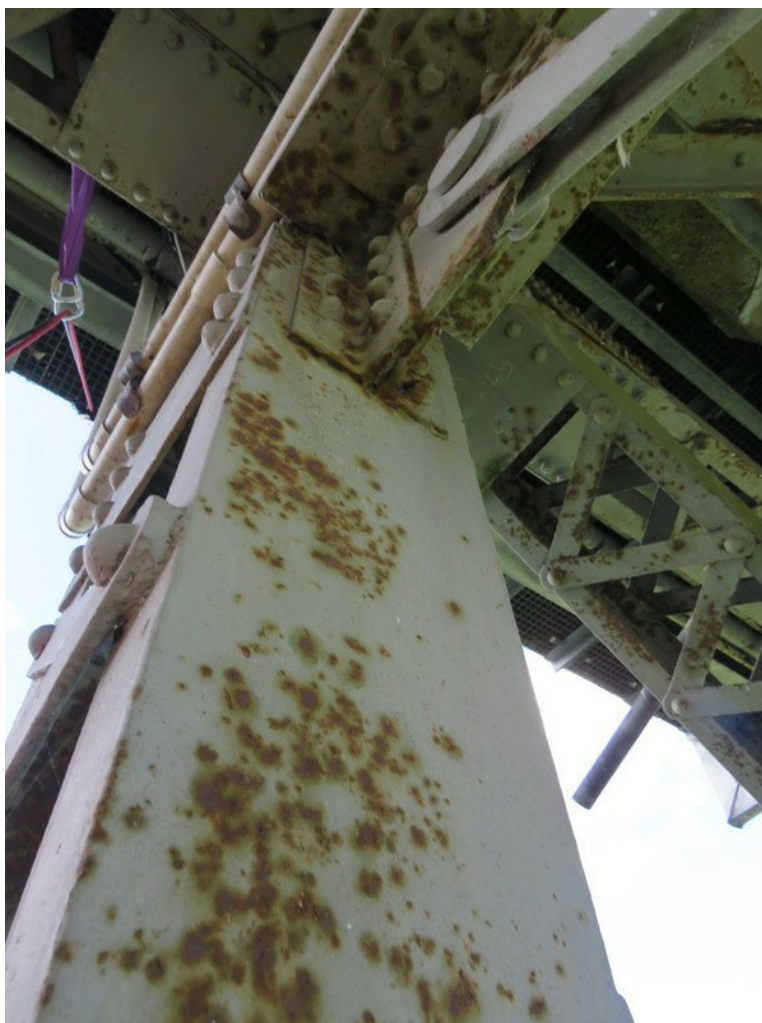
Primary Load Carrying Element (Element 1) : Spots of corrosion on vertical laced columns at UT05.

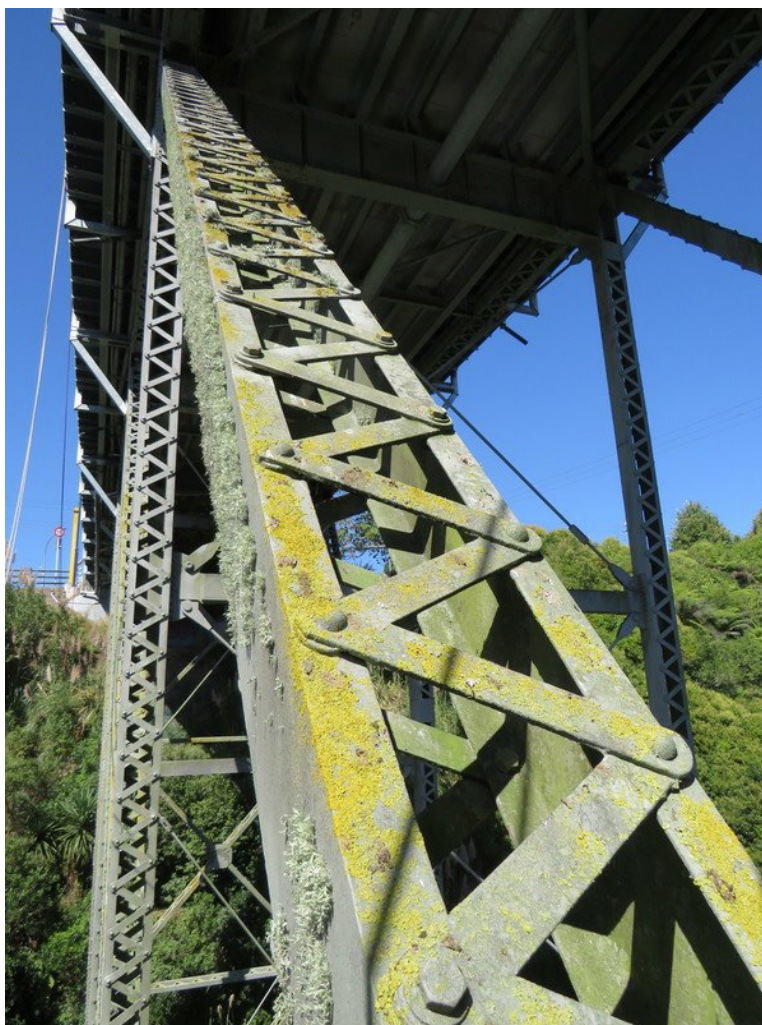
Primary Load Carrying Element (Element 1) : Fungal growth on diagonal laced columns at UT11-UB10.

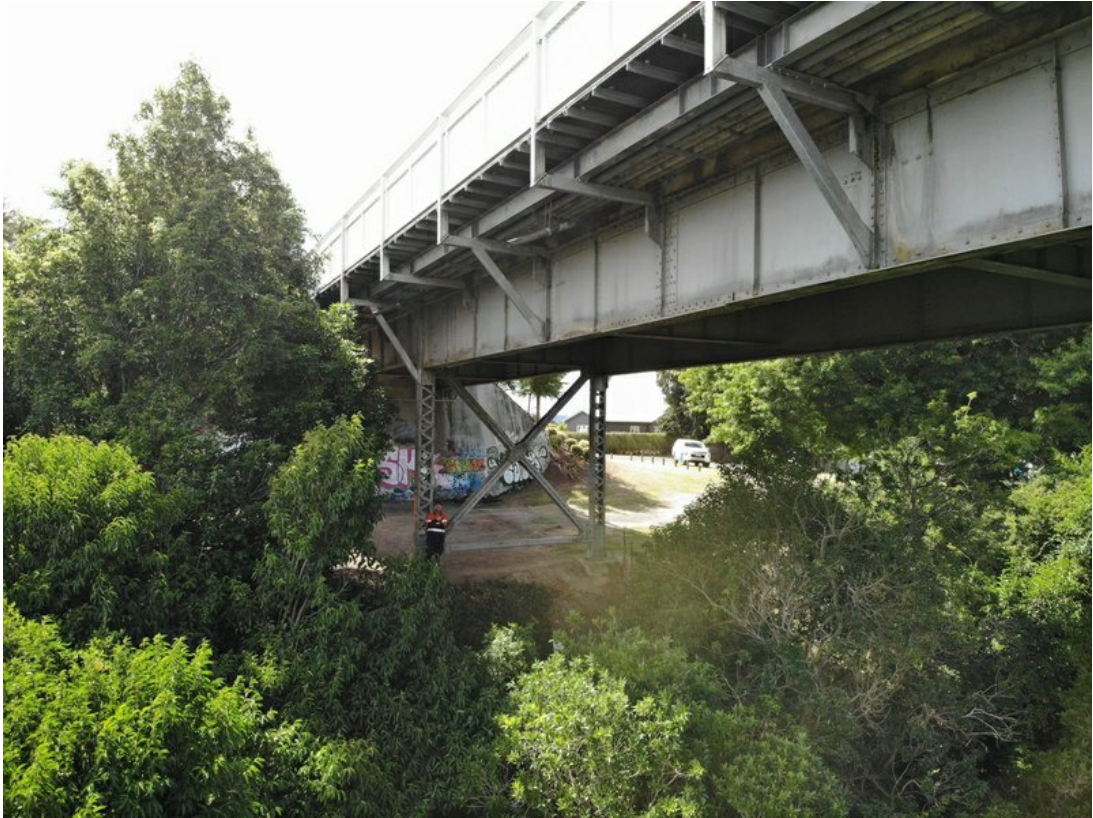
Primary Load Carrying Element (Element 1) : Steel beams on land spans generally in good condition. View from D/S side looking towards Cambridge end.

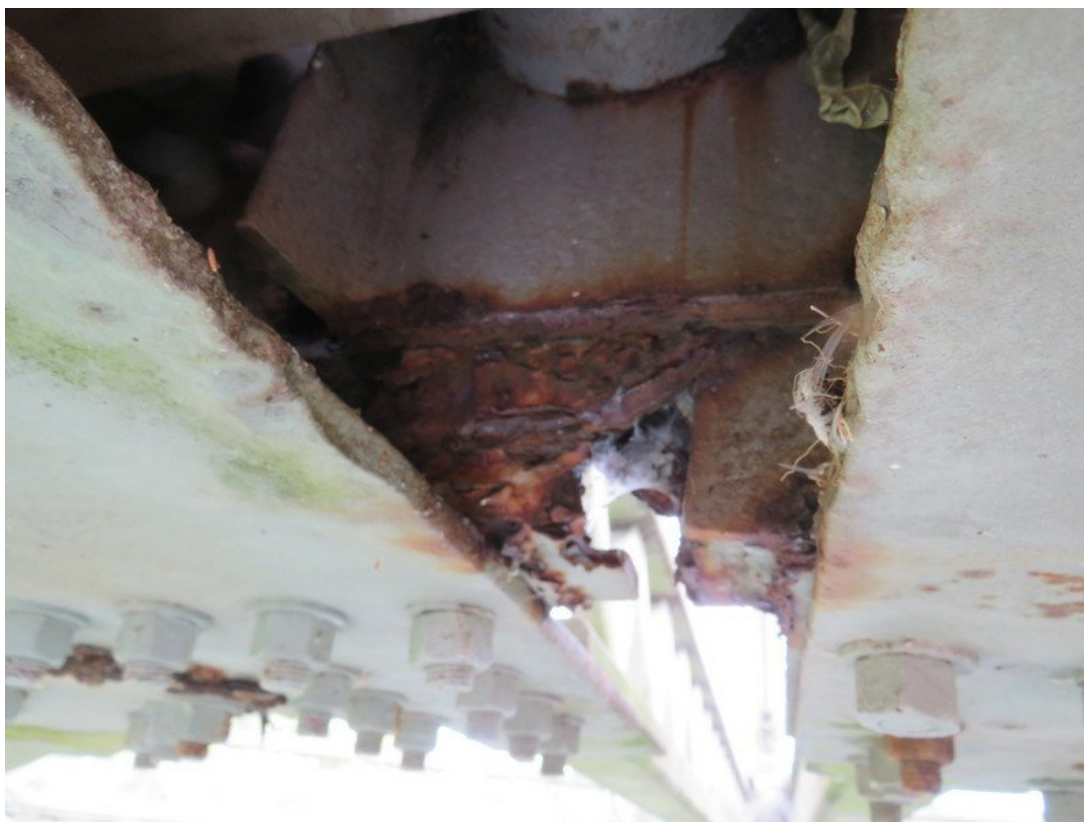
Primary Load Carrying Element (Element 1) : Crevice corrosion, metal loss and coating failure at U/S Centre pin.

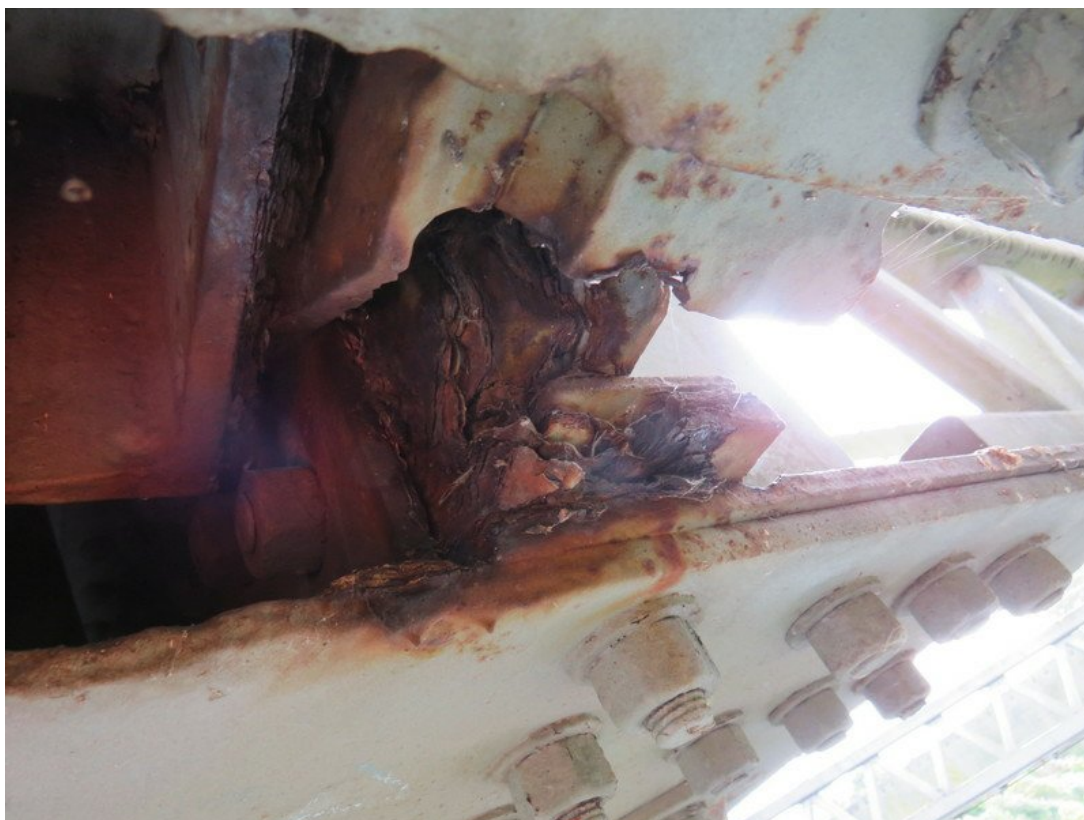
Primary Load Carrying Element (Element 1) : Crevice corrosion, metal loss and coating failure at D/S Centre pin.

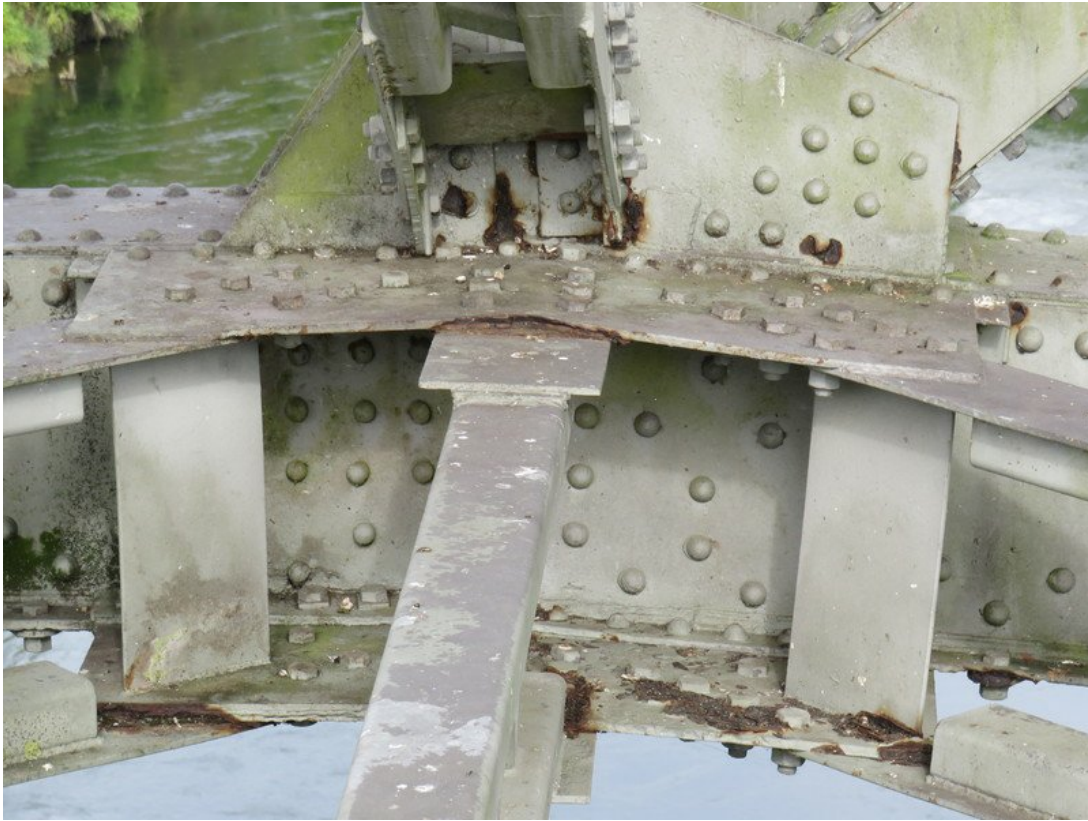
Primary Load Carrying Element (Element 1) : Element UB06-DN06 showing signs of delamination corrosion and loss of protective coating.

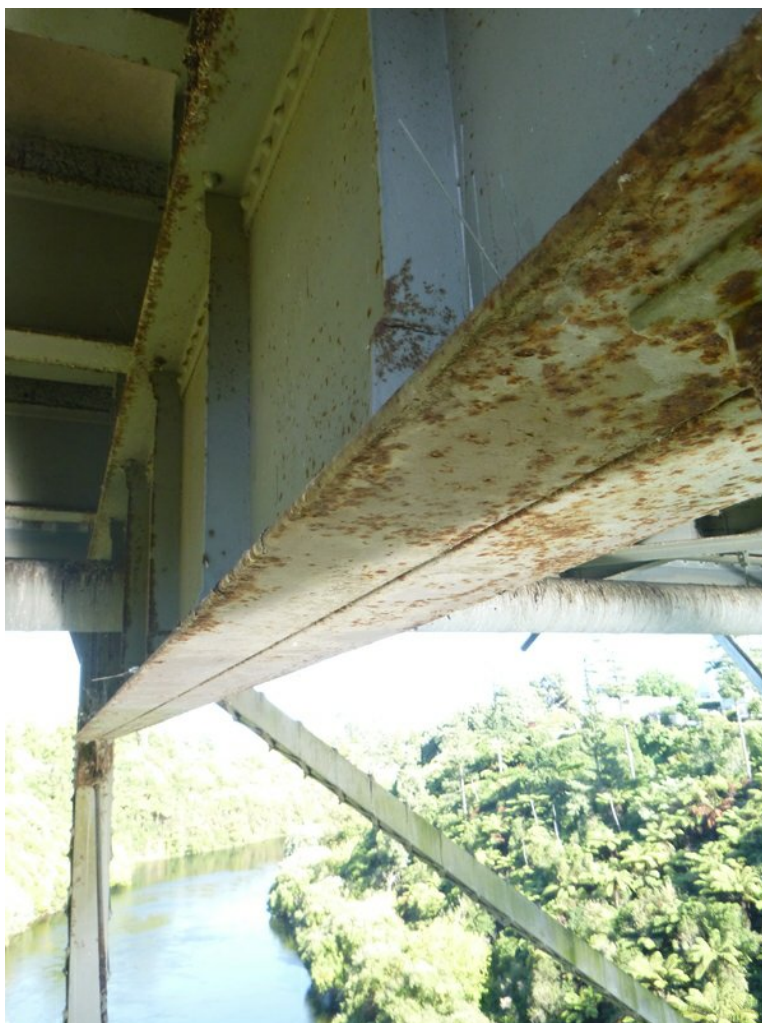
Secondary Elements - Transverse Beams (Element 2): Widespread corrosion spots were observed on element "UT09-DT09".

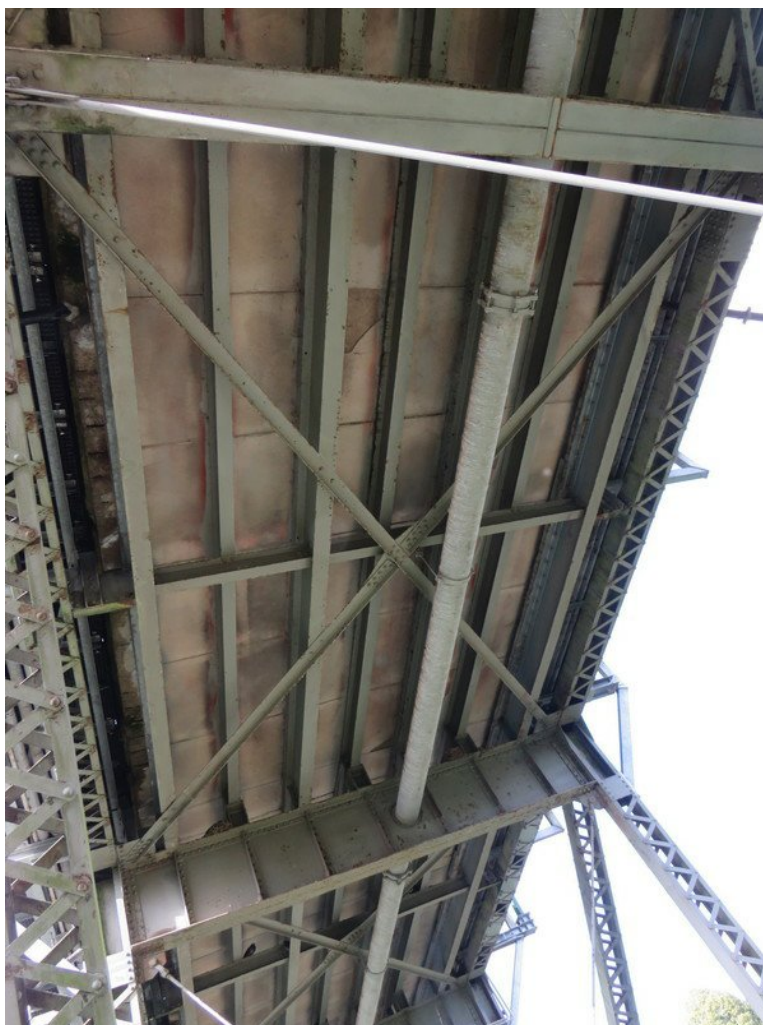
Secondary Elements - Other Including Deck (Element 3): Underside of deck covered by asbestos panels, except where asbestos panels are broken.

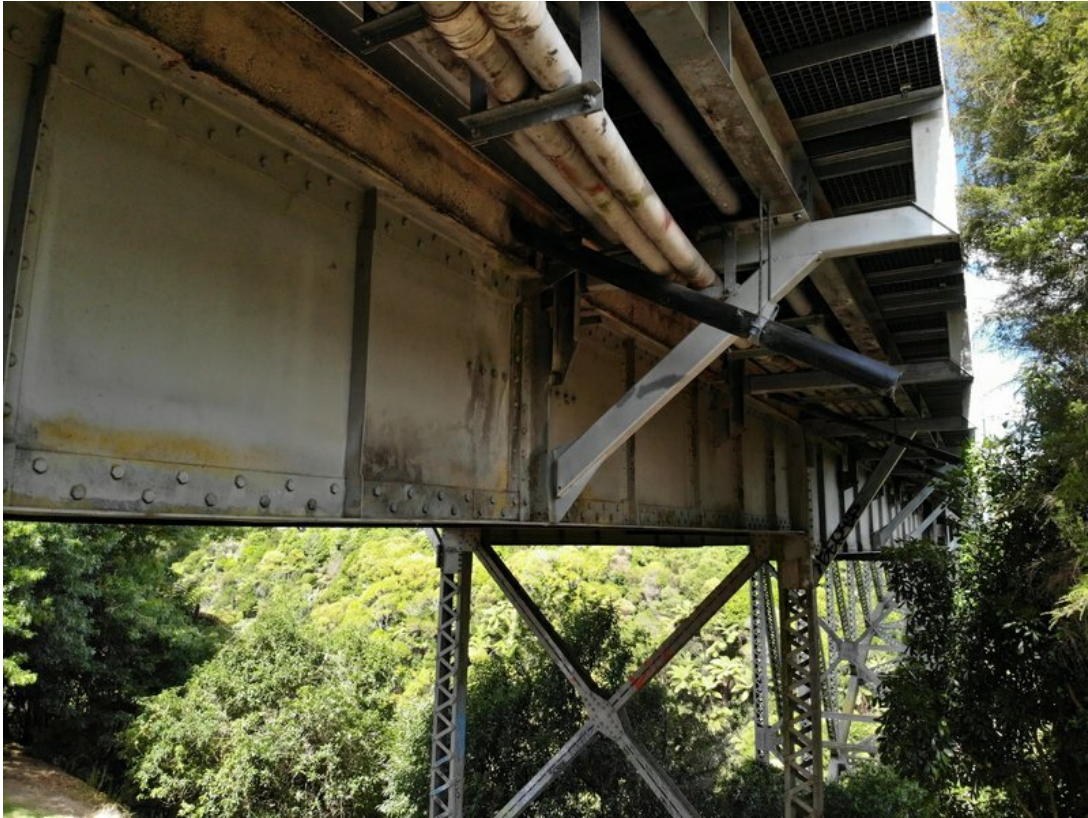
Parapet Beam or Cantilever (Element 6): The deck cantilever is generally in good condition. However a portion of it was not visible to inspect being covered by service utilities.

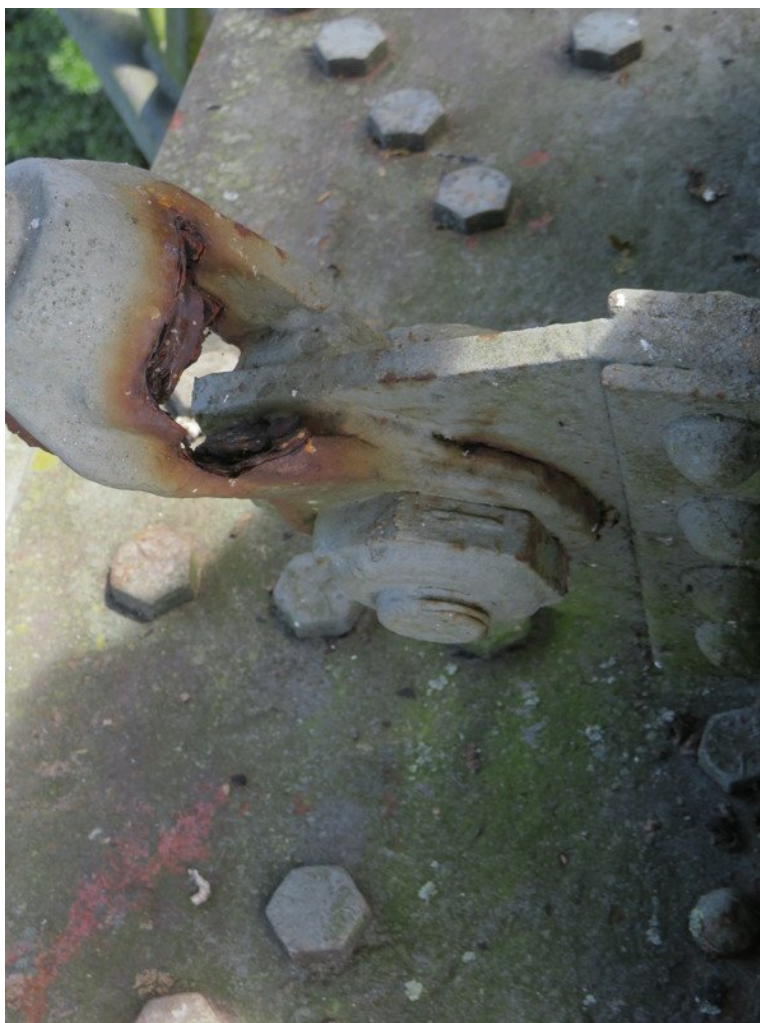
Cross bracing / diaphragms (Element 7): Corroded tie rod connection at UP T4.
