# Victoria Street Bridge (Cambridge) Condition Assessment Report

Prepared for Waipa District Council

Prepared by Beca Limited

10 August 2020

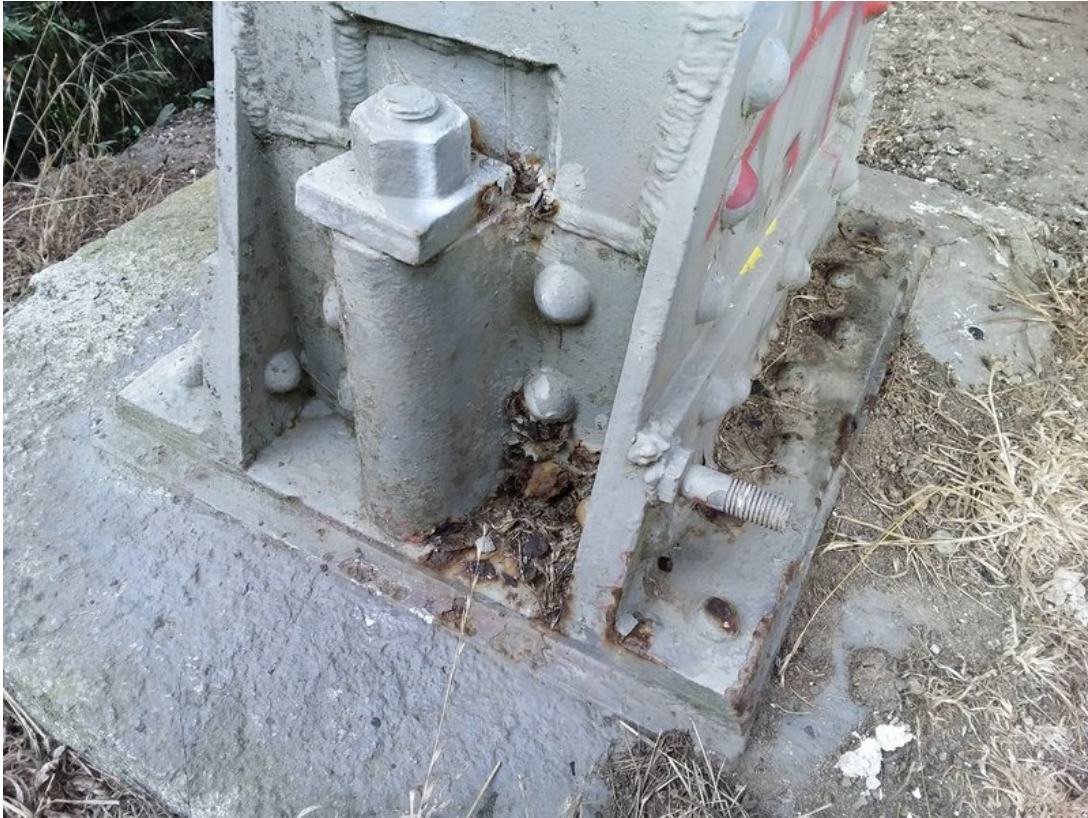
Pier / Column (Element 11): Corrosion on base plate of upstream side of Column Pier B.

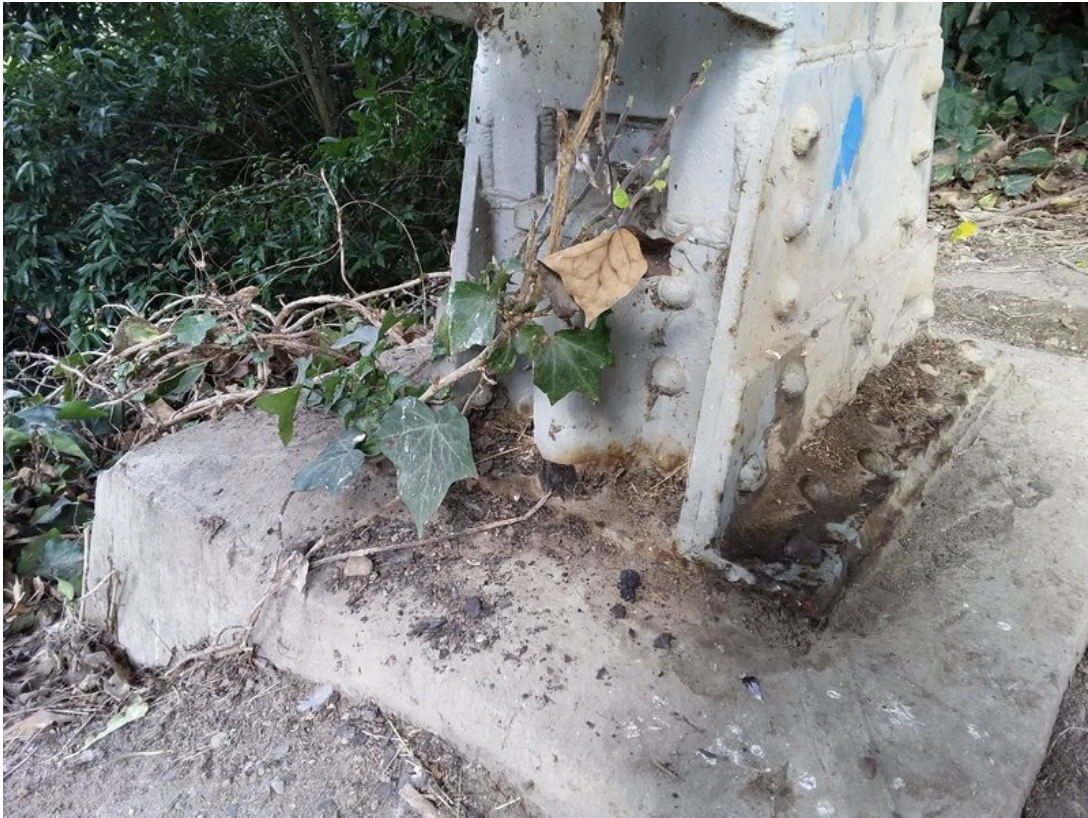
Pier / Column (Element 11): Corrosion on base plate of upstream side of Column Pier B.

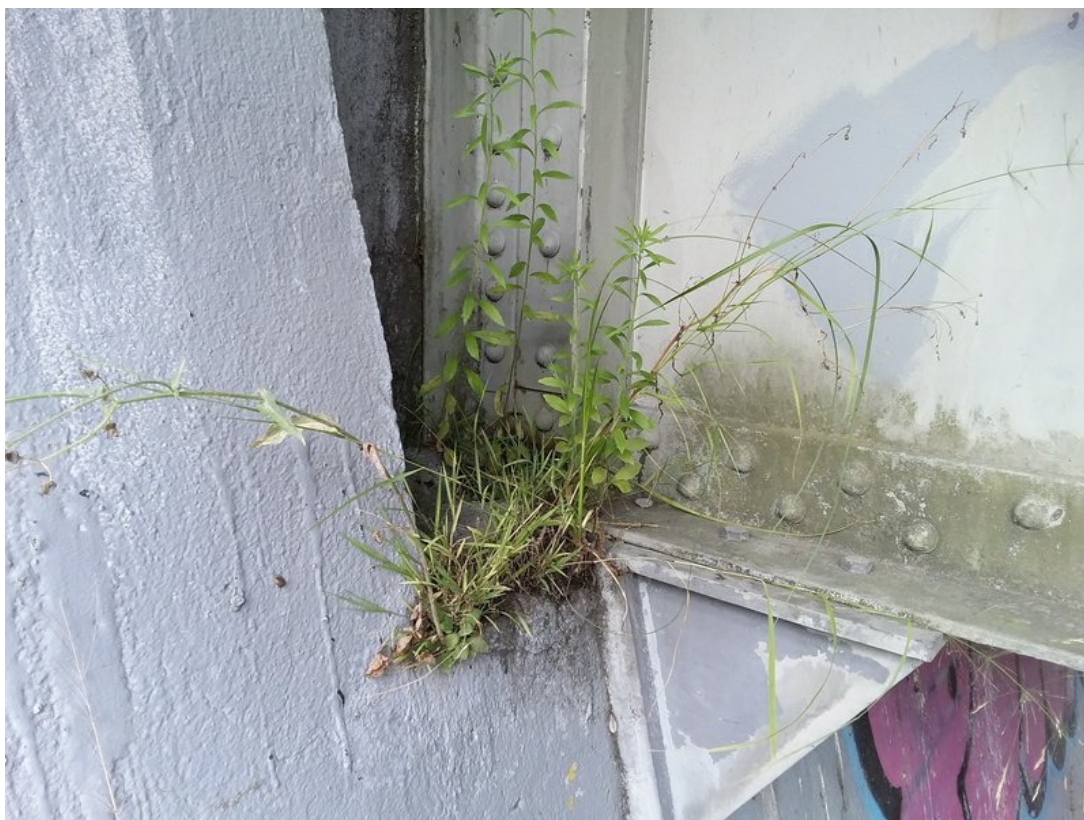
Bearing Plinth / Shelf (Element 14): Vegetation growth on upstream side of Abutment B bearing shelf.

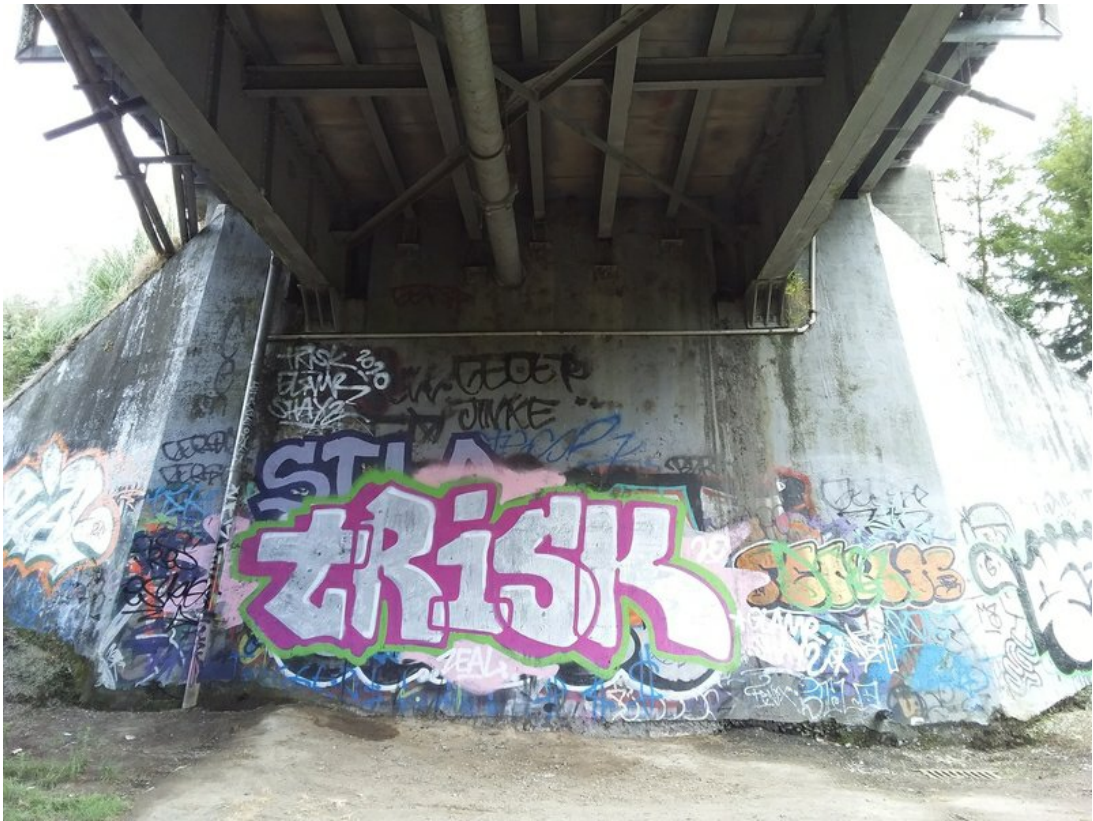
Substructure Drainage (Element 16): Water leakage marks on front face of Abutment A.

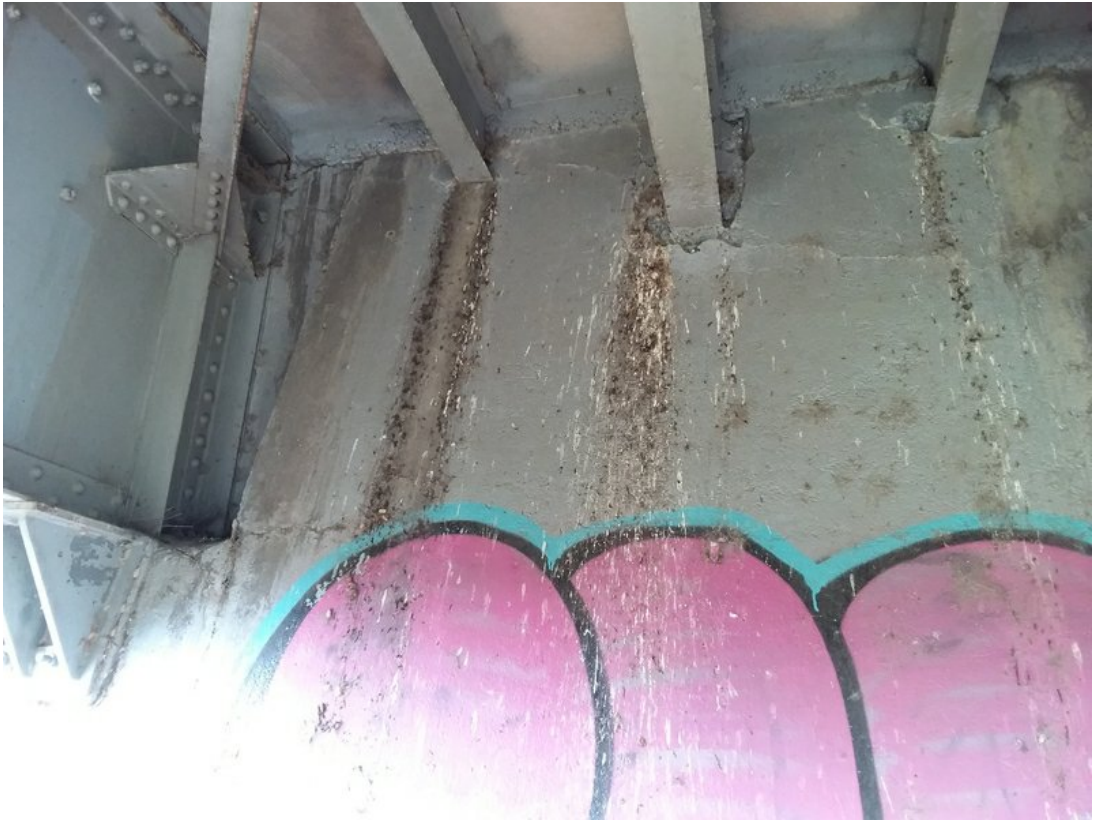
Substructure Drainage (Element 16): Water leakage marks on front face of Abutment A.

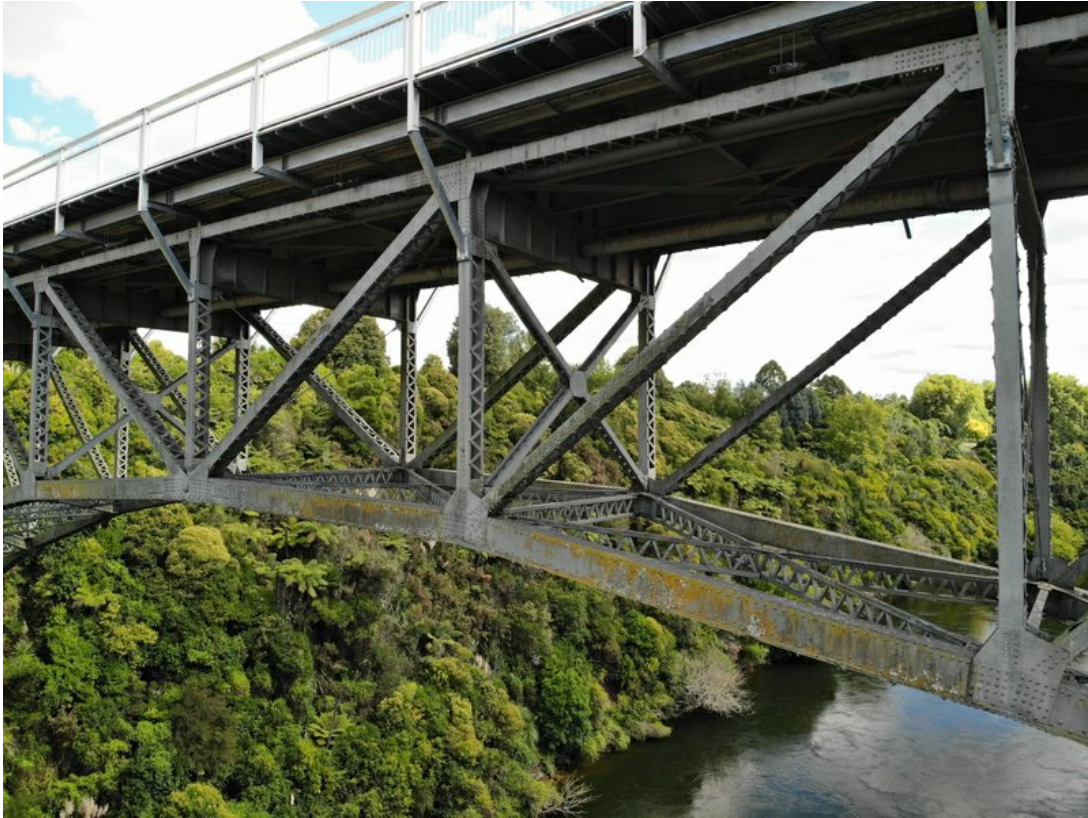
Painting: Superstructure Elements (Element 18): The general condition of the entire coating system is considered stable. View from U/S side.

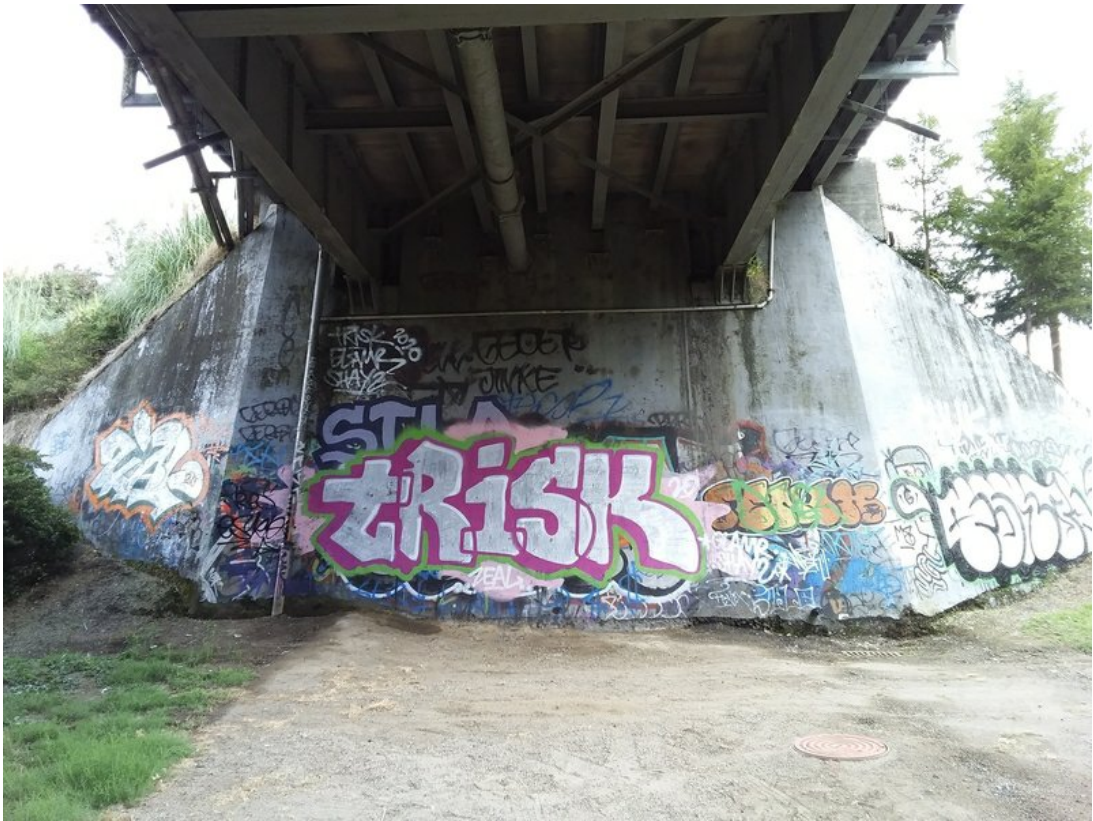
Painting: Substructure Elements (Element 19): Graffiti on Abutment A and wing walls.

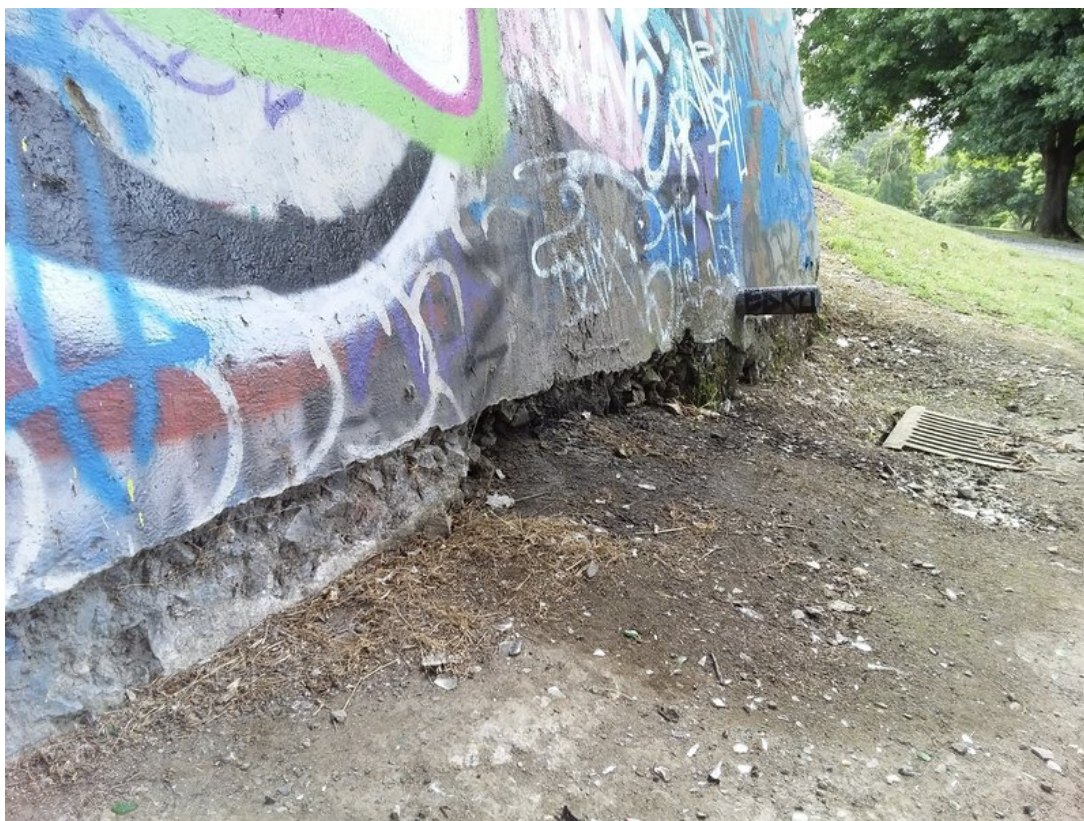
Scour (Element 29): Erosion at base of upstream side of Abutment A caused by stormwater runoff.

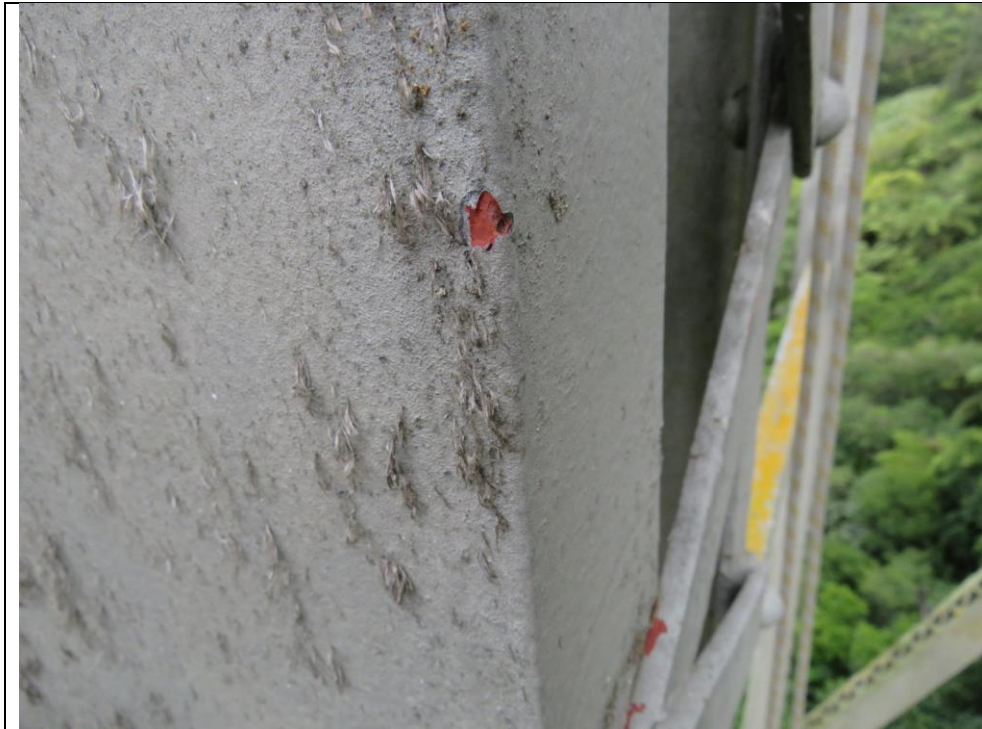
MECHANICAL DAMAGE EXPOSING RED LEAD COATING

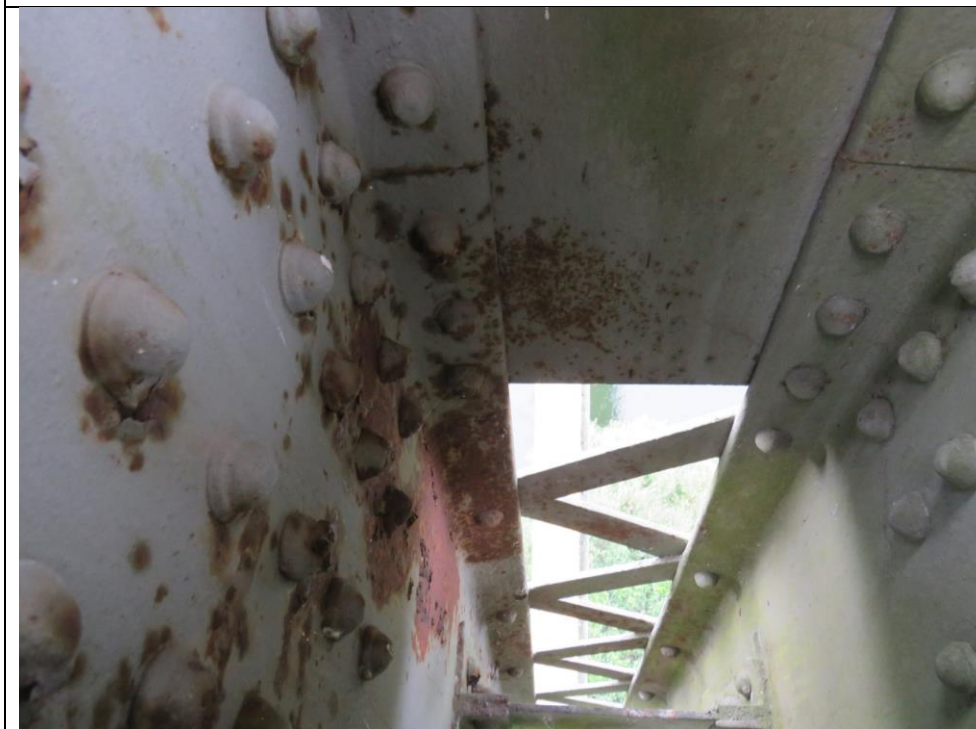
CORROSION ON INTERNAL FACE OF VERTICAL LACED COLUMN CAUSING COATING DELAMINATION

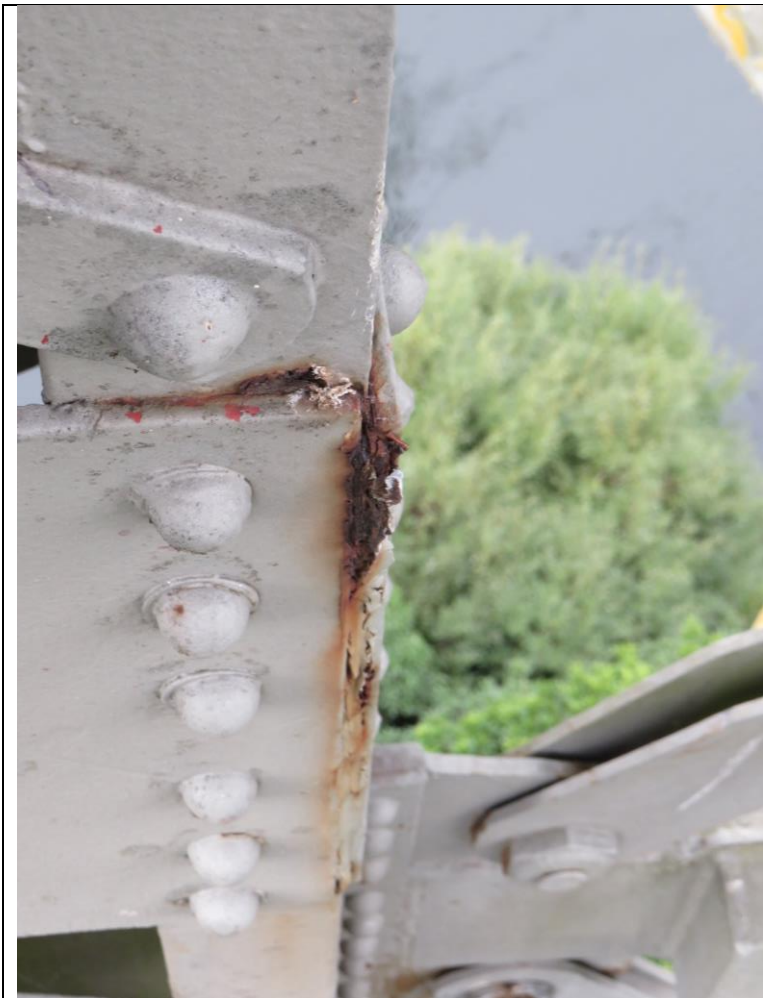
METAL LOSS DUE TO CREVICE CORROSION ON SPLICED SECTION OF LACED COLUMN

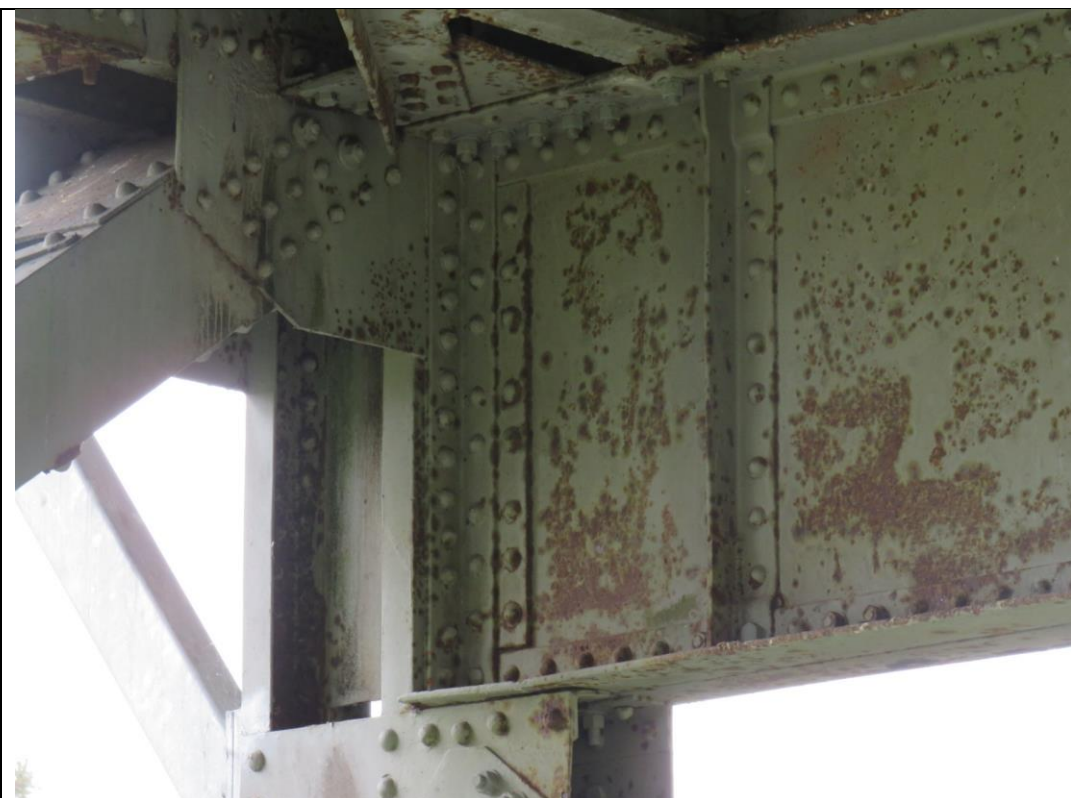
SURFACE CORROSION SCATTERED ON TRANSOM

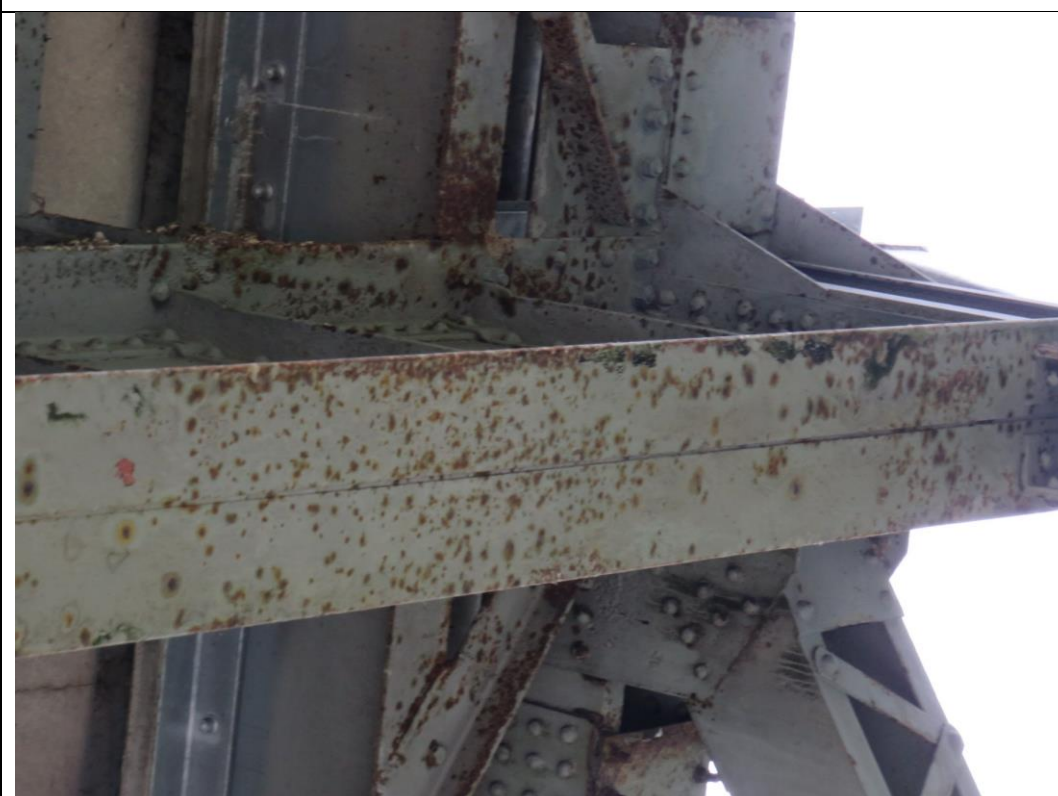
SURFACE CORROSION SCATTERED ON SHARP EDGES AND FLANGE UNDERSIDE OF TRANSOM

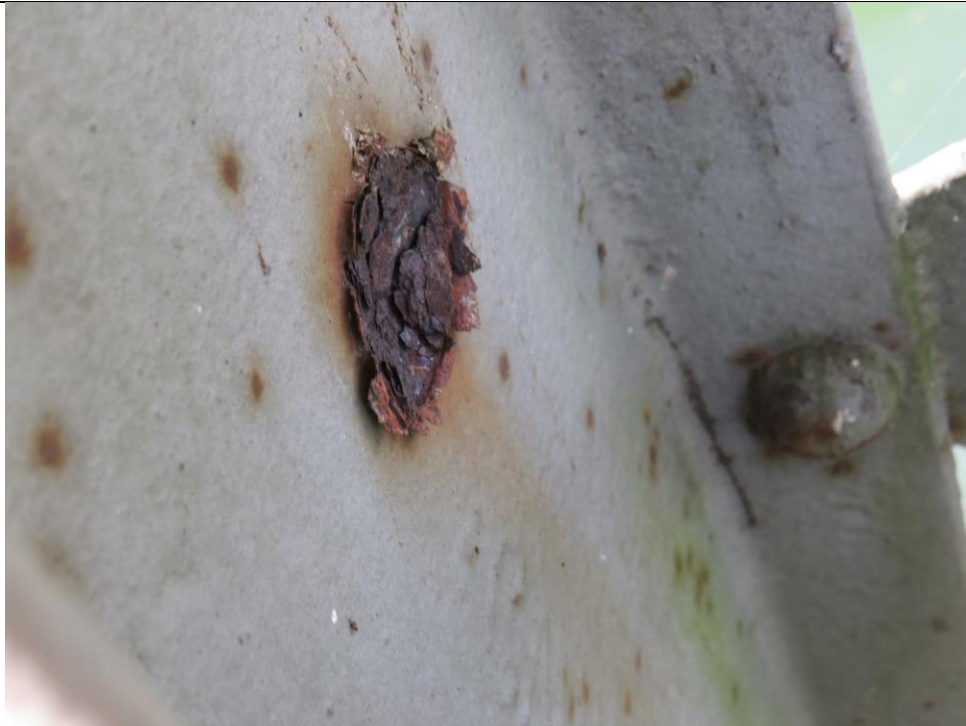
PITTING CORROSION ON INTERNAL FACE OF VERTICAL COLUMN

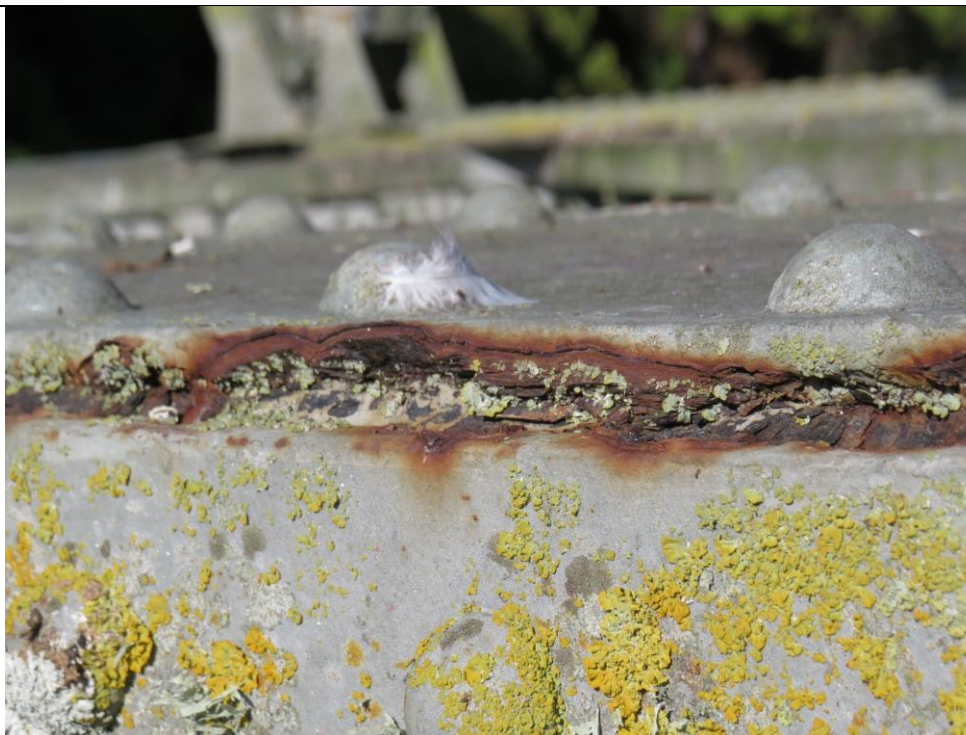
PITTING CORROSION WHERE JOINT SEAL HAS FAILED.

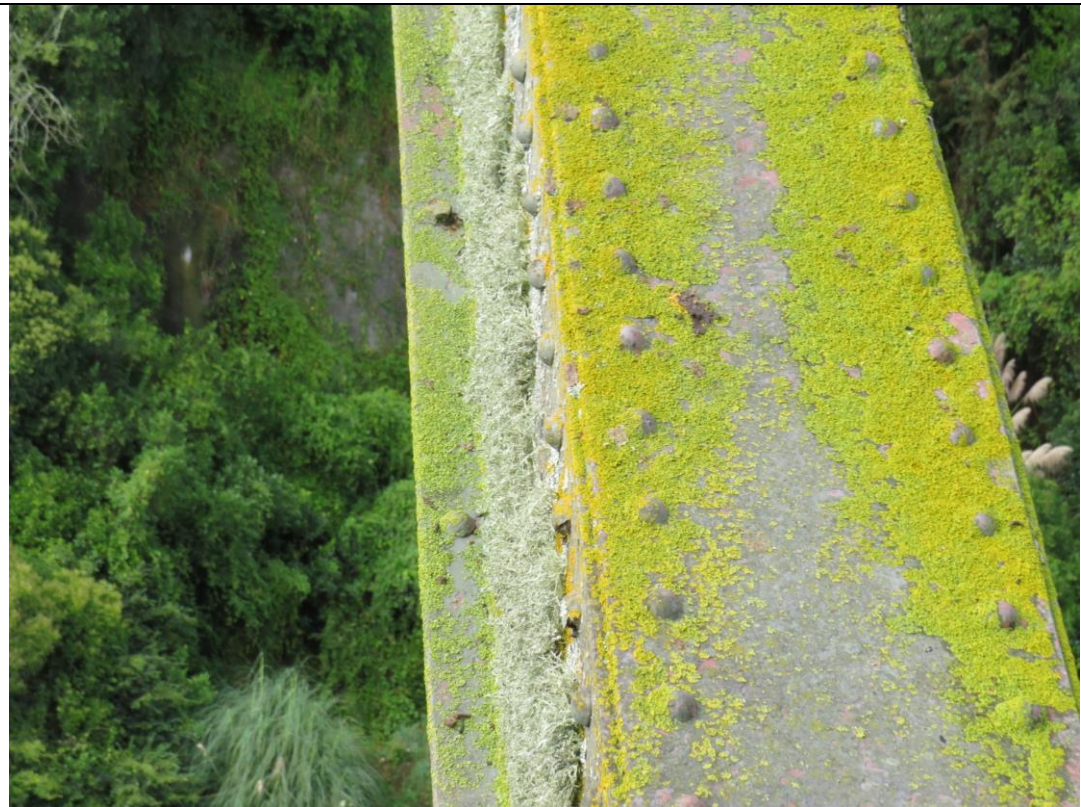
FUNGAL GROWTH WITH CORROSION VISIBLE AT RIVET ENDS

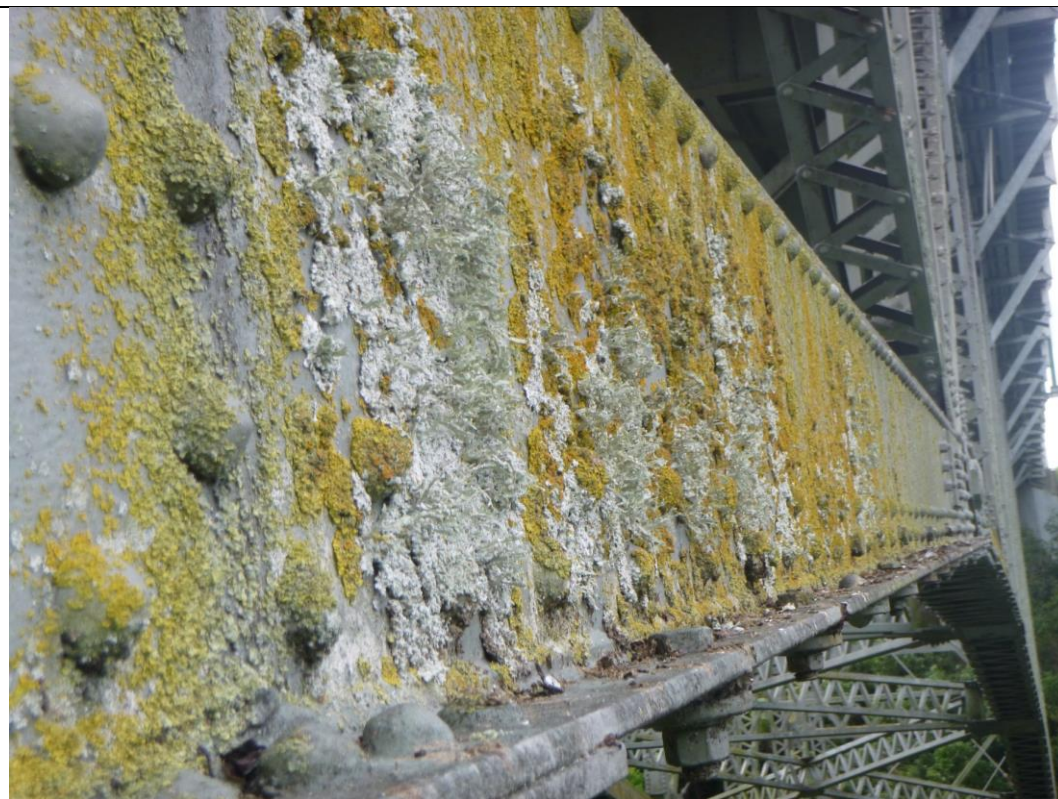
FUNGAL GROWTH ON INTERNAL FACES OF LACED COLUMN

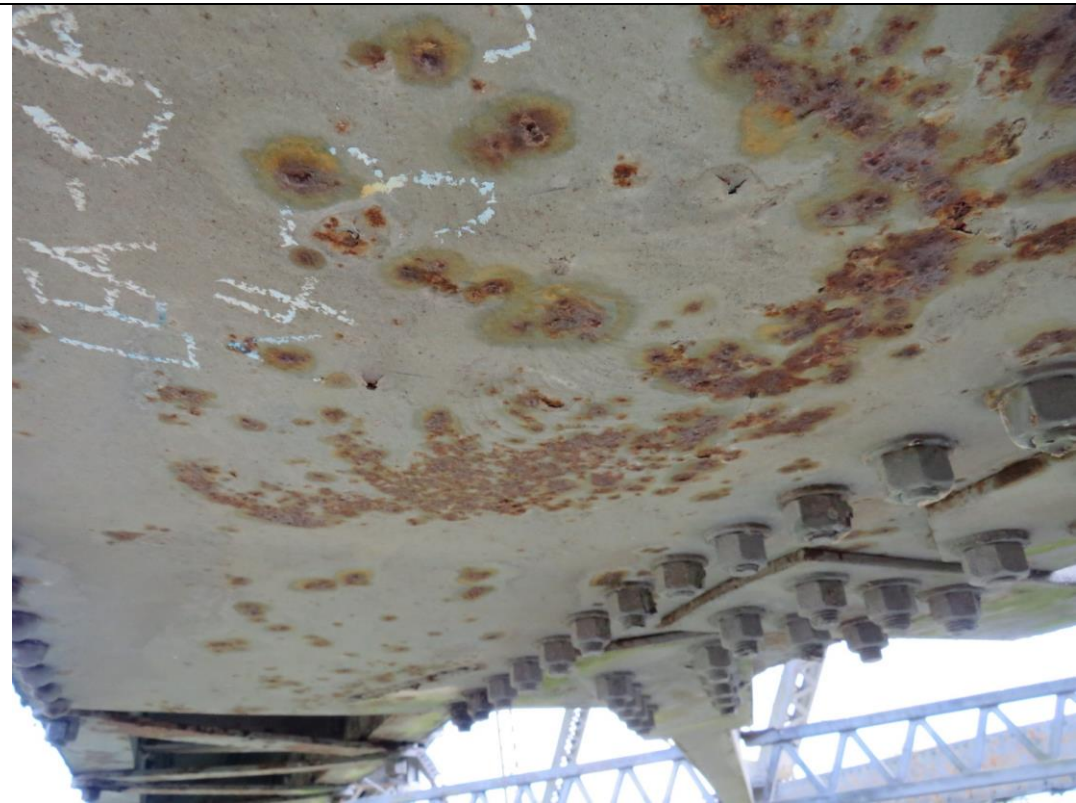
GENERAL CORROSION ON UDESIDE FACE OF BOTTOM ARCH

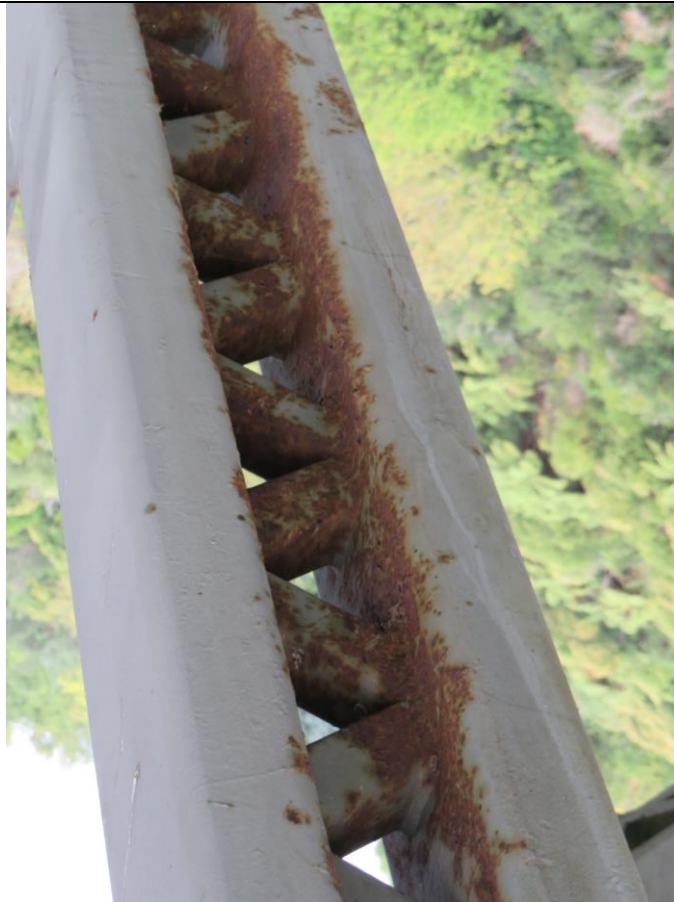
SURFACE CORROSION ON DIAGONAL CROSS BRACING

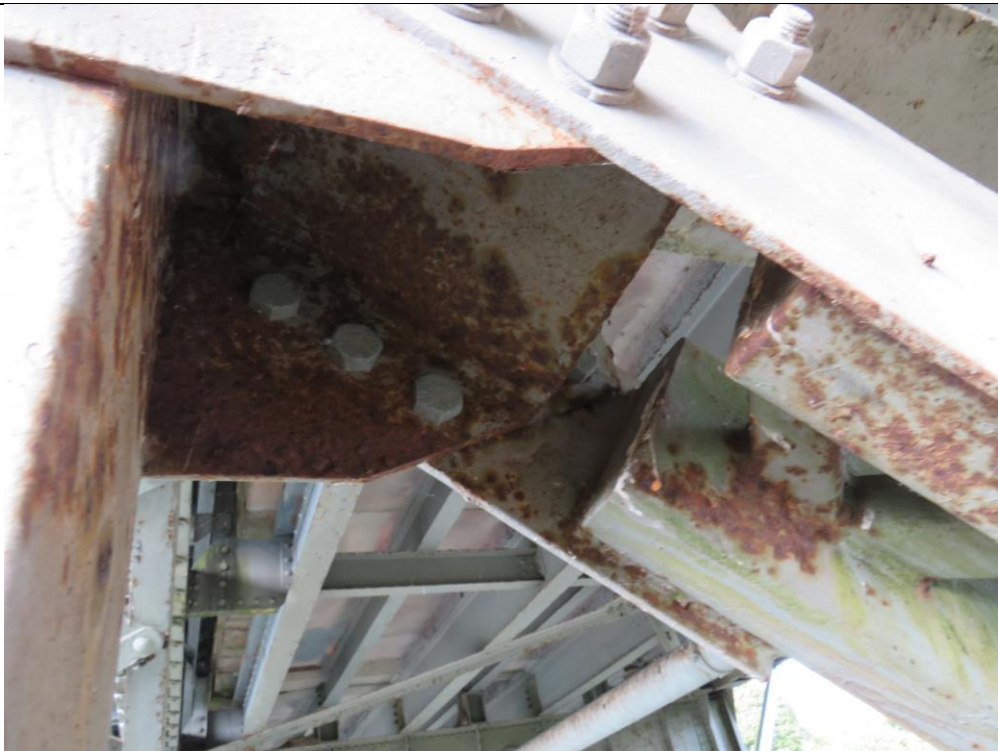
SURFACE CORROSION AT CONNECTION NODE OF DIAGONAL CROSS BRACING

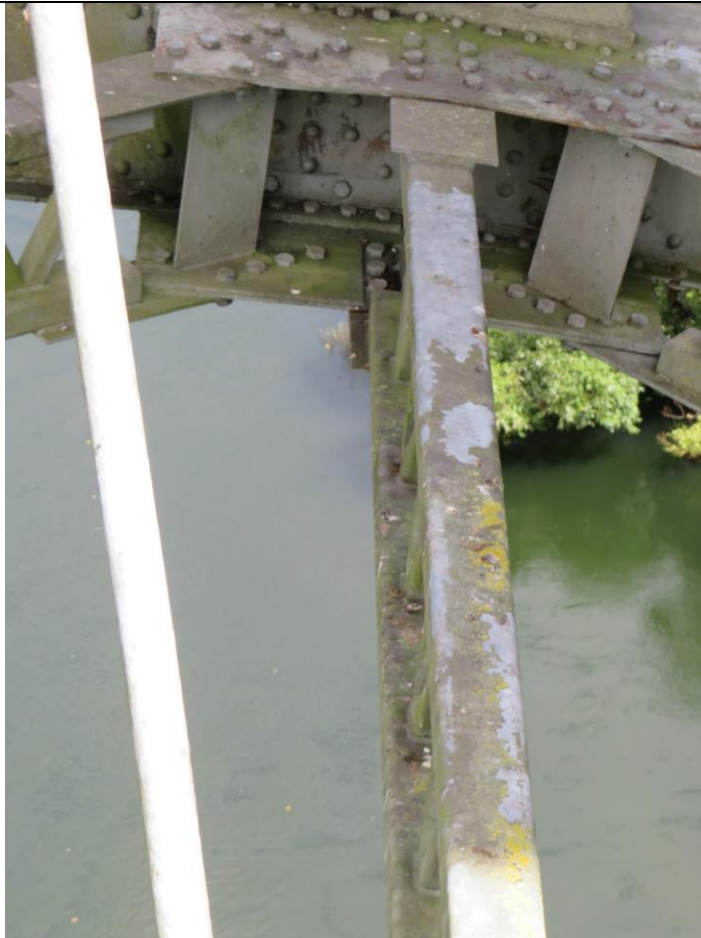
COATING DELAMINATION

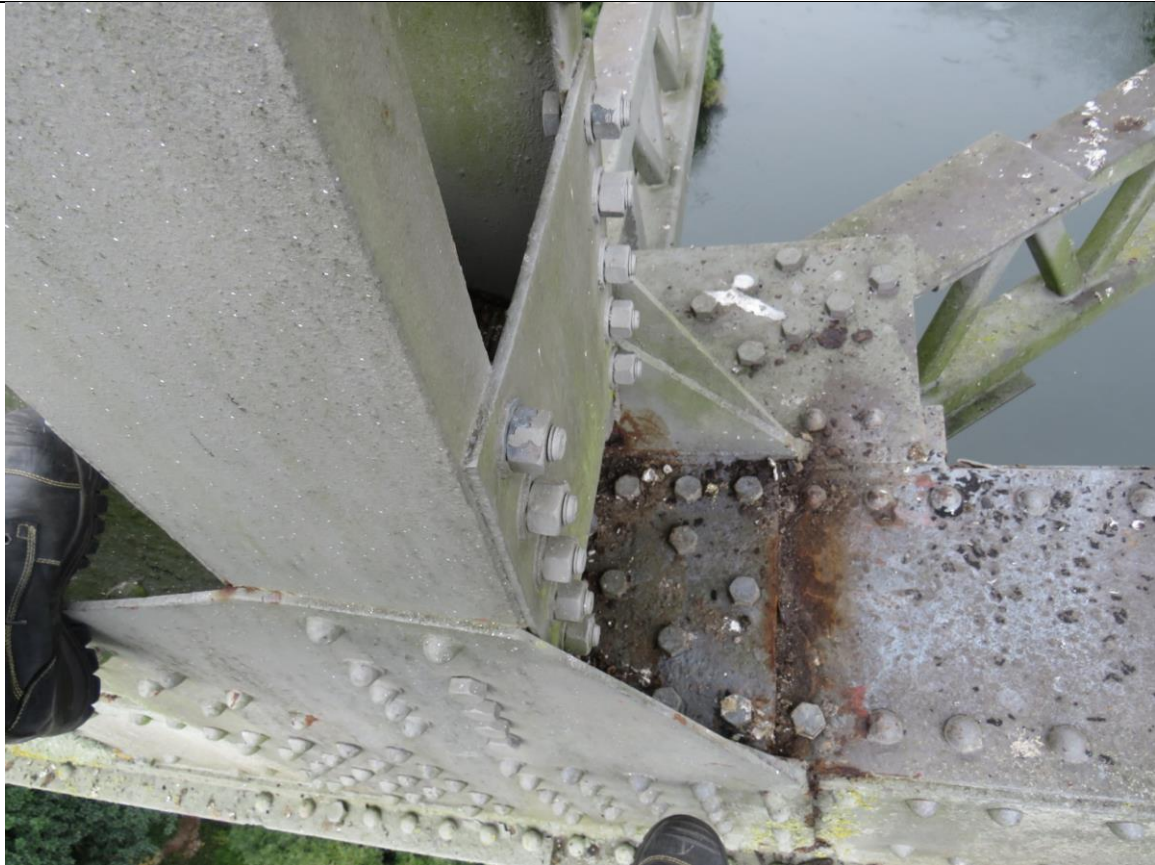
GENERAL CORROSION AT VERTICAL COLUMN AND ARCH CONNECTION

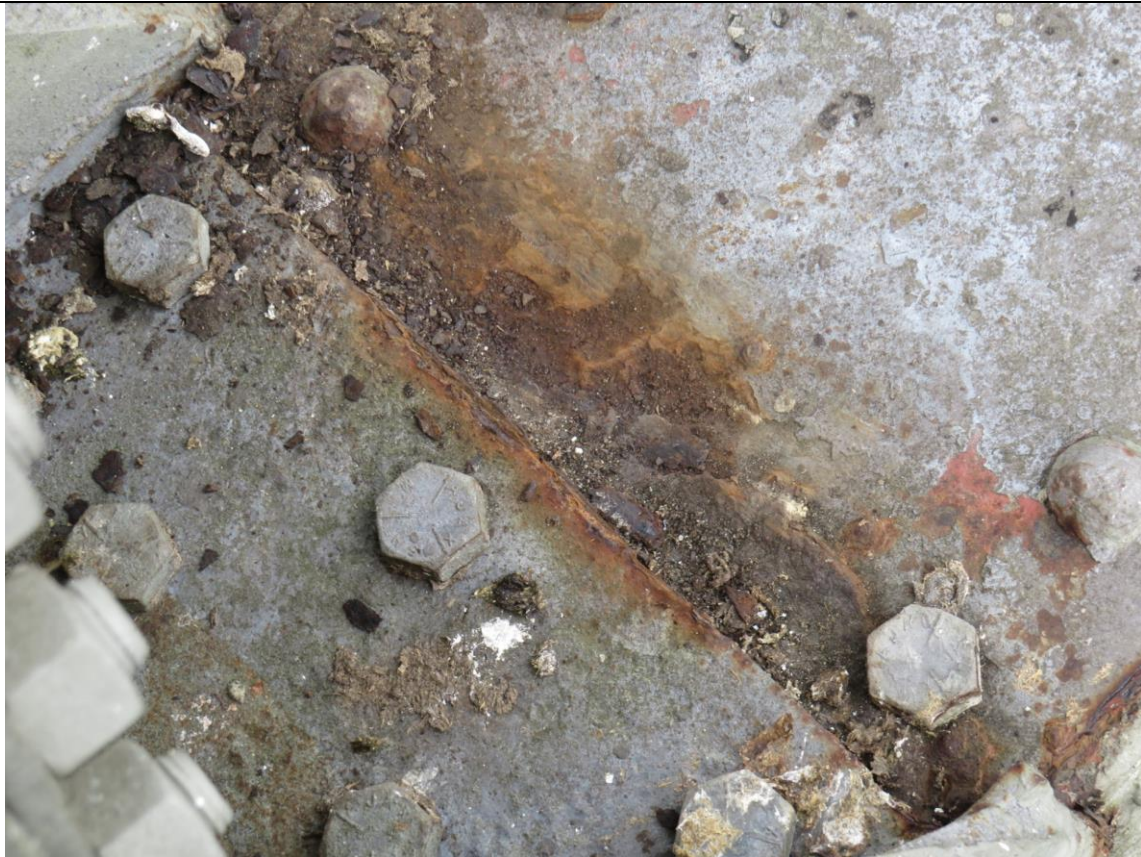
GENERAL CORROSION AT VERTICAL COLUMN AND ARCH CONNECTION

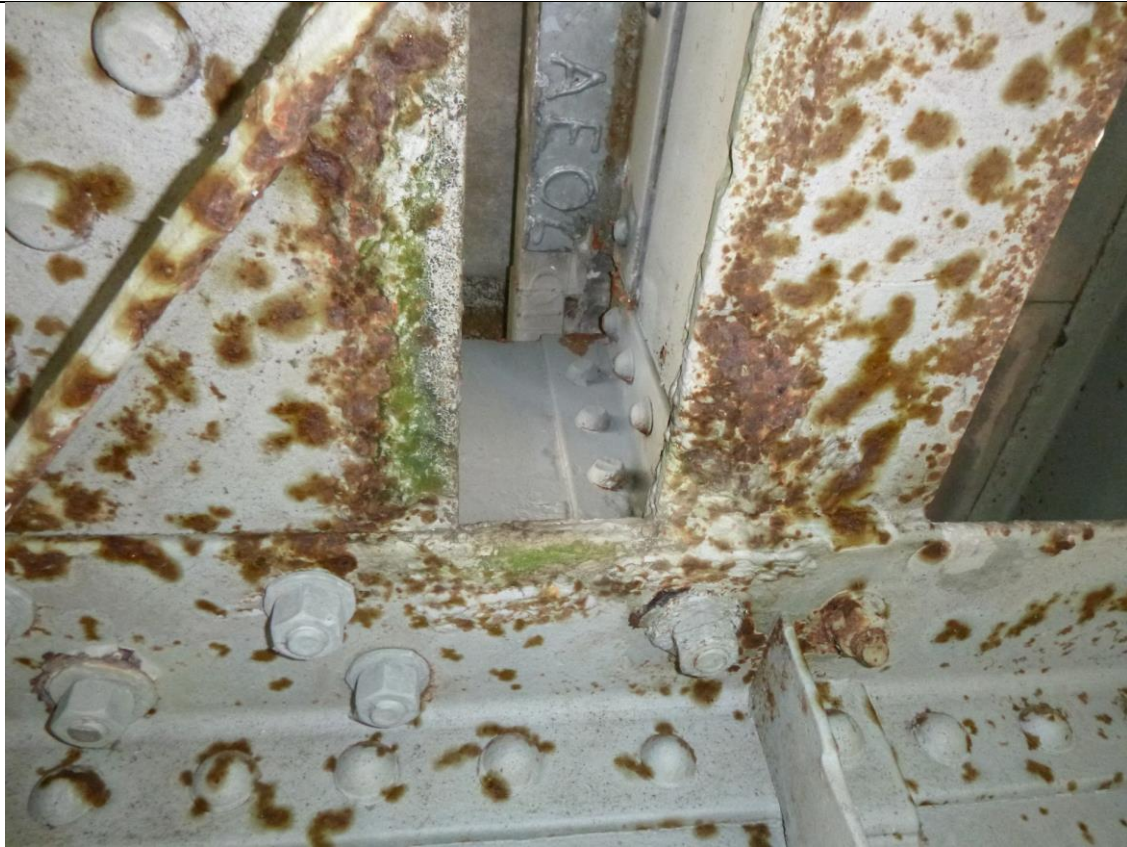
GENERAL CORROSION WITH COATING DELAMINATION AT TRANSOM AND STRINGER CONNECTION

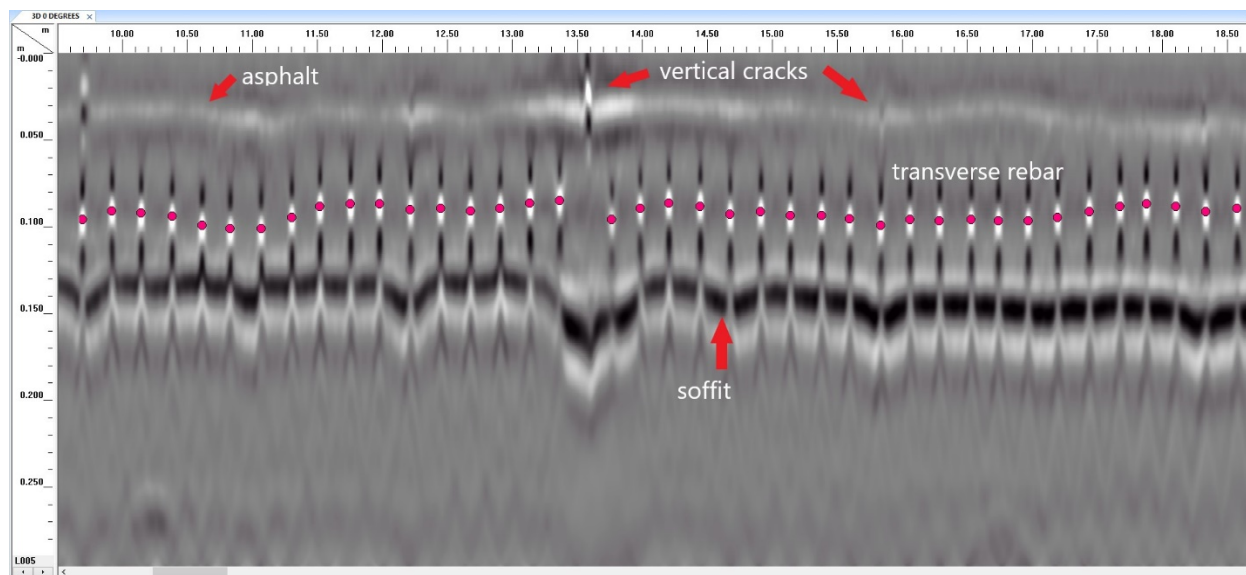
**Fig 2:** Northbound Inner Edge, Y=2.15m showing crack at 13.6m.

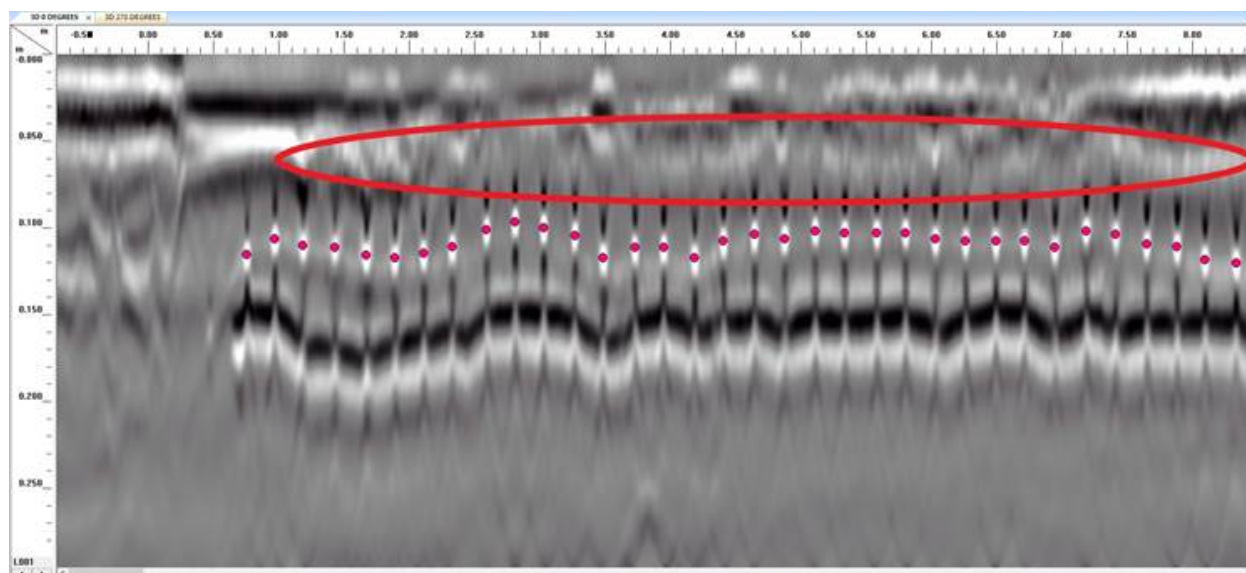
**Fig 3:** Northbound Outer Edge, Y=0.25m showing reflections within the concrete.

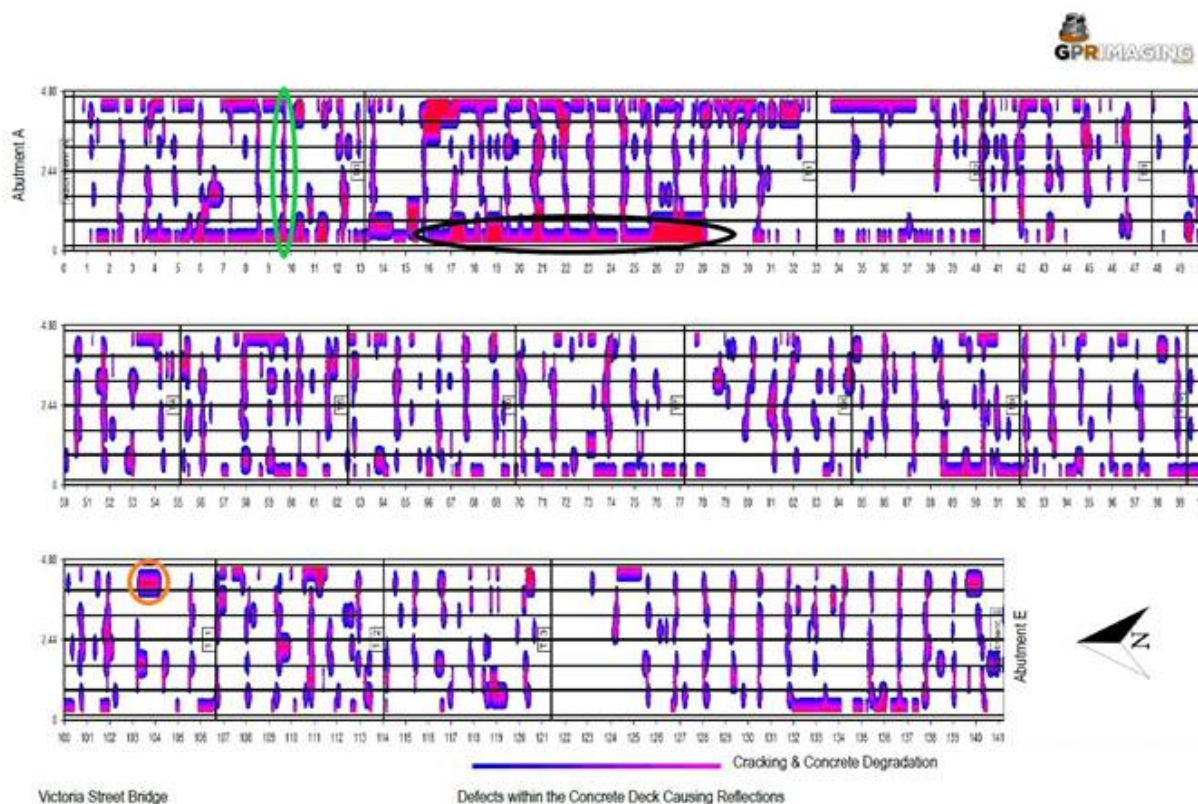
**Fig 4:** An example of vertical cracking is circled in green. An example of an area of overall poor concrete condition is circled in black and an example of a localised concrete issue is circled in orange. Further comments are included in the excel spreadsheet.
