# Victoria Street Bridge (Cambridge) Condition Assessment Report

Prepared for Waipa District Council

Prepared by Beca Limited

10 August 2020

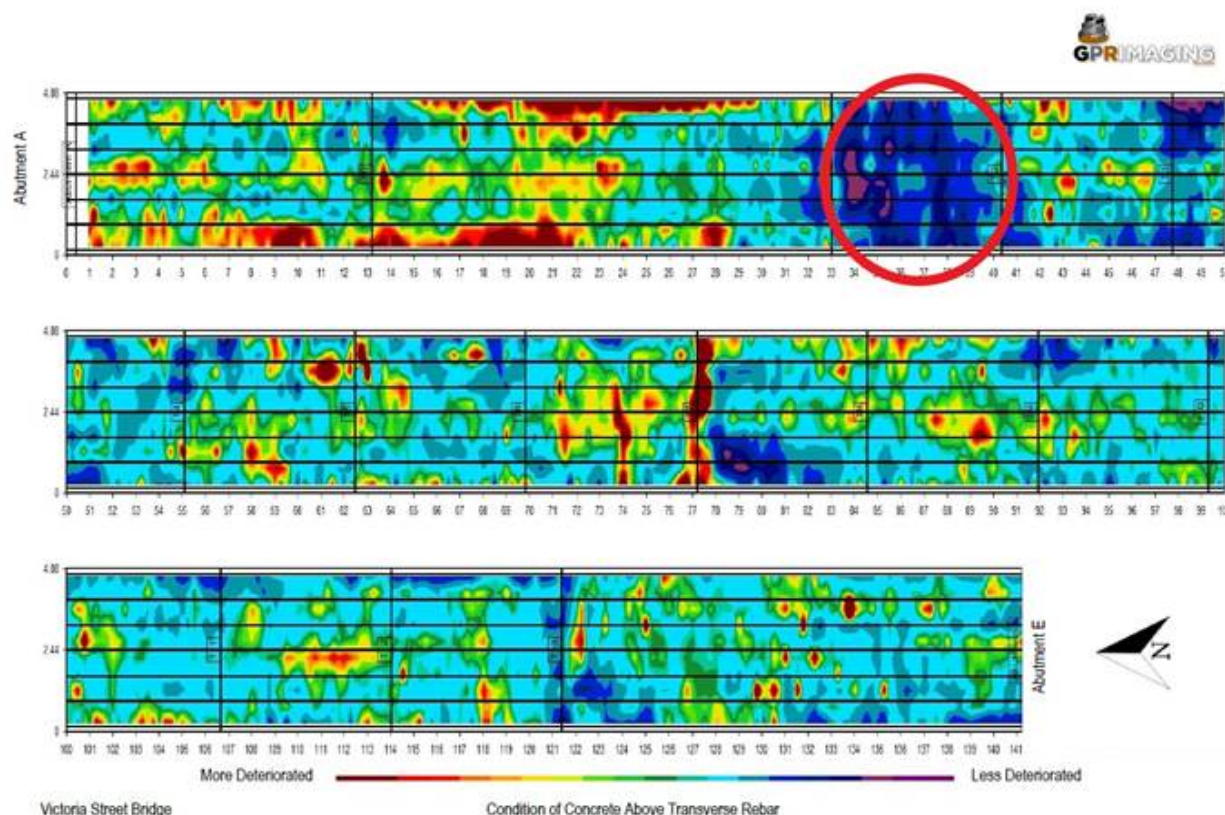
The file “Map of Concrete Condition Above Transverse Rebar” is based on wave scatter above the rebar. Please be aware, the span T1-T2 showing as less deteriorated, is significantly influenced by the compromised cover in this area (only 20-30mm in places), so we would consider the condition of the concrete is similar to elsewhere rather than less deteriorated as shown.

**Fig 5:** Showing the span T1-T2 referred to above.

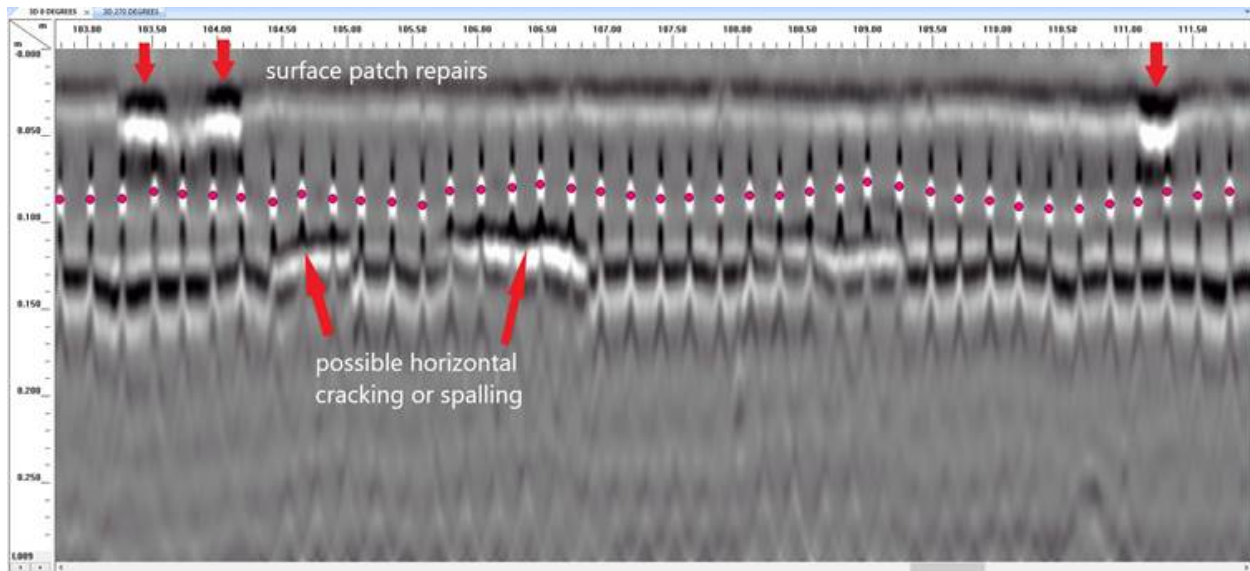
There are also what is interpreted to be surface patch repairs in various locations (though these could also be an area of concrete that is very bony). An example of what these look like (including possible spalling) is shown below. If one of these locations is cored, it will confirm what they are for the length of the deck.

**Fig 6:** Southbound LWP, Y=4.23m showing surface patches and possible horizontal cracking.
