# T4 Growth Cell Private Plan Change

## Ecological Impact Assessment

**Project Name:** T4 Growth Cell Private Plan Change

**Document:** Ecological Impact Assessment

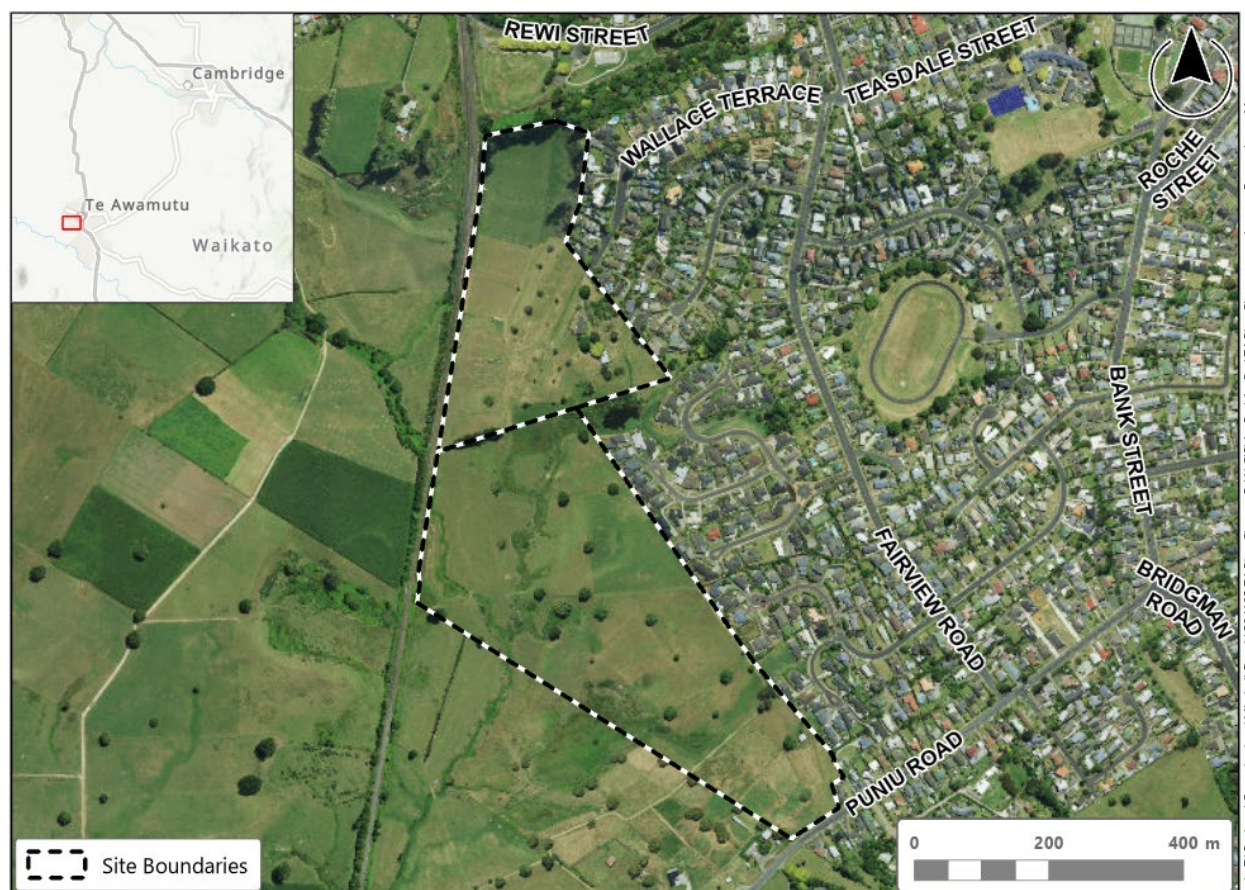
Figure 1: Overview of the T4 Growth Cell, Te Awamutu.

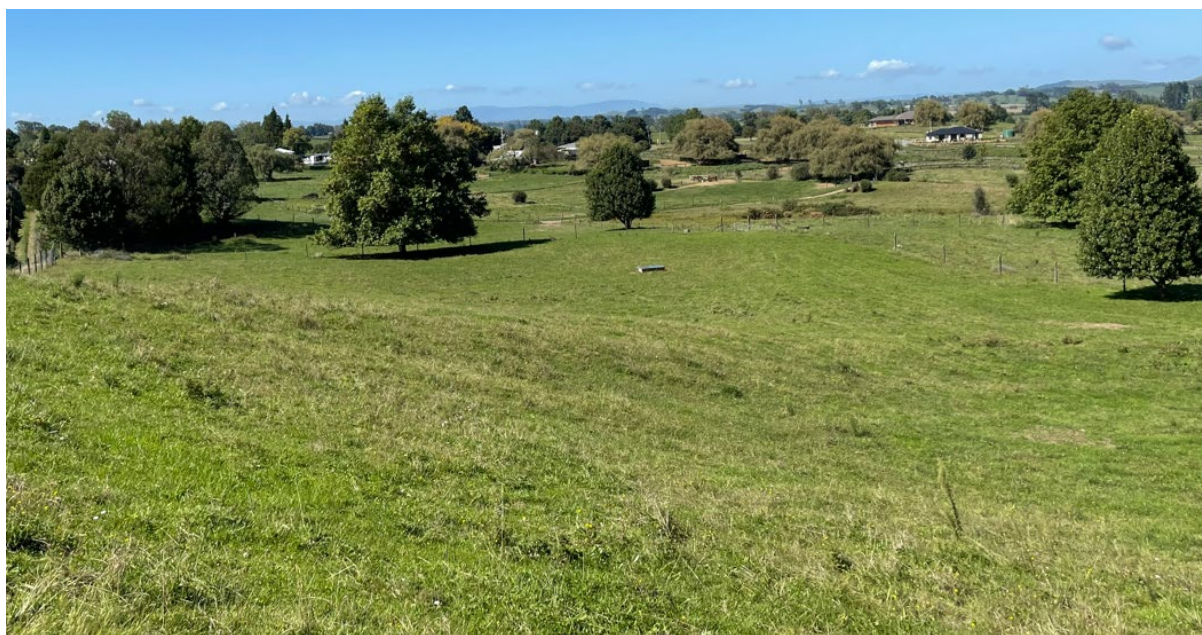
Figure 2: Looking southwest from the farm race across pasture fields with sporadic mature exotic trees on the southern property.

The LCDB describes the entire site as high producing exotic grassland, which is an accurate high-level description (refer to the aerial photograph in the map provided as Appendix 1). Landcover on the southern-most property is primarily in pasture grass (*Lolium perenne*) as well as paspalum (*Paspalum dilatatum*), and the associated herbaceous vegetation buttercup (*Ranunculus repens*), clover (*Trifolium repens*), and dock (*Rumex obtusifolius*) (Figure 2). The northern property is utilised for crop production; at the time of the March 2023 site visit the property was predominantly exposed soils due to the recent harvesting of maize (Figure 3).

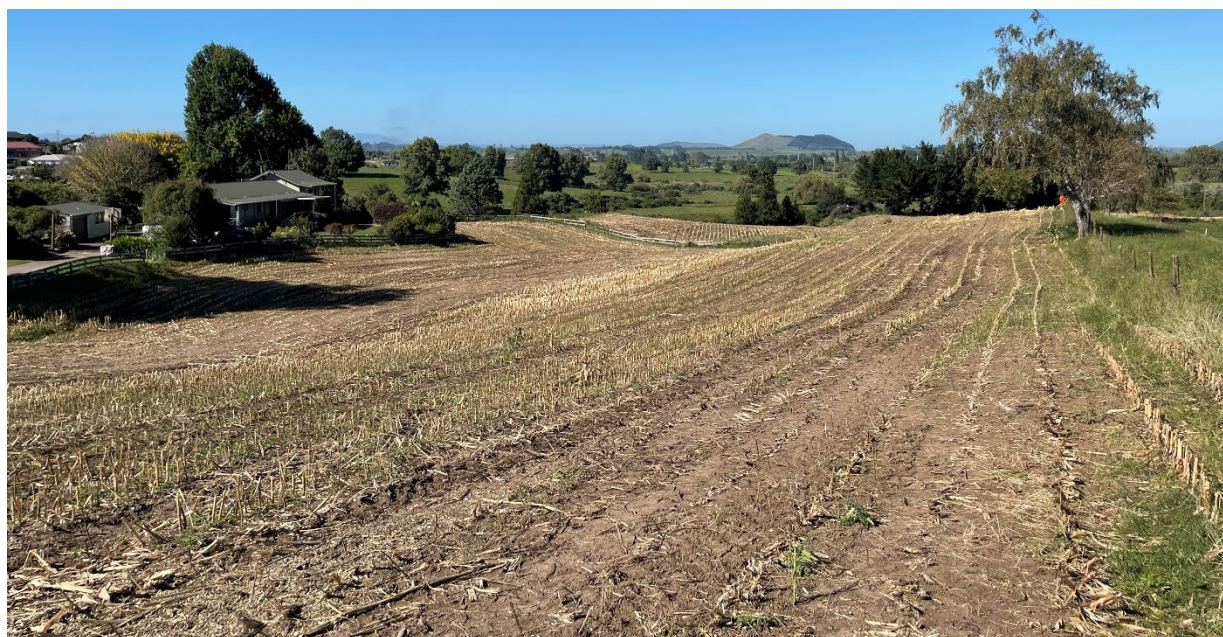
Figure 3: Looking south across the northern property from the northern boundary; visible recent crop harvest.

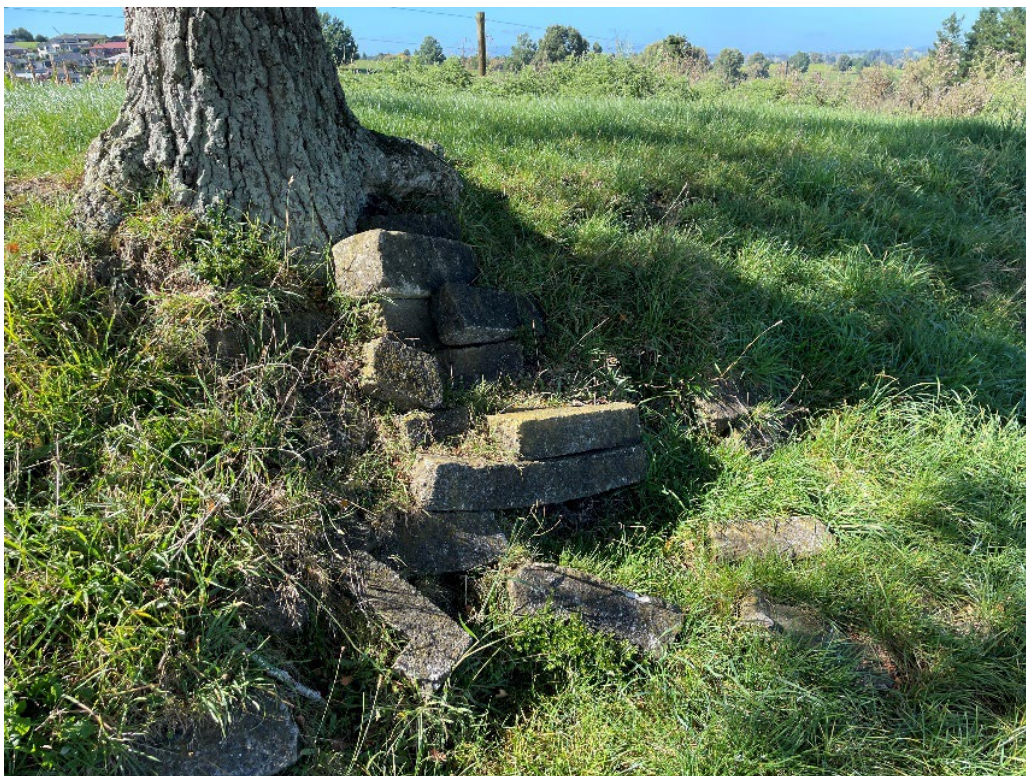
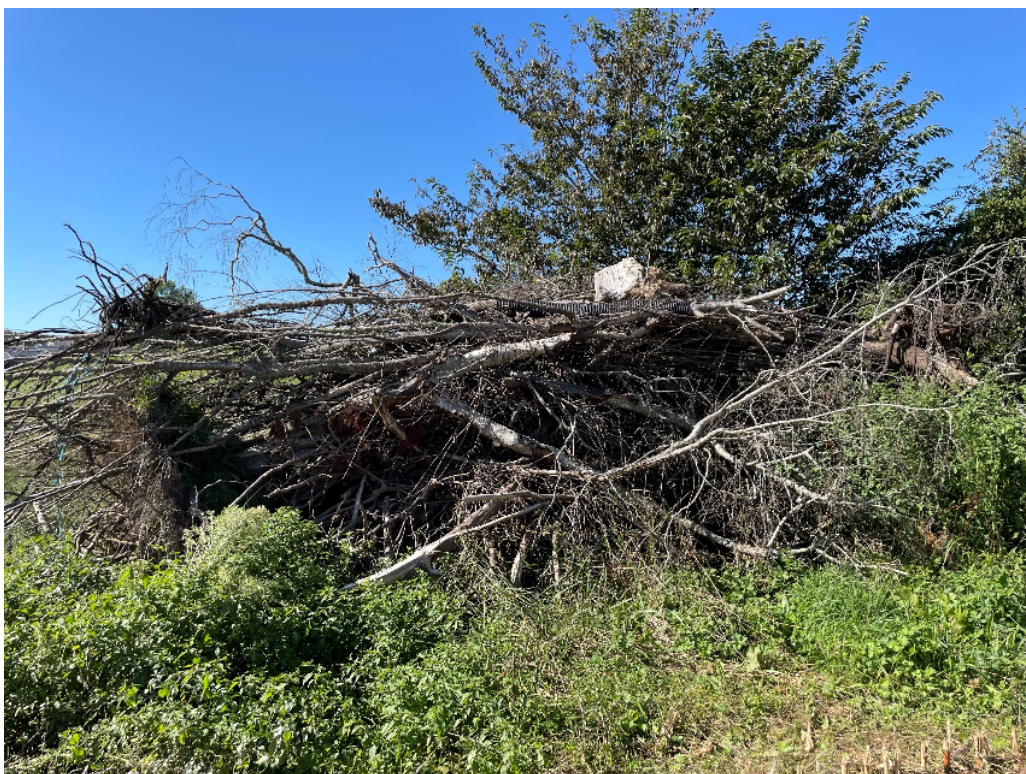
Figure 4: Examples of potential skink habitat.

There is potential that the site is inhabited by the copper skink (*Oligosoma aeneum*) based on the habitat on-site and records within similar habitat in the wider area. Copper skinks are found throughout the North Island, and live amongst leaf litter, under rocks, logs, and debris, as well as in rank pasture.

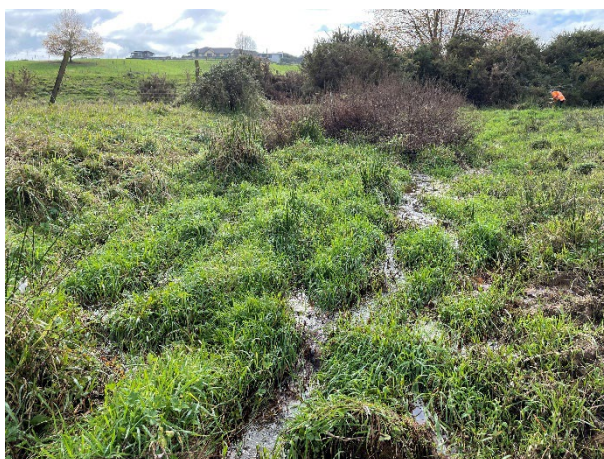
Figure 5: Stream 1 looking north from the southern boundary of the site.

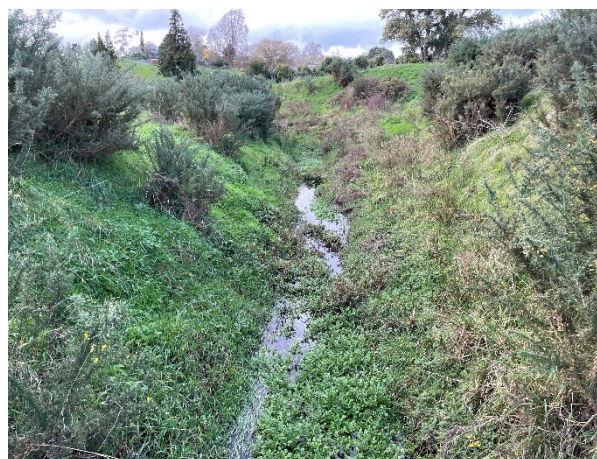
Figure 6: Stream 2 looking north from the northern-most stream crossing.

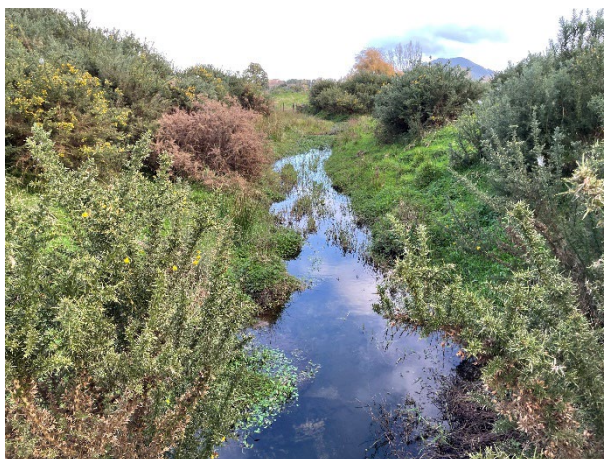
Figure 7: Pool habitat in Stream 2, looking south from the northern-most stream crossing.

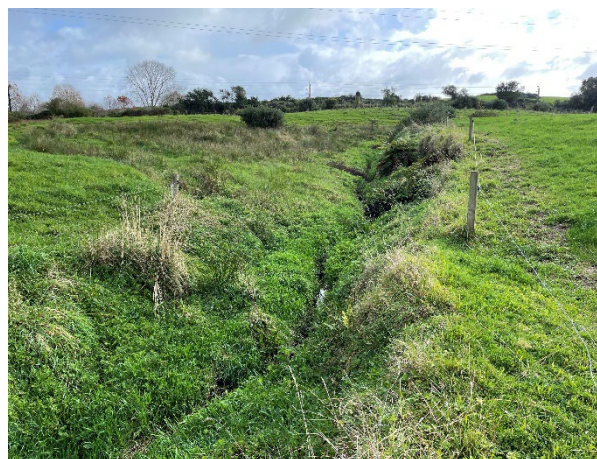
Figure 8: Stream 3 looking northwest from the site stream crossing.

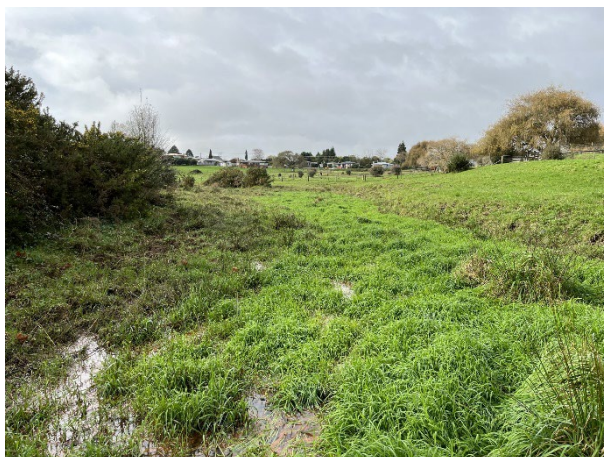
Figure 9: Looking east from within Wetland 1.

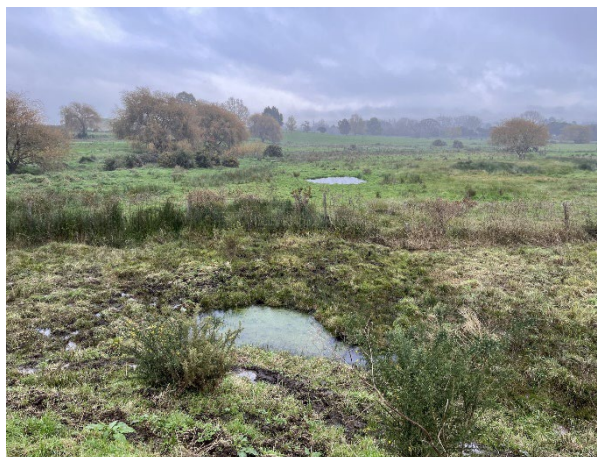
Figure 10: Looking south from above Wetland 1; site boundary fence through the middle of the photo.

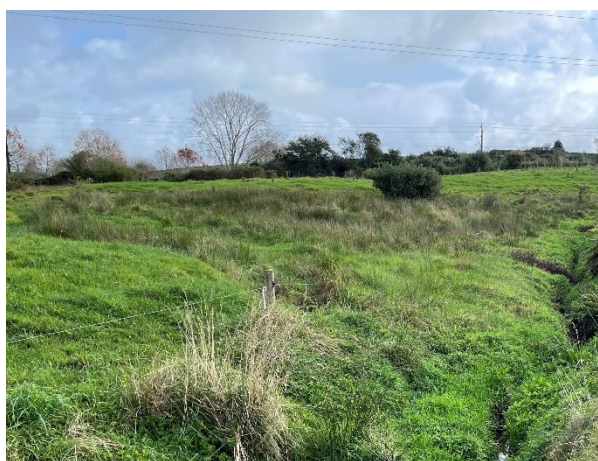
Figure 11: Looking northwest at Wetland 2 on the true left bank of Stream 3.

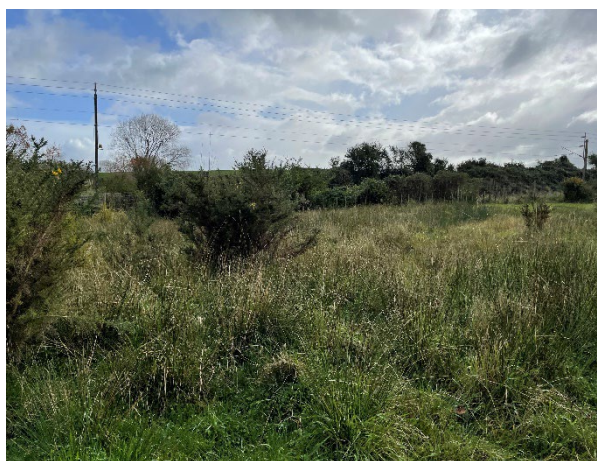
Figure 12: Looking west across Wetland 2.1.

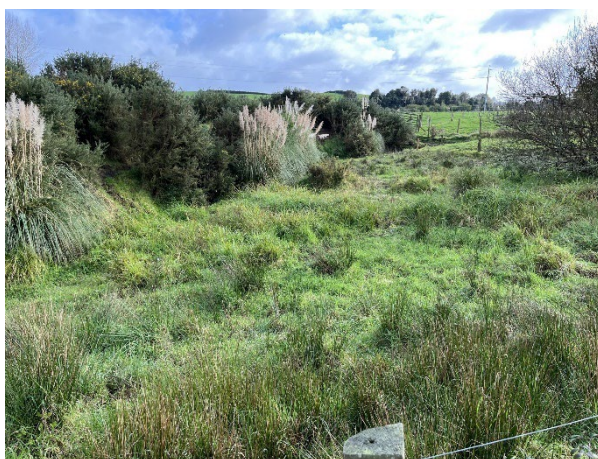
Figure 13: Looking northwest across Wetland 3 from the wetland boundary.

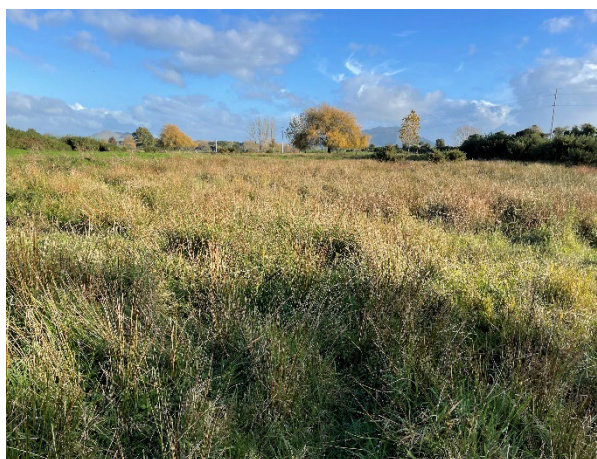
Figure 14: Looking south across Wetland 4.

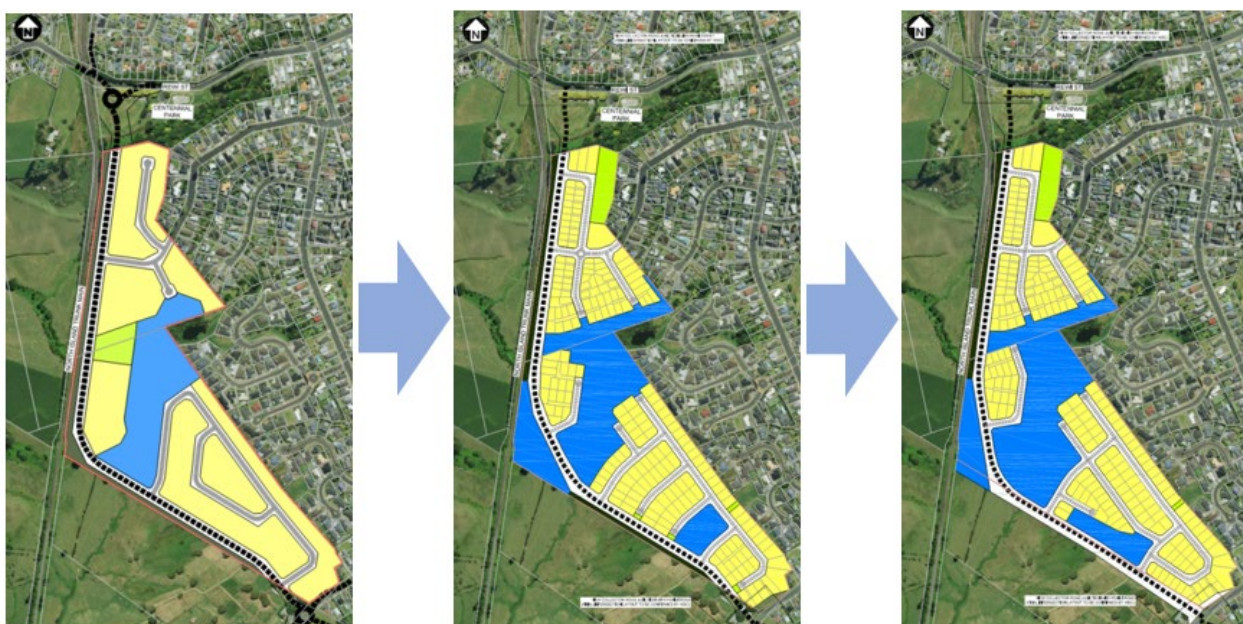
Figure 15: Structure Plan layout evolution to accommodate natural features; residential development is displayed in yellow, with open space in green and stormwater management areas displayed in blue.

The current Structure Plan is the result of design input and feedback from various specialist areas, including the initial ecological findings from the Stage 1 assessment, and subsequent ecological modelling. The layout of the development has been amended to avoid as much of the natural hydrological features as possible, as demonstrated by the Structure Plan evolution in Figure 15 which demonstrates 3 of the previous revisions of the structure plan that all reduce the impact on streams and wetlands. The finalised layout and how it interacts with site freshwater features is displayed in Figure 16.

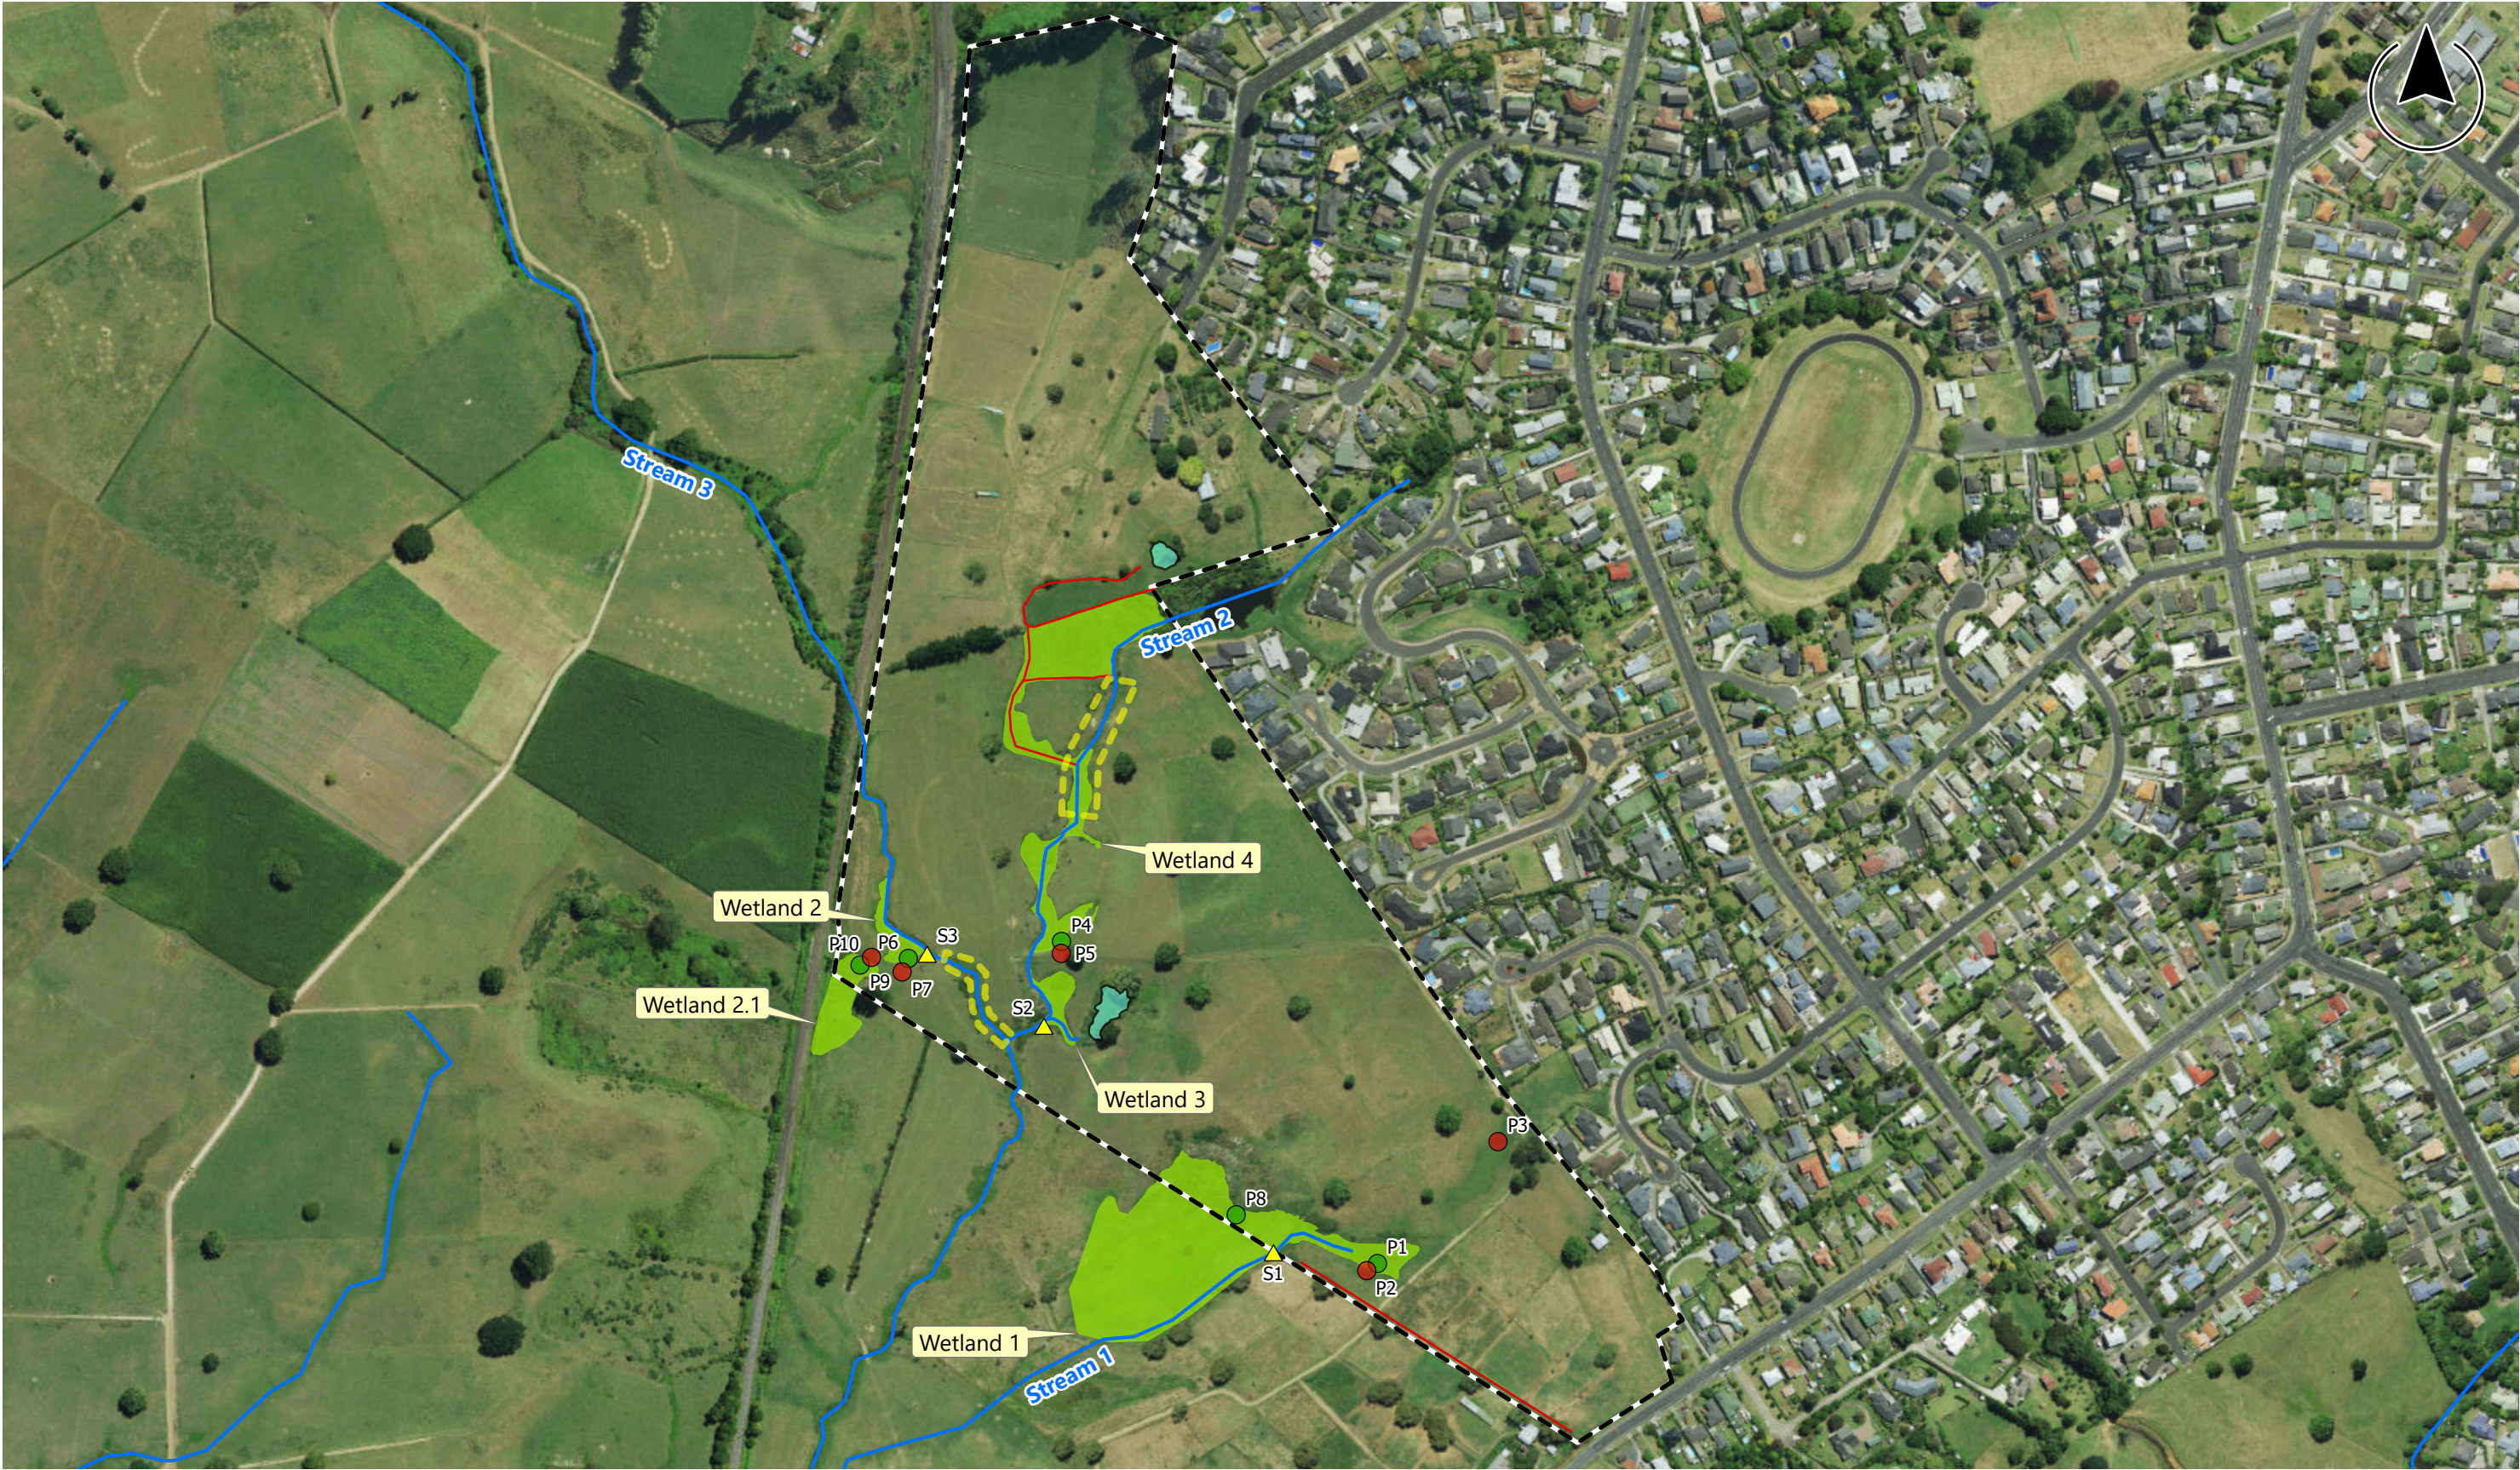
SITE OVERVIEW

- Not Wetland
  - Wetland
- ▲ eDNA Sample
  - Streams
  - Artificial Drains
  - SEV Reach
- Wetlands
  - Ponds
  - Site Boundary

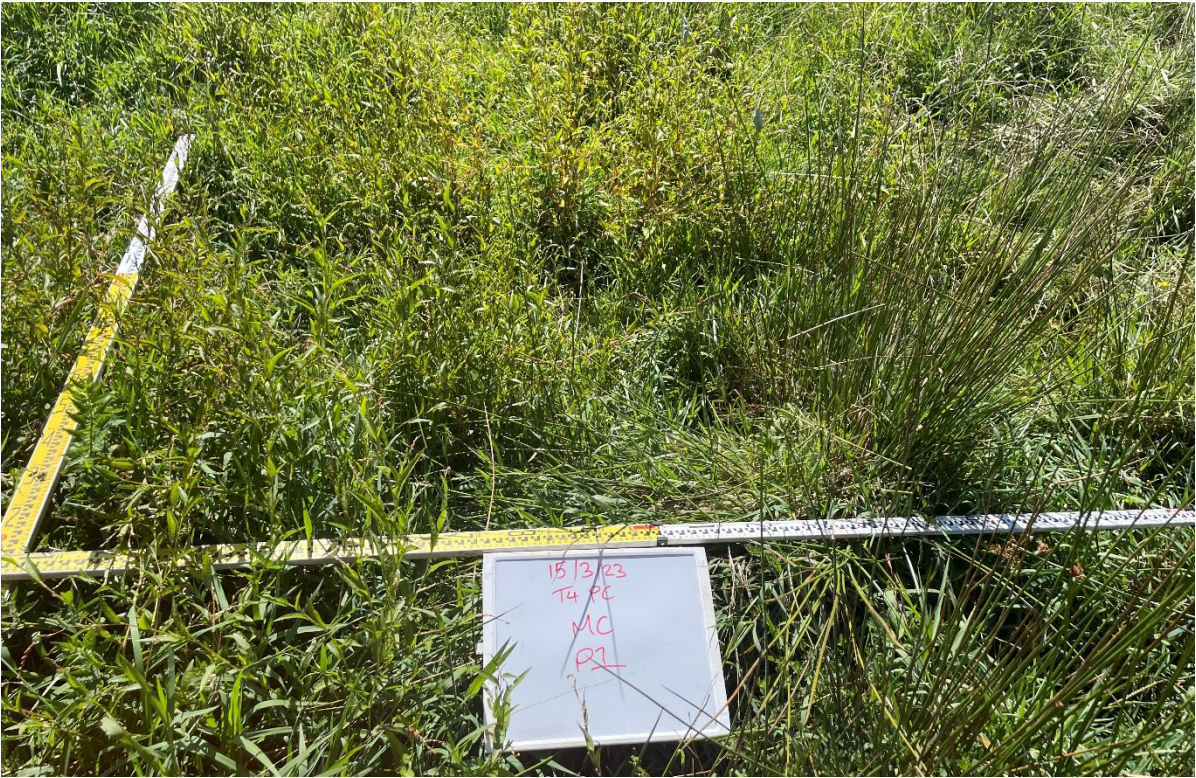
**Conclusion:** Presence of aquatic vegetation and ponded surface water, indicates the area is a wetland.

Figure 17: Point 1 vegetation plot.

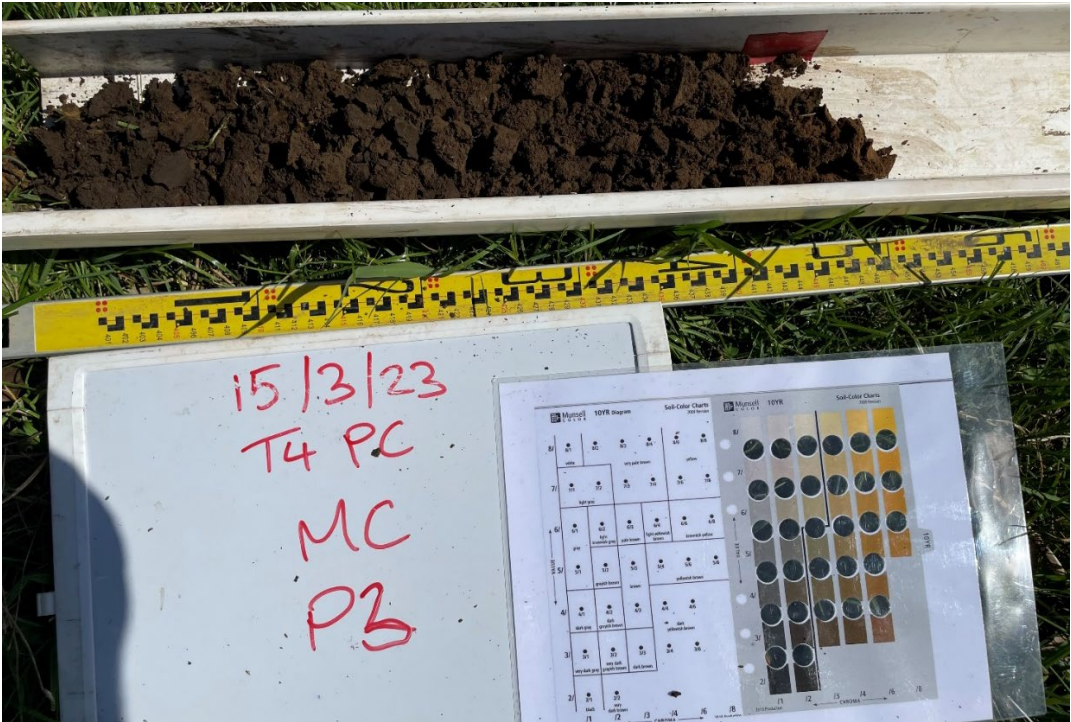
**Indicators of hydric soils:** No. Field notes describe the soils as relatively uniform from 0 – 500 mm, dry, friable, with no mottles or nodules. 0 – 300 mm 10YR 3/3, 300 – 500 mm 10YR 3/4, See Figure 20.

**Conclusion:** The vegetation and soils are not reflective of sustained hydric conditions reflective of wetland habitat. The area is indicative of an overland flowpath.

Figure 19: Point 3 soil profile.

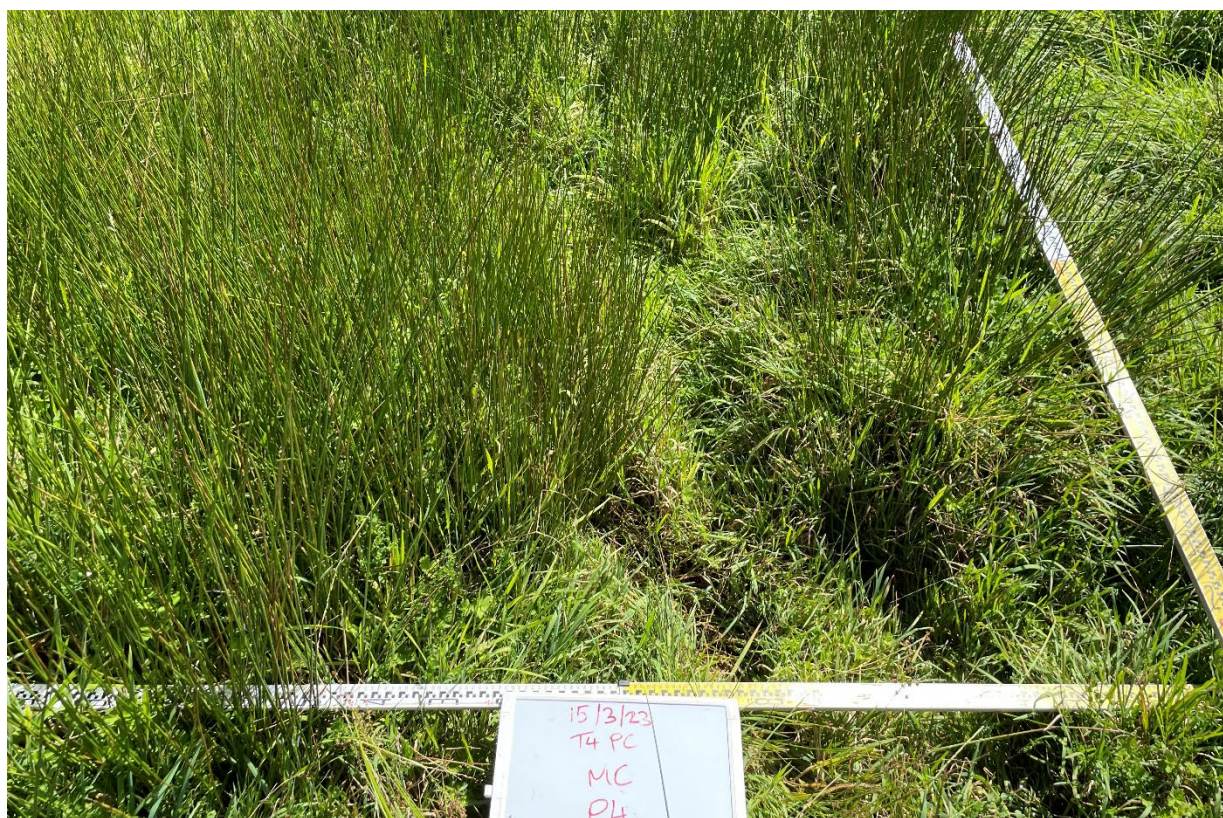
**Conclusion:** Dominance of facultative wetland vegetation and ponded surface water, indicates the area is a wetland.

**Figure 20: Point 4 vegetation plot.**

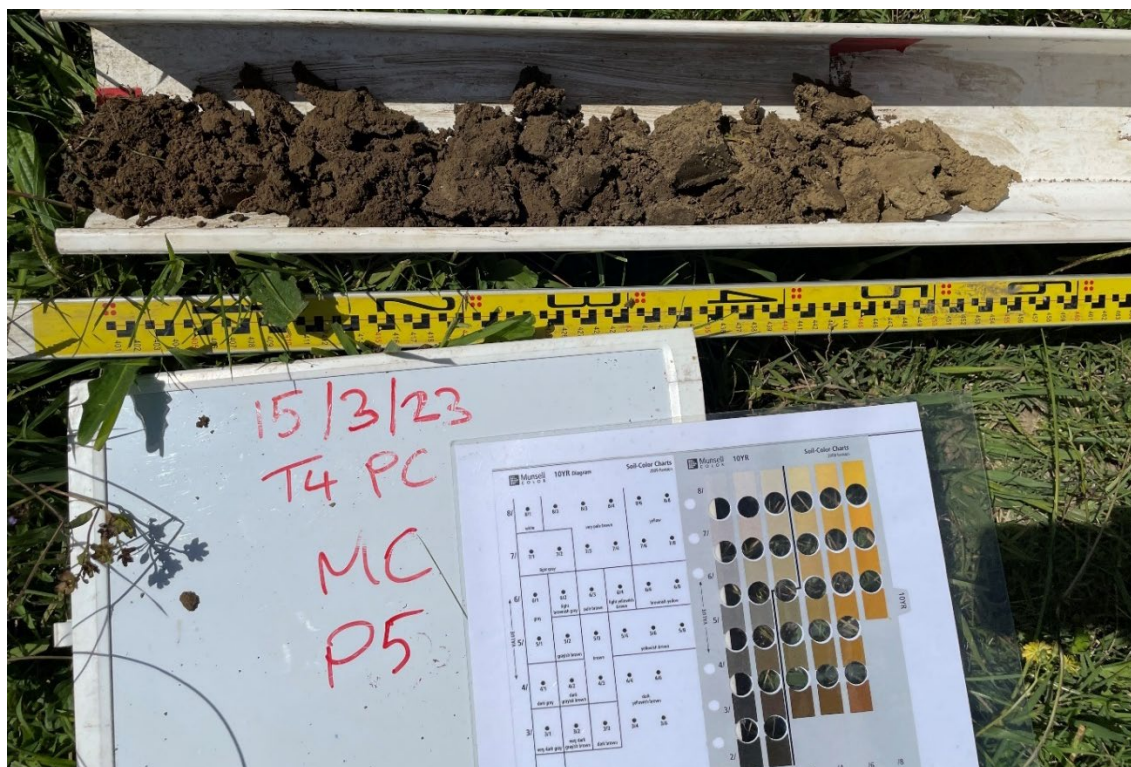
**Indicators of hydric soils:** No. Field notes describe the soils at 0 – 100 mm as topsoil (10YR 3/4), at 100 – 350 mm transition to light, friable, 10YR 4/4 sandy soils with no mottles or nodules; and at 350 – 500 mm slight increase in plasticity, but still light with no mottles or nodules (10YR 6/4). See Figure 22.

**Conclusion:** The vegetation and soils are not reflective of hydric conditions. This area is not a wetland.

**Figure 21: Point 5 soil profile.**

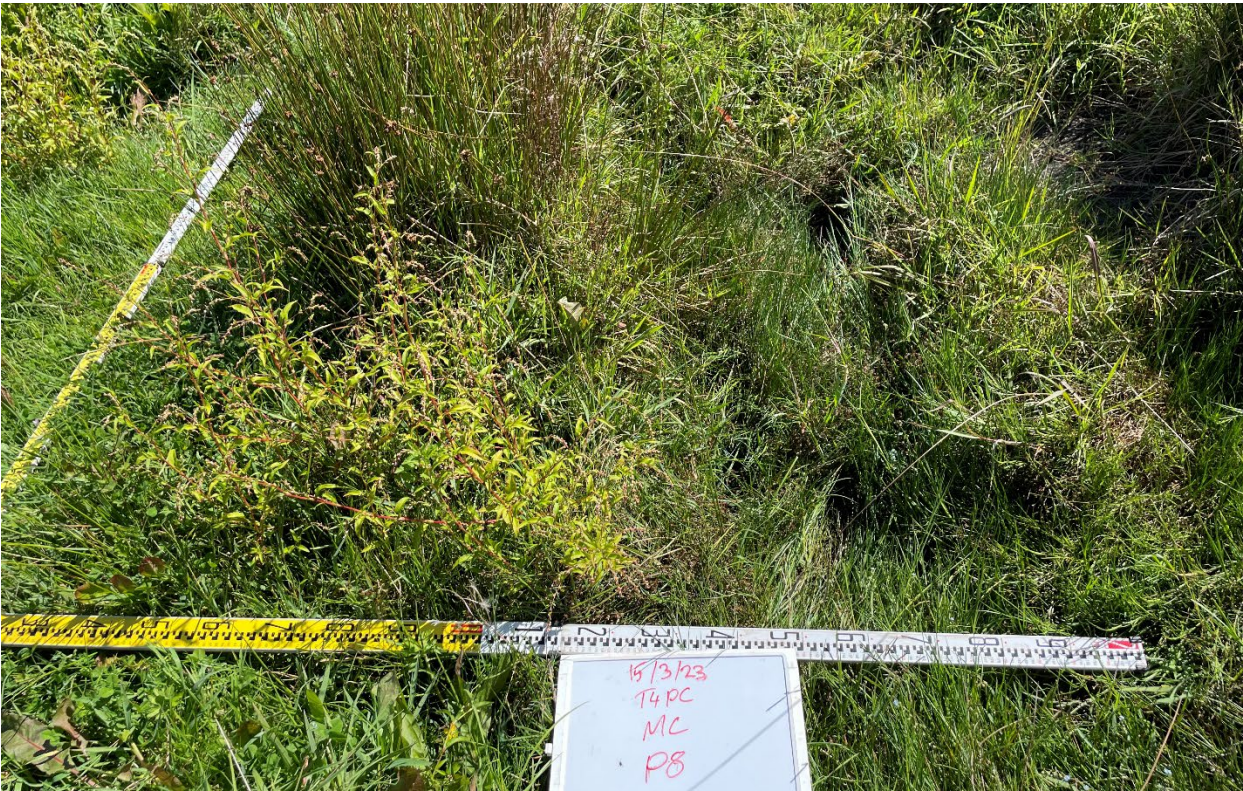
**Conclusion:** Dominance of facultative wetland vegetation and ponded surface water, indicates the area is a wetland.

Figure 24: Point 8 vegetation plot.

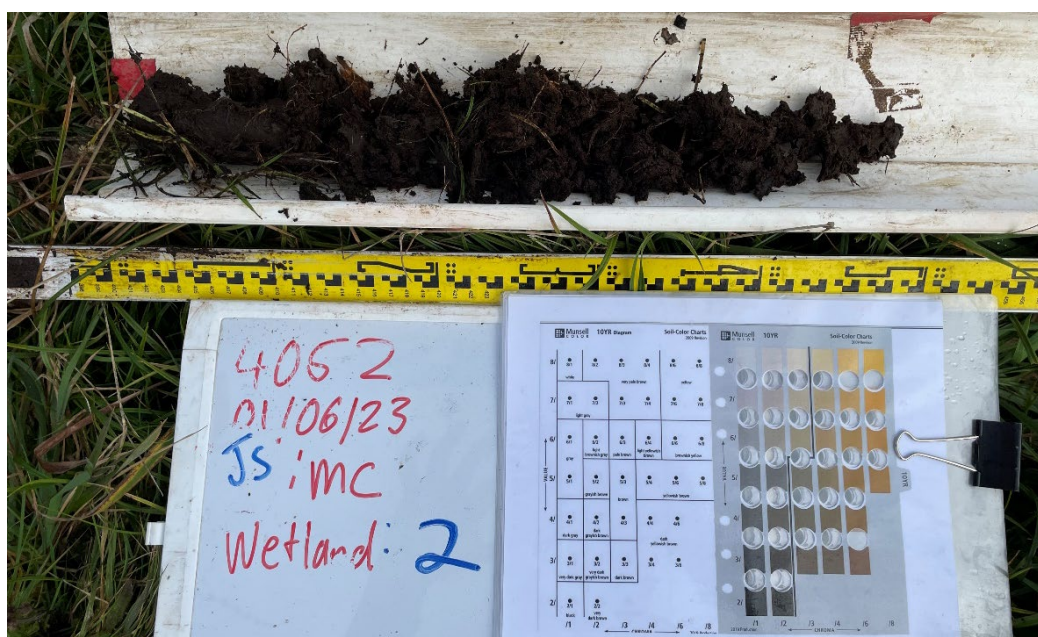
**Indicators of hydric soils:** Yes. Saturated, dark (10YR 2/1), peaty soils throughout the top 500 mm; water-logged with high organics content, no nodules or mottles (see Figure 26).

**Conclusion:** Vegetation and soil assessment indicates that this area is wetland.

**Figure 25: Point 9 soil profile.**

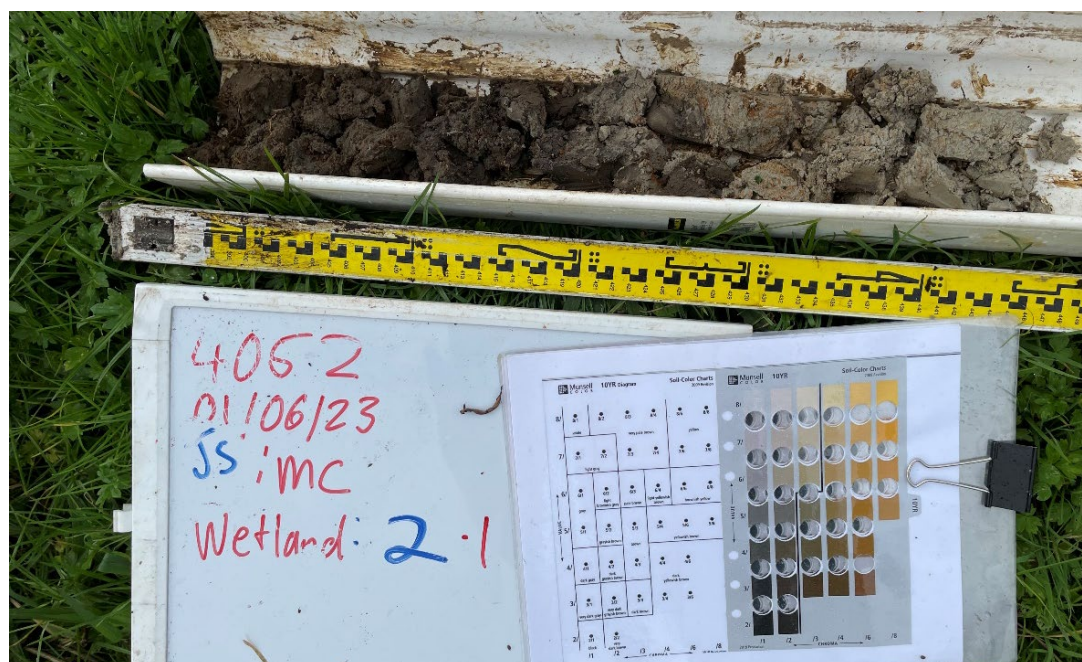
**Indicators of hydric soils:** Yes. 0-150 mm is dark damp topsoil (10YR 5/2) with low density (~10%) of orange mottles (2.5YR 3/6). 150-300 mm transition to lighter coloured (10YR 6/1) clay soils, moderate plasticity, with similar density of orange mottles (2.5YR 3/6). From 300 - 500 mm transition to gleyed (10YR 7/2) soils with increased density (~40%) of light orange mottles (2.5YR 6/8) (see Figure 27).

**Conclusion:** Although the soil assessment indicates hydric features at depth, the vegetation community present excludes this area from being a wetland.

**Figure 26: Point 10 Soil profile.**
