15 Ryburn Road Plan Change

Ohaupo

# GEOTECHNICAL INVESTIGATION REPORT

Job No. HAM2024-0126AB | Version 1

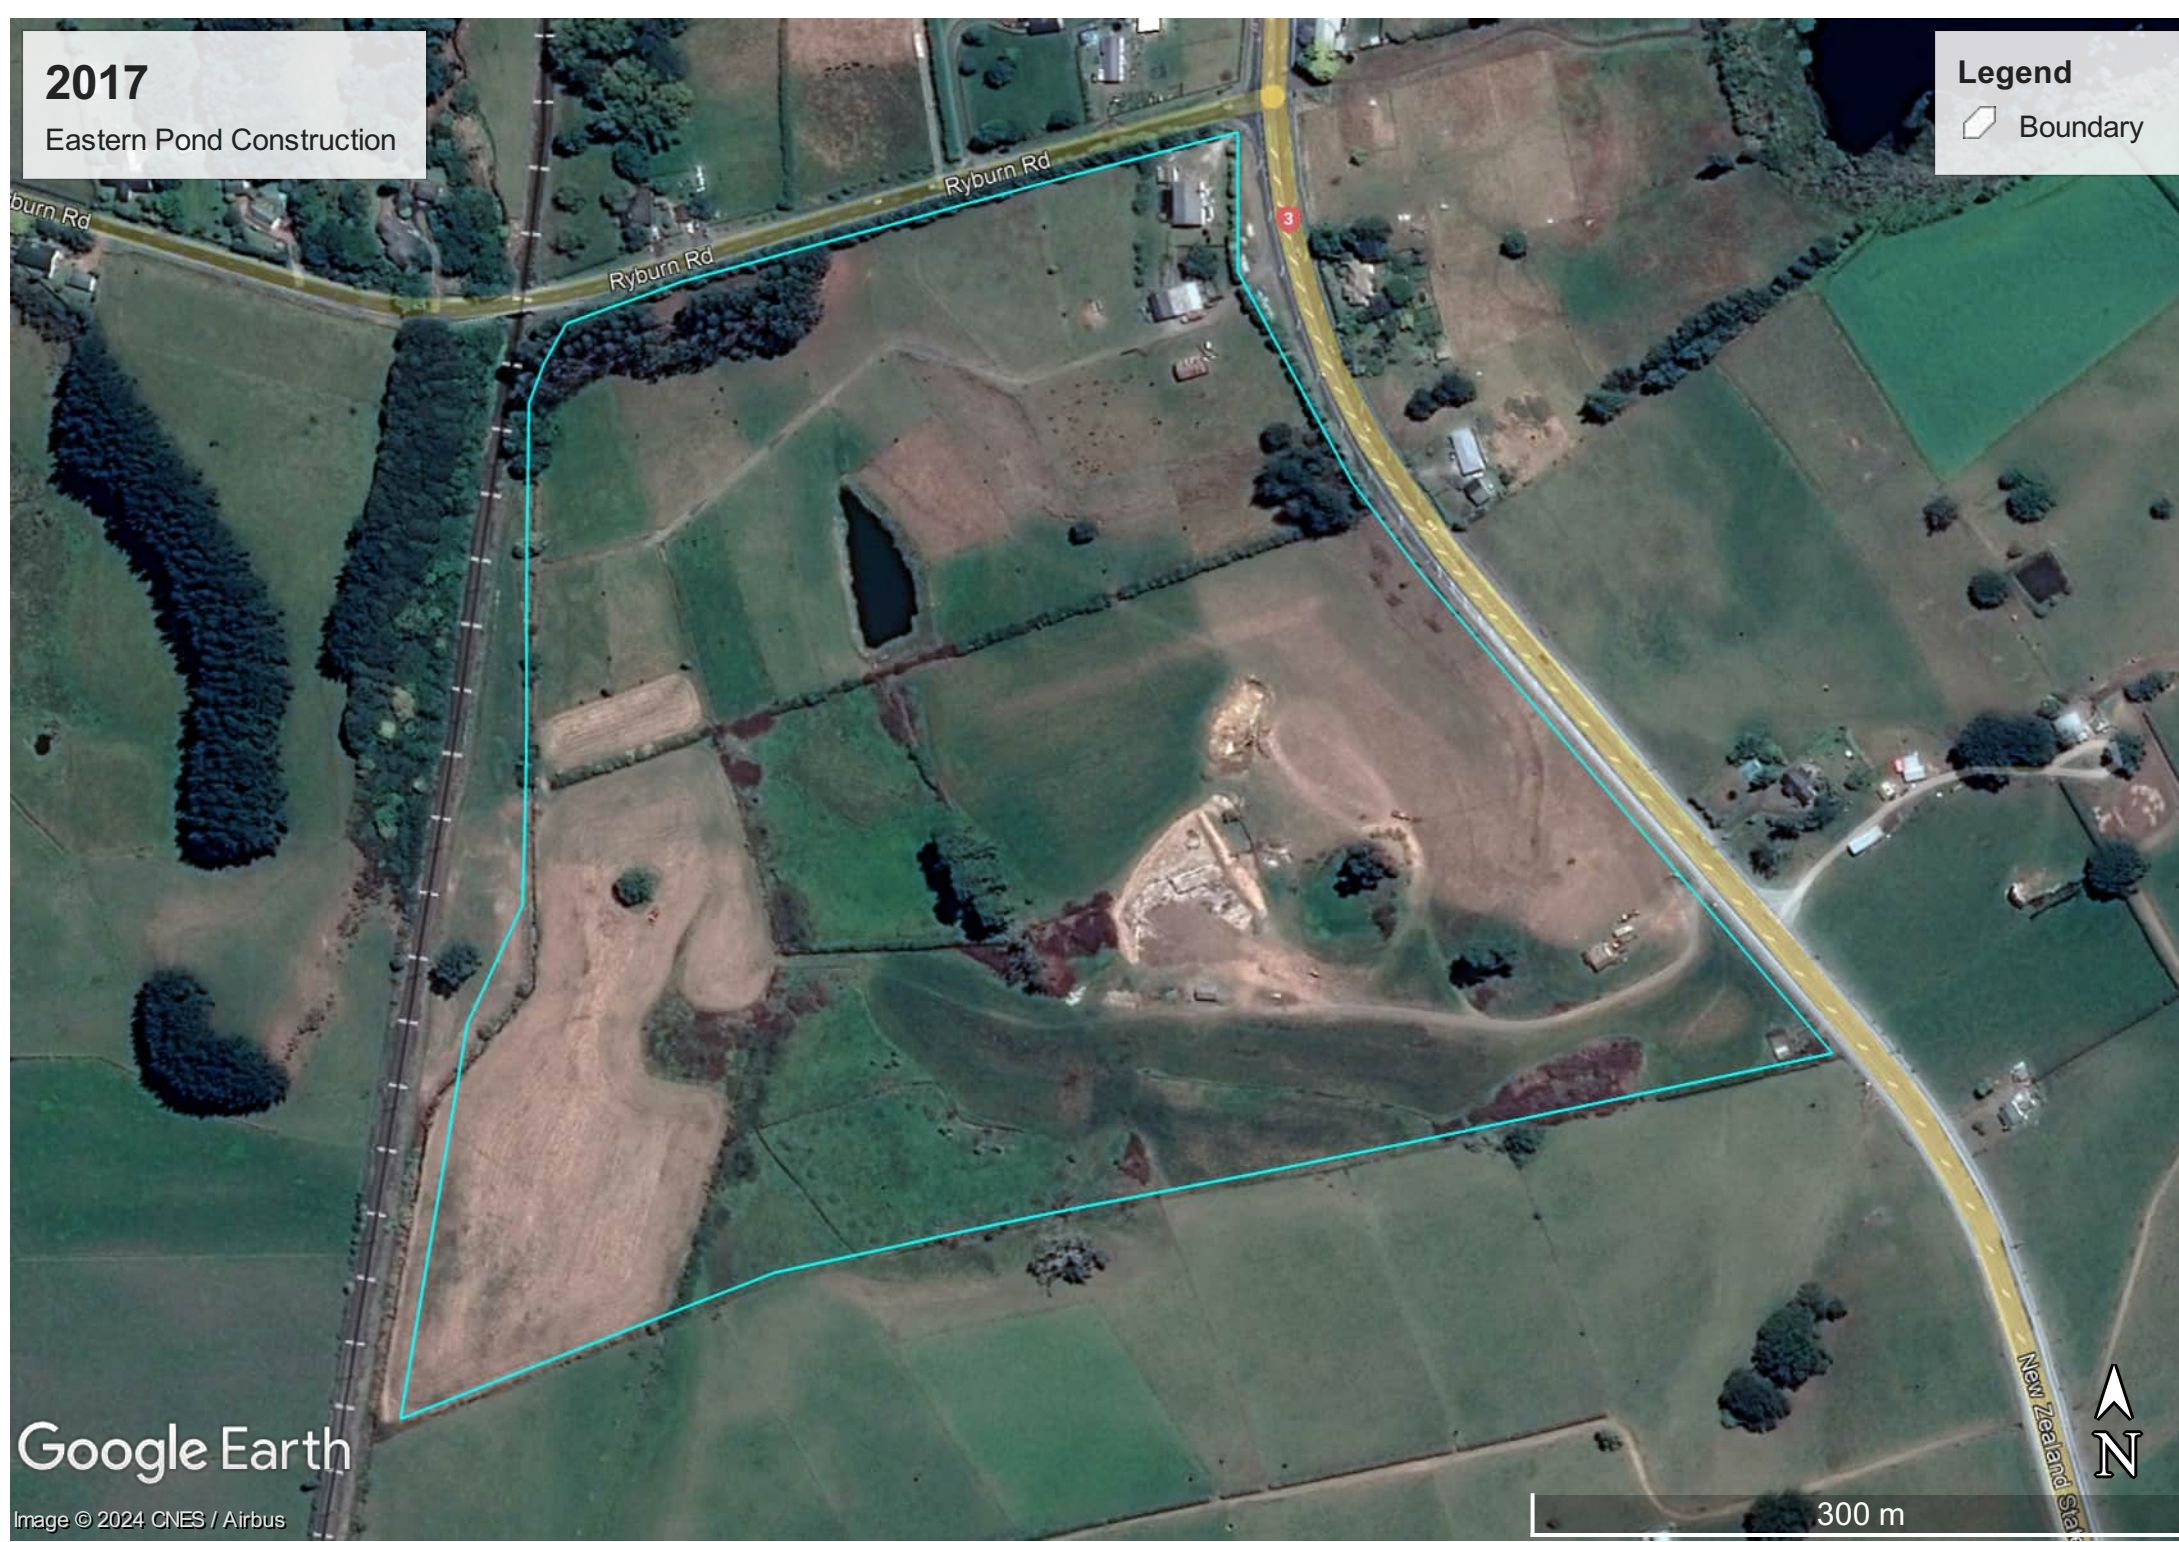
2014

Northern Pond Construction

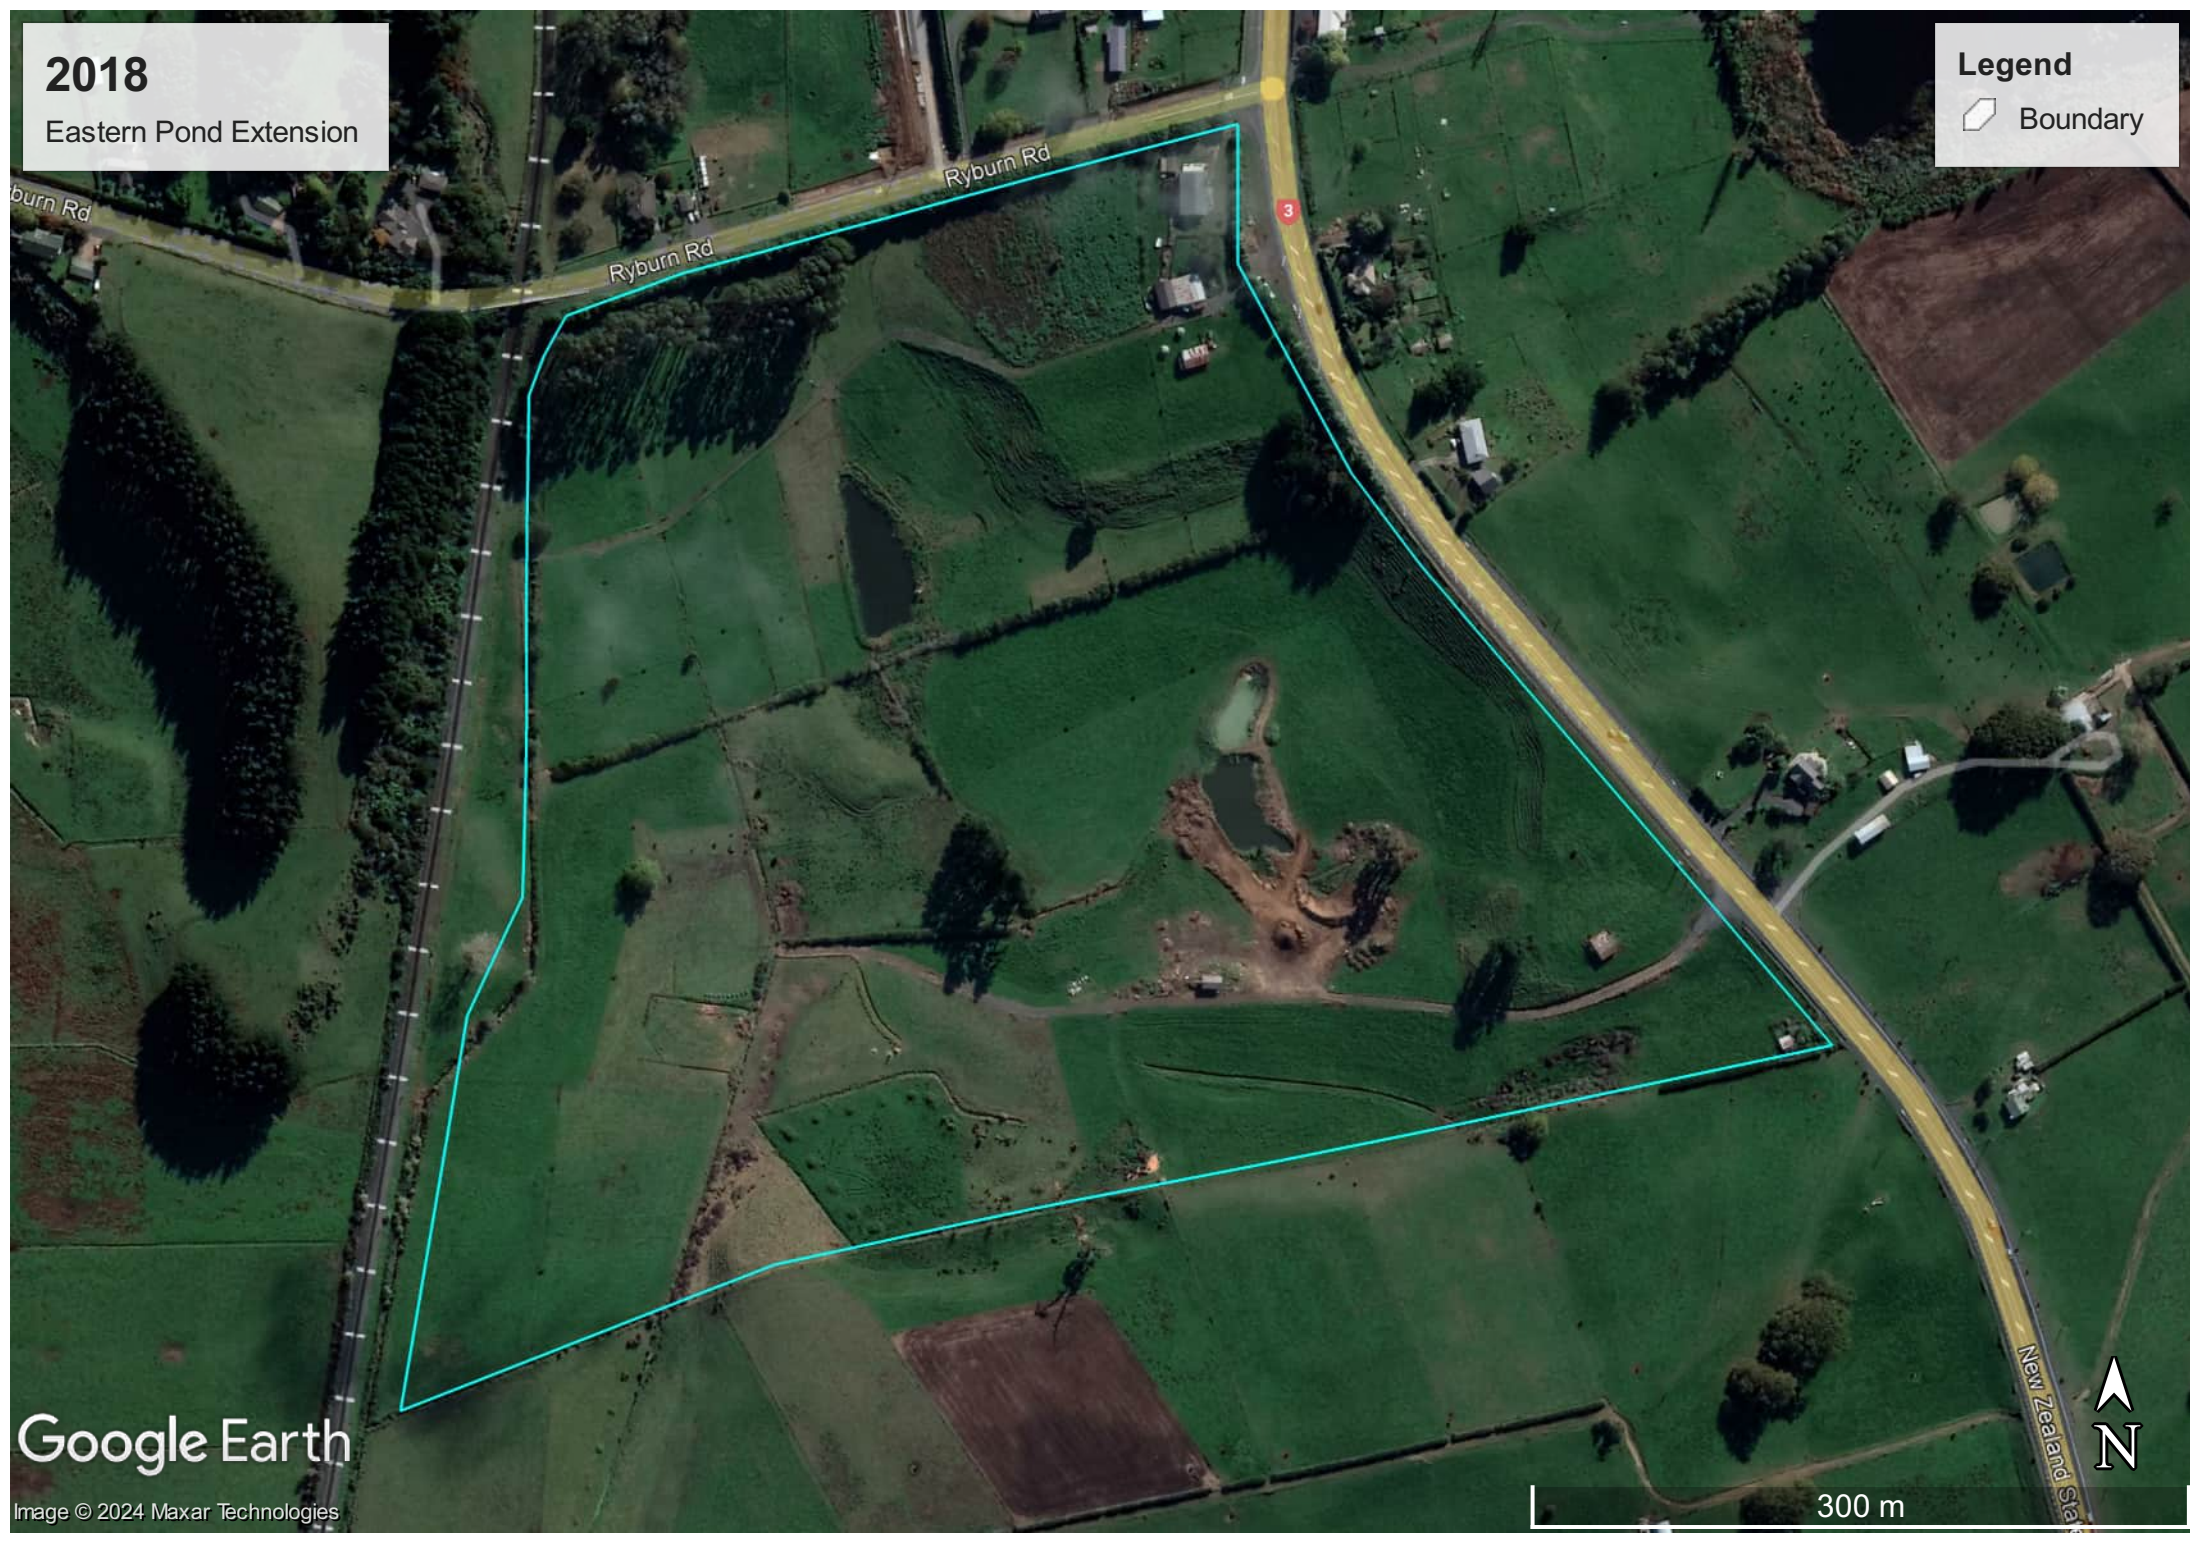
2018

Eastern Pond Extension
