**T4 STRUCTURE PLAN**

**552 PUNIU ROAD, TE AWAMUTU**

# GEOTECHNICAL INVESTIGATION REPORT

HAM2022-0065AB Rev 1

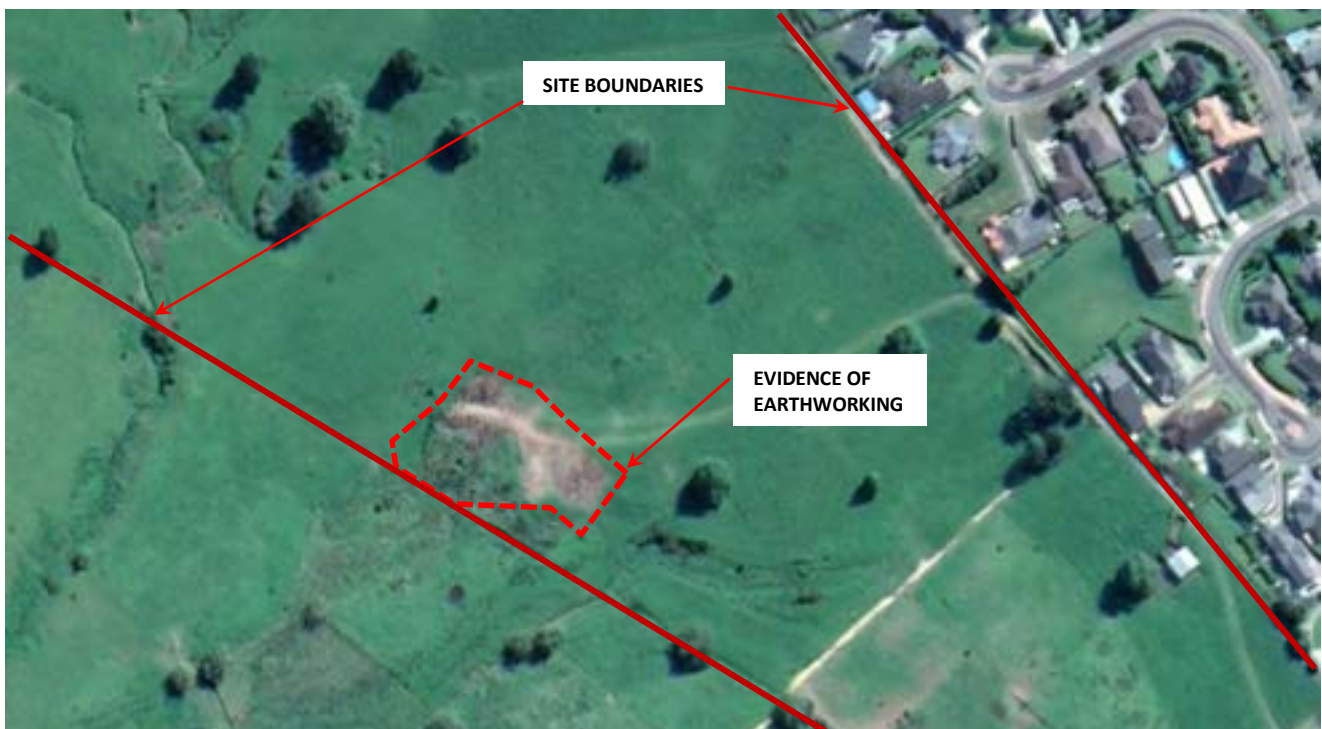
Historical aerial photographs<sup>1</sup> indicate the Northern and Southern Blocks have been in grazed pasture since the 1940s. Aerial photography also indicates an approximately 1,500m<sup>2</sup> area near the southwestern boundary of the Southern Block has previously been earthworked, as shown on Figure 2 below.

Figure 2: Site location plan indicating earth working on southern farm (Reference i.e. Google Earth)

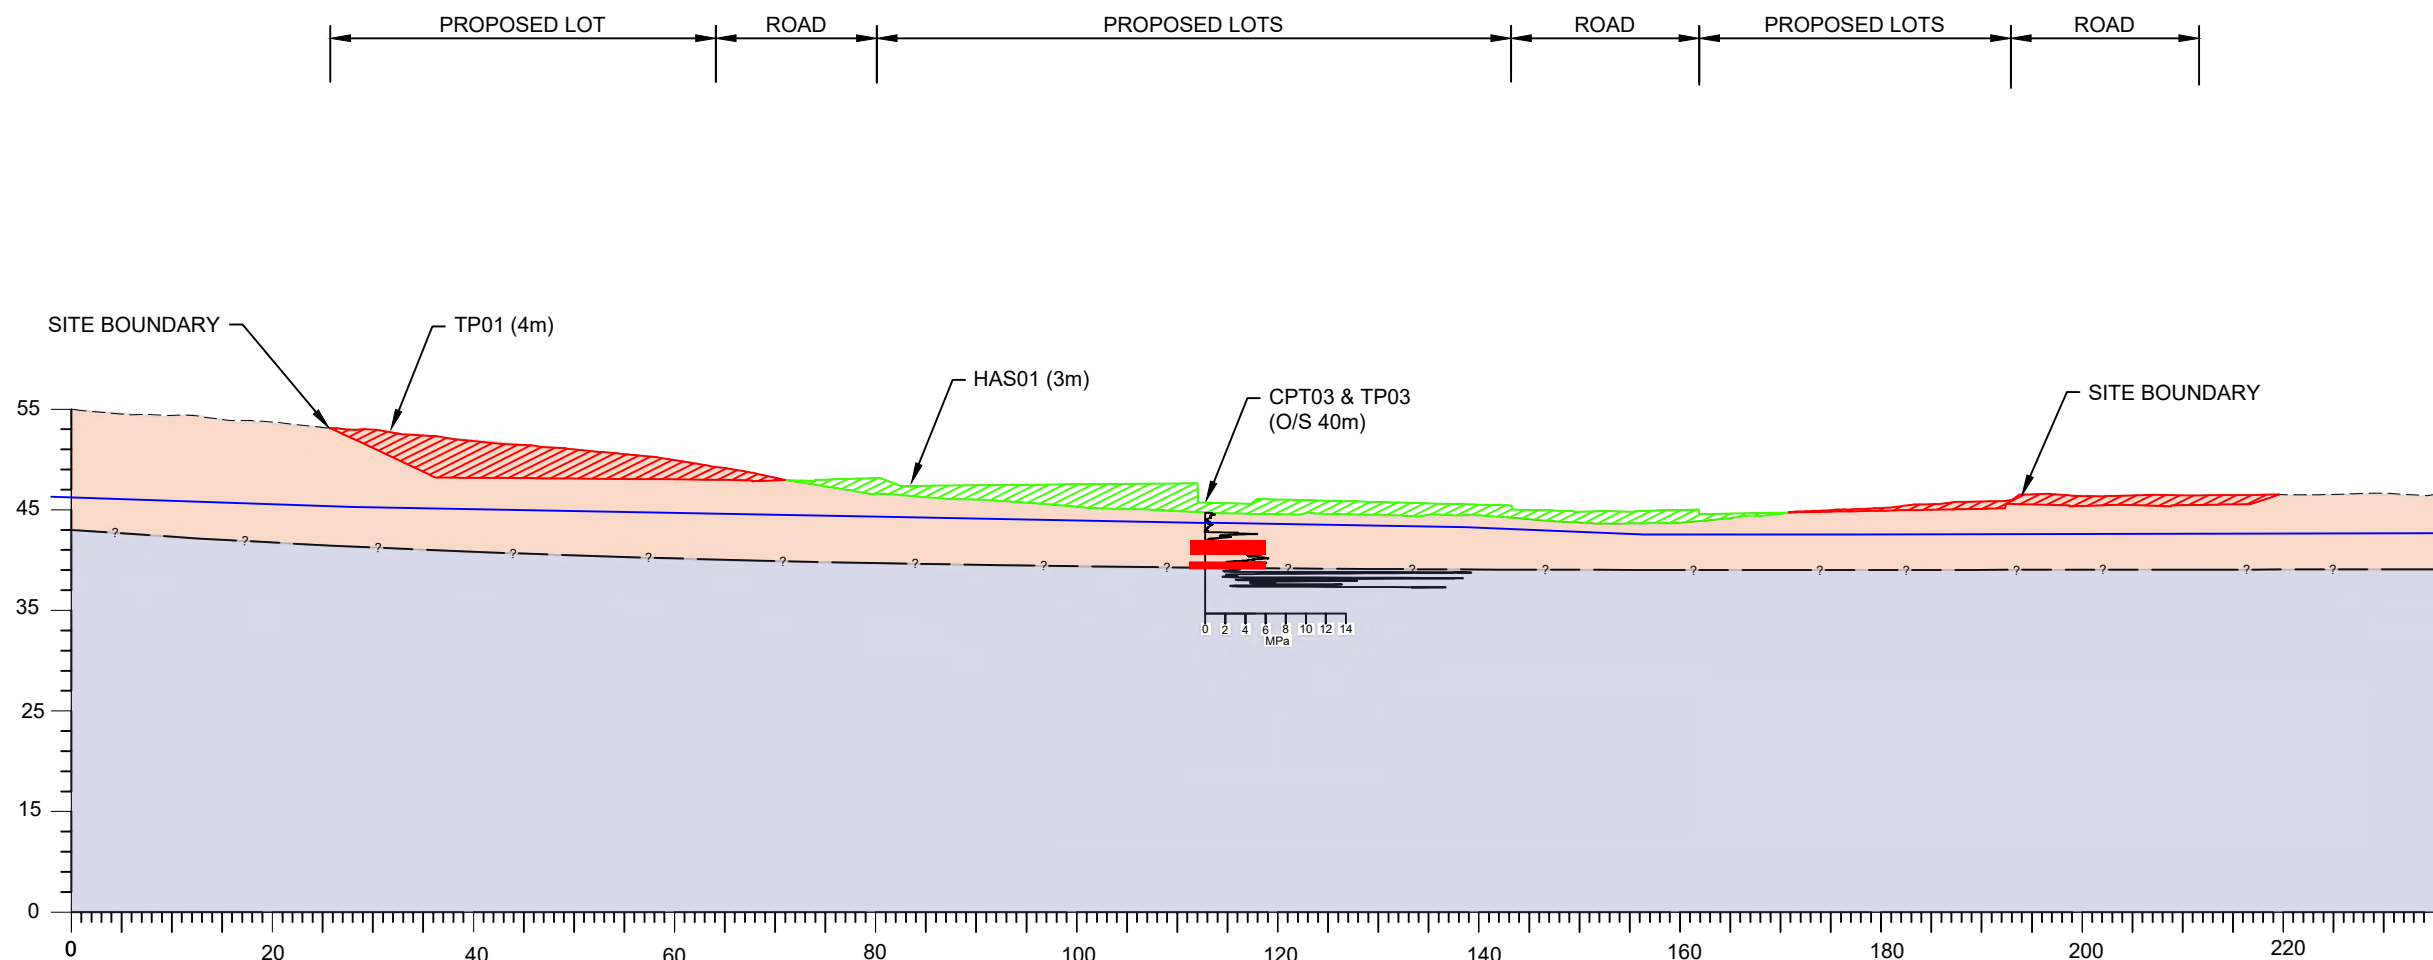
| TITLE:<br><b>GEOLOGICAL CROSS SECTION A</b> | REVISION:<br>0 | SCALE:<br>1:750 |

- VERY STIFF TO HARD SILTY CLAY / CLAY (VOLCANIC ASHES)
- SILTY FINE TO COARSE GRAVEL / SANDY FINE TO COARSE GRAVEL (WALTON SUBGROUP)
- SOFT TO FIRM SILT / CLAYEY SILT / ORGANIC SILT / LOOSE SANDS (ALLUVIUM - PIAKO SUBGROUP)
- PROPOSED CUT
- PROPOSED FILL
- ULS LIQUEFIABLE SOIL LAYERS (EXCLUDING LAYERS <0.5m THICK)

The ground conditions encountered and inferred from the investigation were generally consistent with the published geology for the area. The distribution of the various units encountered is presented in the appended Geological Sections **Drawings 03 to 08** and summarised below in Table 1.

The calculations indicate that liquefaction may occur in some soil layers during a ULS earthquake event. Affected layers are shown on the geological cross sections (**Drawings 03 to 08**). Based on the above, the site has been divided into the following two liquefaction hazard categories, as shown on **Drawings 09 and 10**.

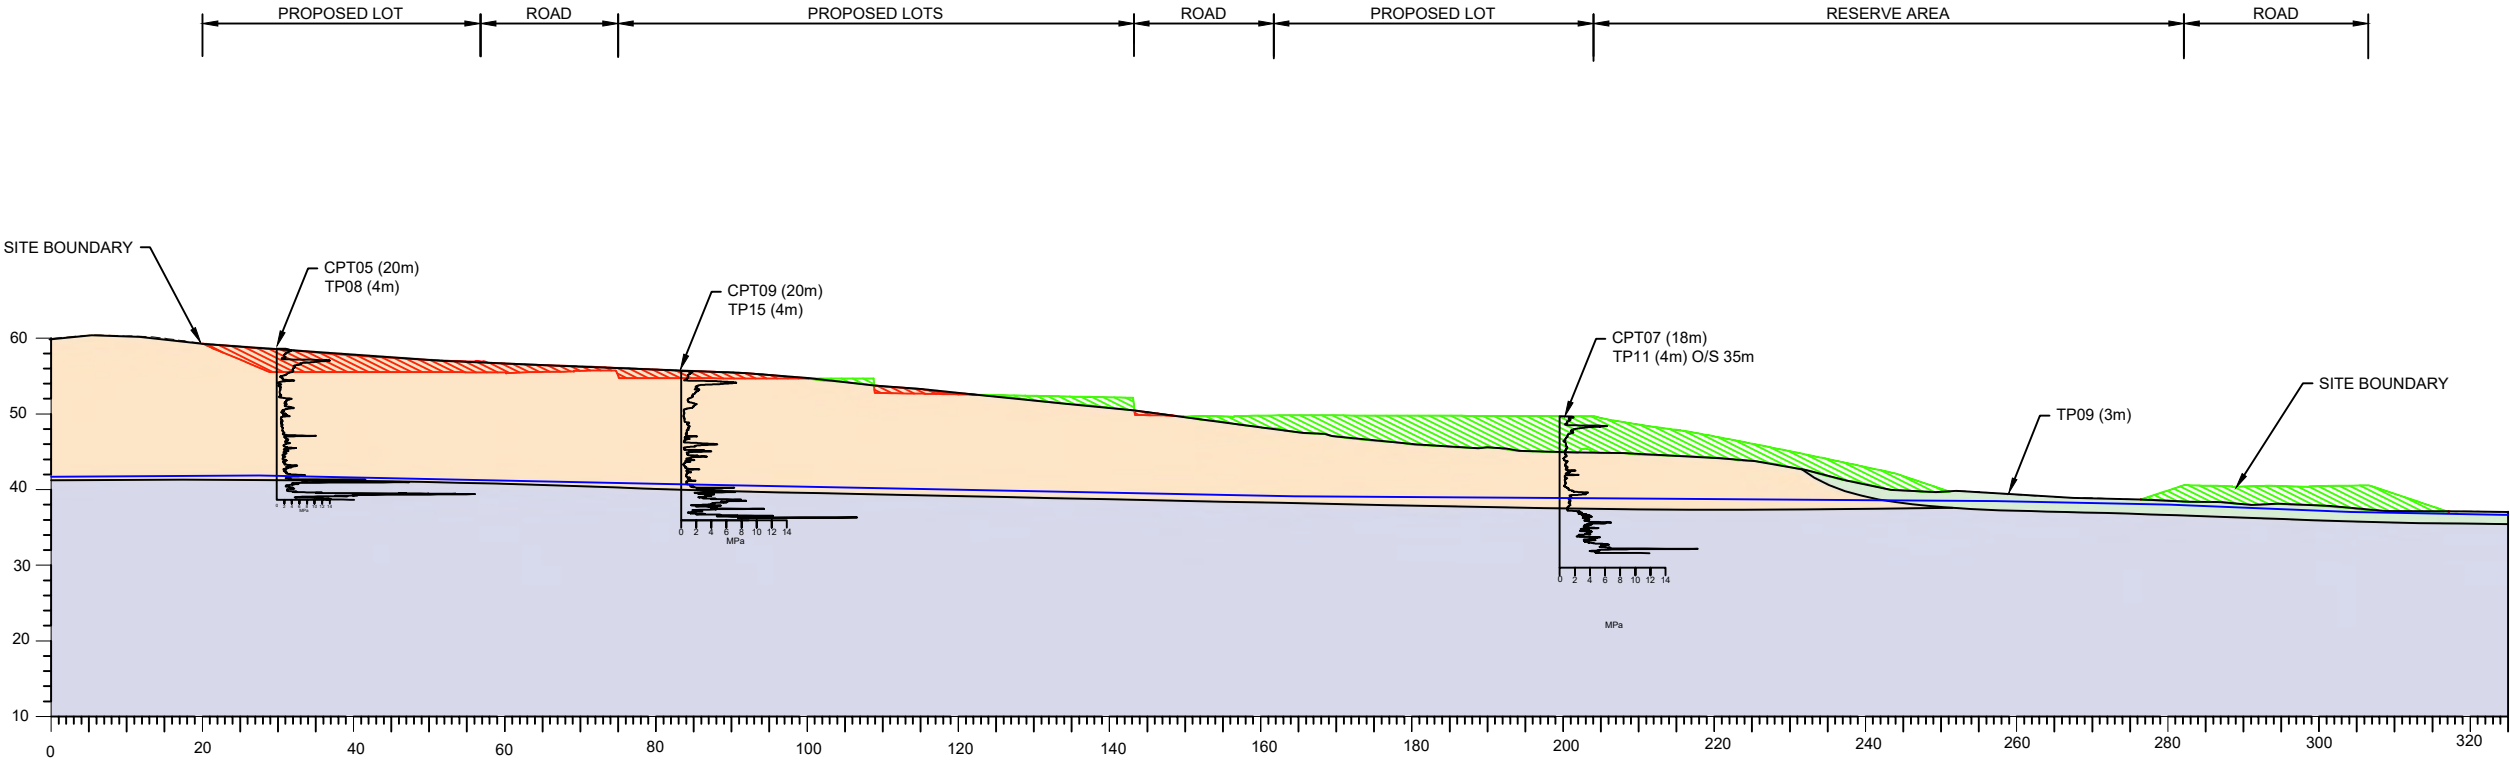
| TITLE:<br><b>GEOLOGICAL CROSS SECTION B</b> | REVISION:<br>0 | SCALE:<br>1:1000 |

- VERY STIFF TO HARD SILTY CLAY / CLAY (VOLCANIC ASHES)
- SILTY FINE TO COARSE GRAVEL / SANDY FINE TO COARSE GRAVEL (WALTON SUBGROUP)
- SOFT TO FIRM SILT / CLAYEY SILT / ORGANIC SILT / LOOSE SANDS (ALLUVIUM - PIAKO SUBGROUP)
- PROPOSED CUT
- PROPOSED FILL
- GROUNDWATER TABLE

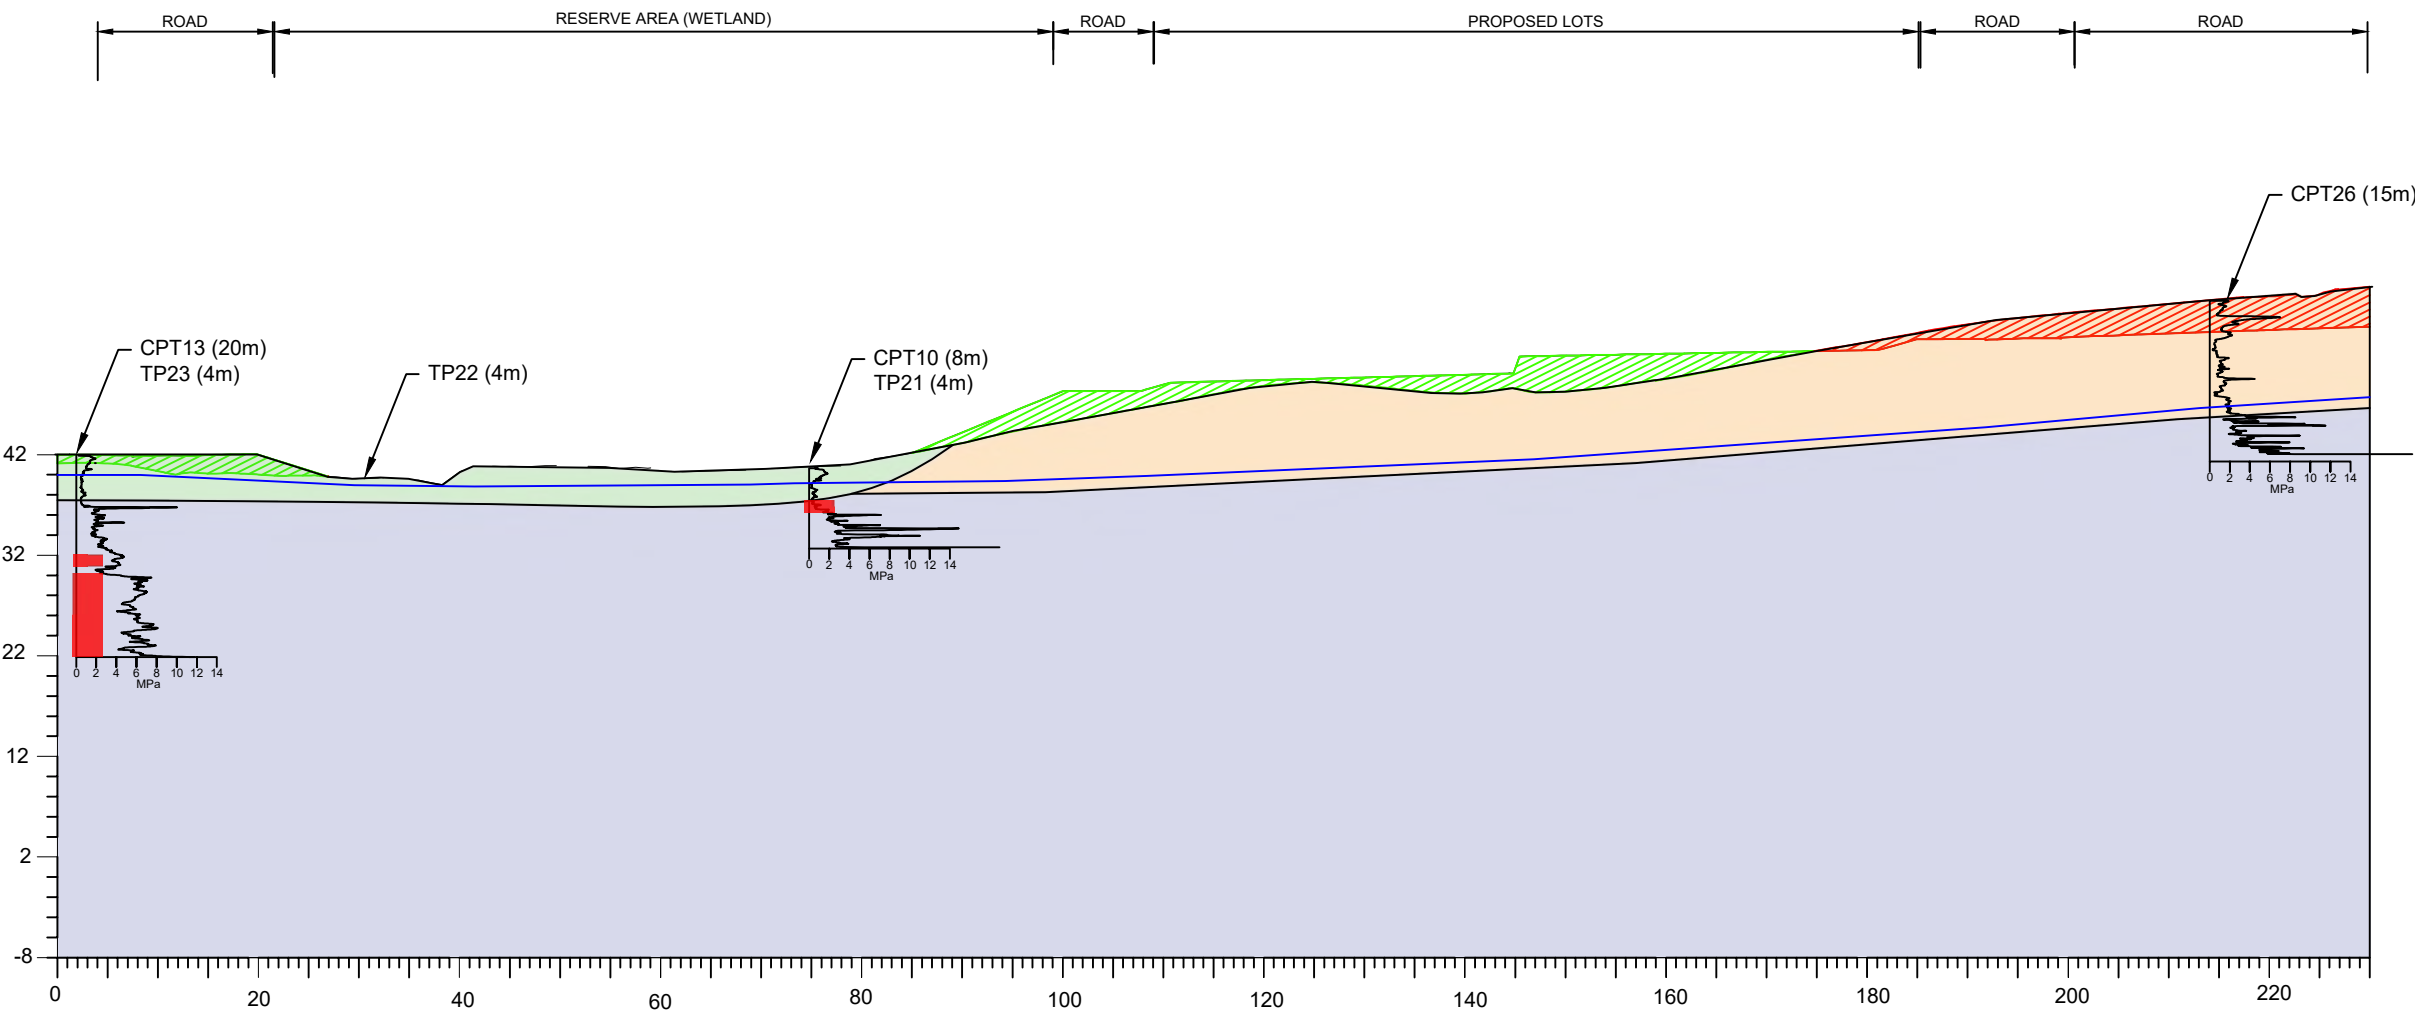
| TITLE:<br><b>GEOLOGICAL CROSS SECTION C</b> | REVISION:<br>0 | SCALE:<br>1:750 |

- VERY STIFF TO HARD SILTY CLAY / CLAY (VOLCANIC ASHES)
- SILTY FINE TO COARSE GRAVEL / SANDY FINE TO COARSE GRAVEL (WALTON SUBGROUP)
- SOFT TO FIRM SILT / CLAYEY SILT / ORGANIC SILT / LOOSE SANDS (ALLUVIUM - PIAKO SUBGROUP)
- PROPOSED CUT
- PROPOSED FILL
- ULS LIQUEFIABLE SOIL LAYERS (EXCLUDING LAYERS <0.5m THICK)

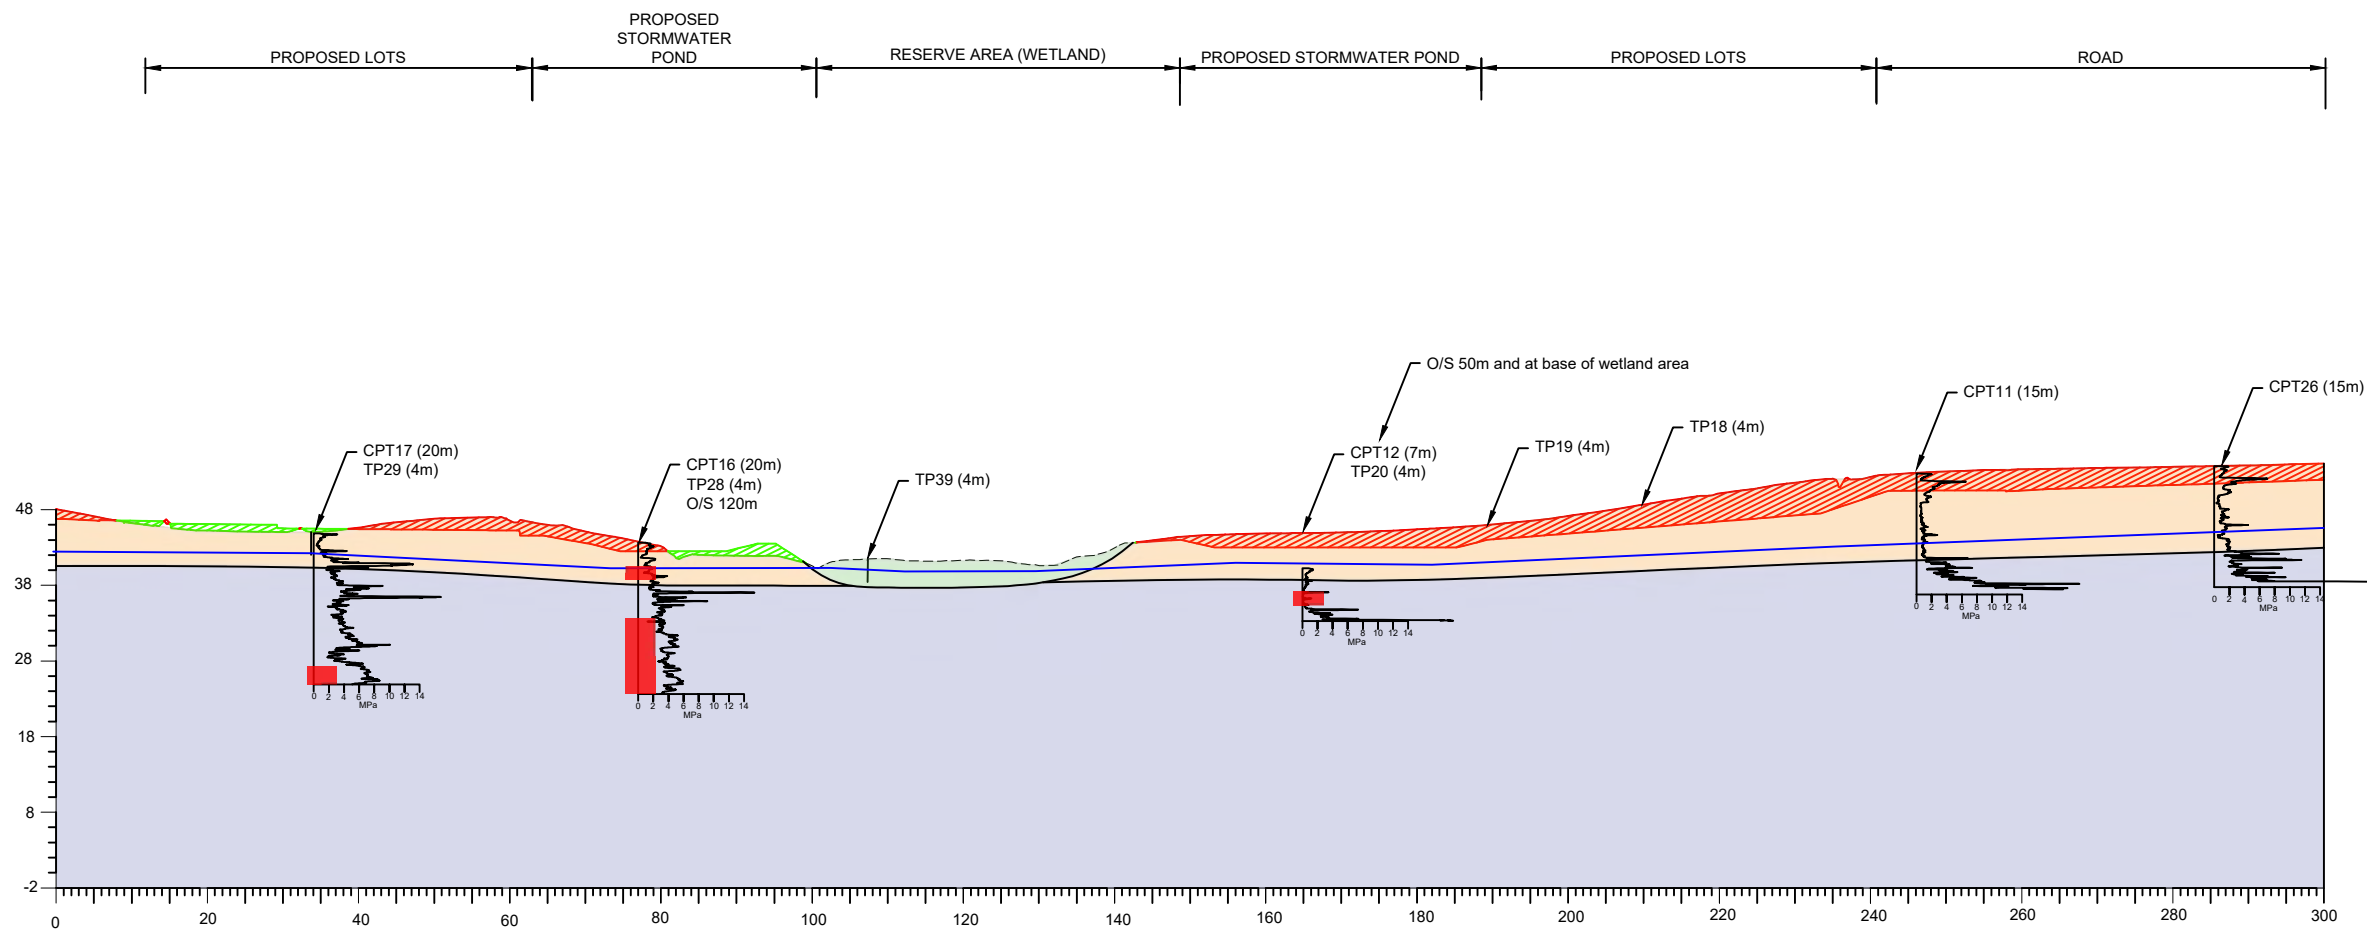
- VERY STIFF TO HARD SILTY CLAY / CLAY (VOLCANIC ASHES)
- SILTY FINE TO COARSE GRAVEL / SANDY FINE TO COARSE GRAVEL (WALTON SUBGROUP)
- SOFT TO FIRM SILT / CLAYEY SILT / ORGANIC SILT / LOOSE SANDS (ALLUVIUM - PIAKO SUBGROUP)
- PROPOSED CUT
- PROPOSED FILL
- ULS LIQUEFIABLE SOIL LAYERS (EXCLUDING LAYERS <0.5m THICK)

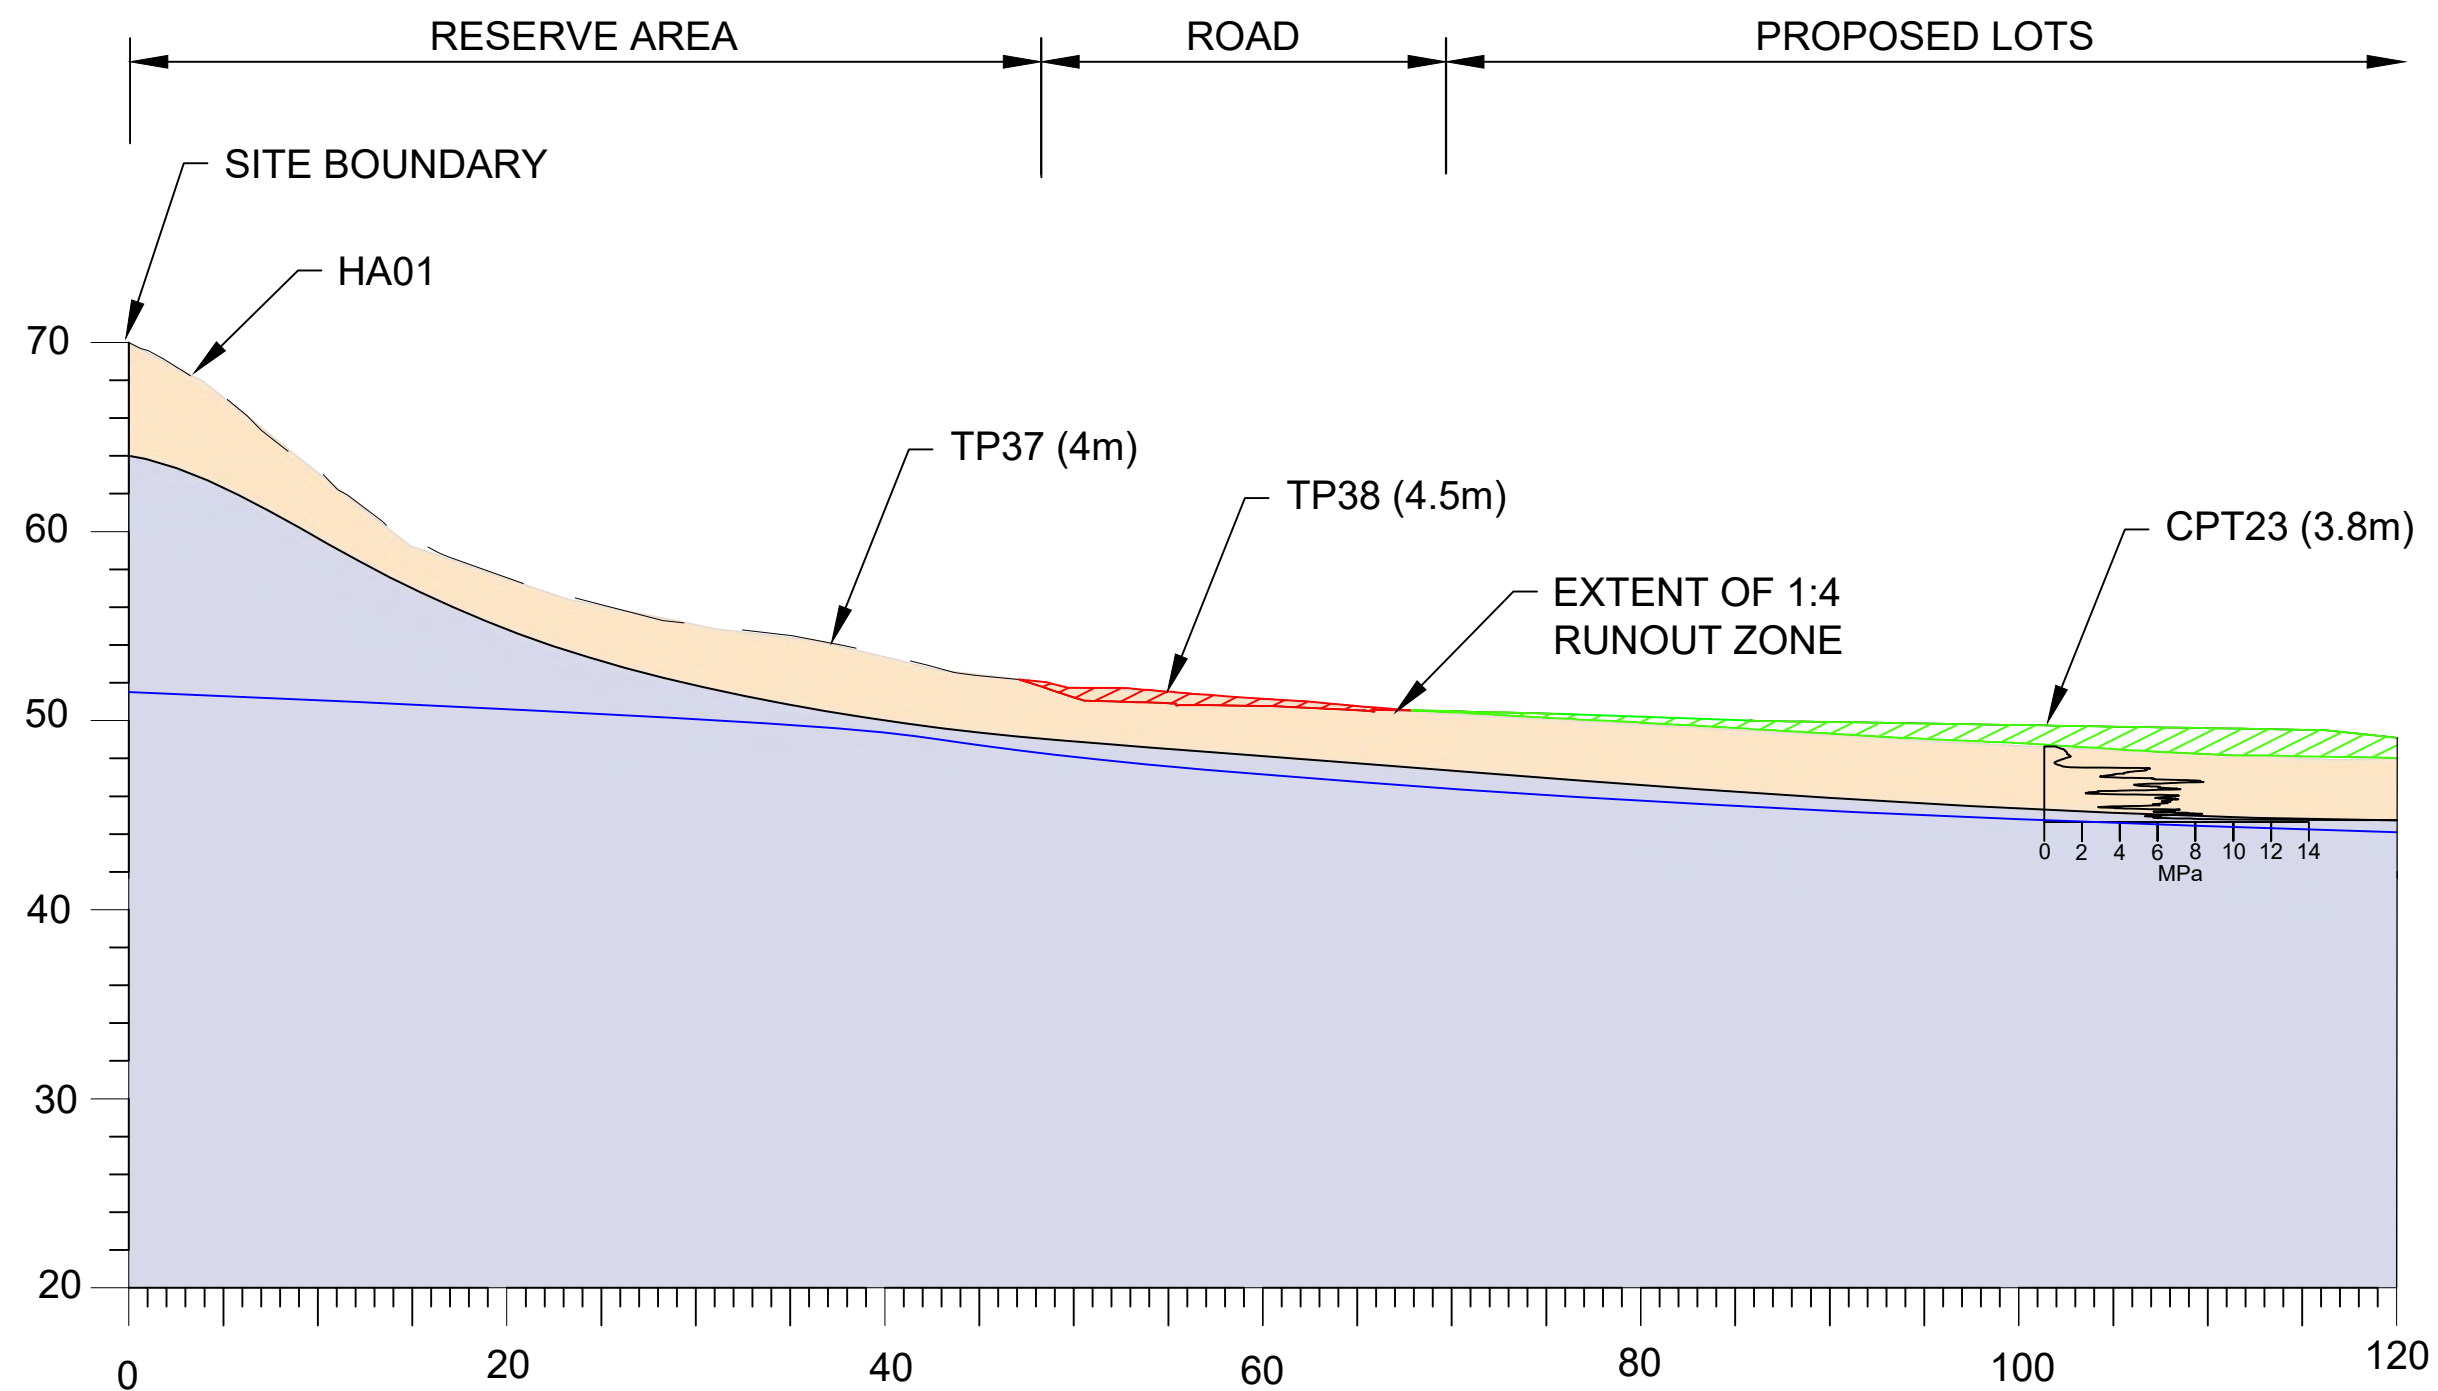
| TITLE: | GEOLOGICAL CROSS SECTION F | | REVISION: | 0 | SCALE: | 1:400 |

- VERY STIFF TO HARD SILTY CLAY / CLAY (VOLCANIC ASHES)
- SILTY FINE TO COARSE GRAVEL / SANDY FINE TO COARSE GRAVEL (WALTON SUBGROUP)
- SOFT TO FIRM SILT / CLAYEY SILT / ORGANIC SILT / LOOSE SANDS (ALLUVIUM - PIAKO SUBGROUP)
- PROPOSED CUT
- PROPOSED FILL
- GROUNDWATER TABLE

The geomorphology of this slope includes several features which may represent previous failure scarps and colluvial deposits. Slope stability analyses were carried out to assess the potential effects of future roading and housing in this area. The analyses considered both the existing and proposed landforms and used the geological model and slope profile shown on Cross Section F (**Drawing 08**).

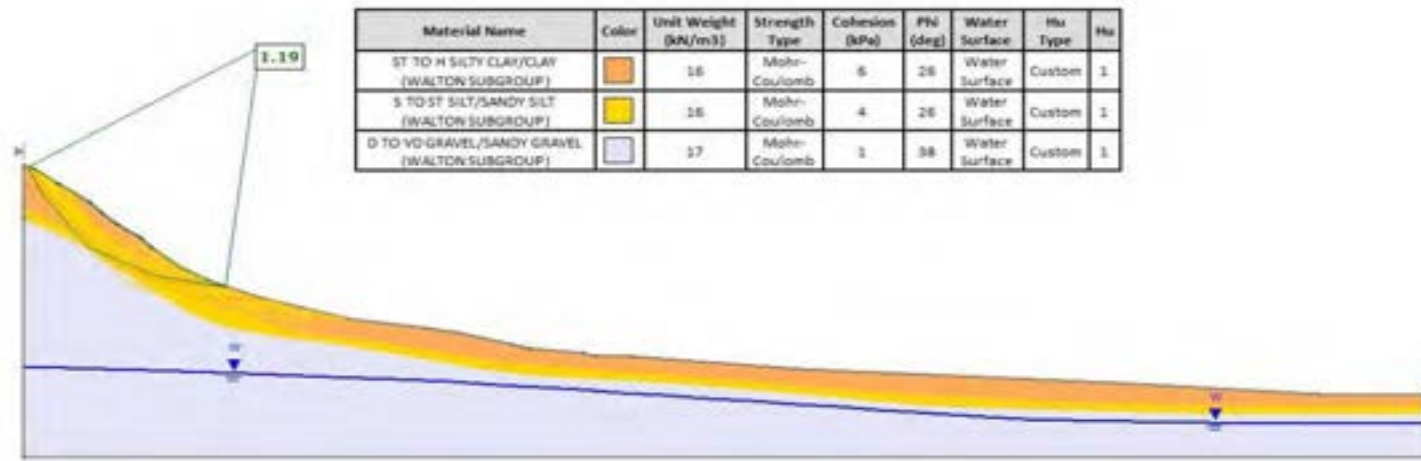
Existing Profile - Normal Groundwater Conditions

Slope stability analyses were undertaken using the Morgenstern-Price method of slices under both circular and non-circular failure mechanisms using the proprietary software SLIDE Version 9.

Groundwater was represented in the models as a piezometric surface based on water levels measured in the investigations and observed on site. A pore pressure ratio ( $R_u$ ) of 0.3 was used to represent short-term elevated groundwater conditions within the surficial soils on the slope.
