# Victoria Street Bridge (Cambridge) Condition Assessment Report

Prepared for Waipa District Council

Prepared by Beca Limited

10 August 2020

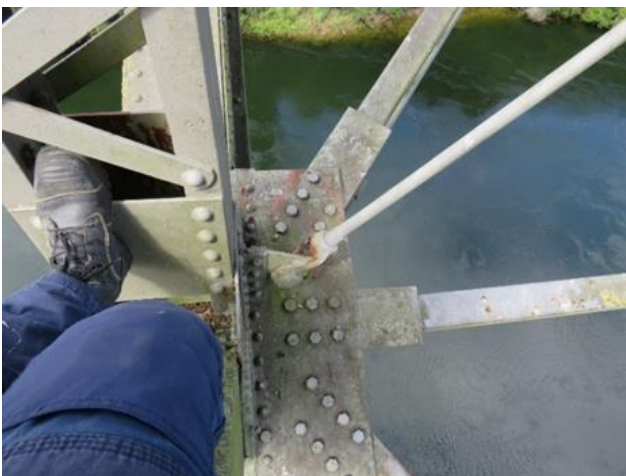
One of the vertical cross bracing rod ties showed signs of significant section loss, all of these tie locations should be checked when full access to the structure is provided for the painting, defective connections should be replaced.

Figure 4-1 Corrosion at bracing connection at UT4.

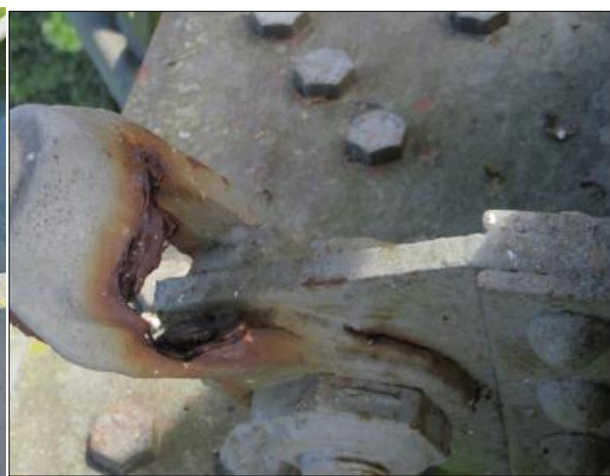
Figure 4-1 - Rod tie at UT4 showing signs of significant corrosion, requires replacement.

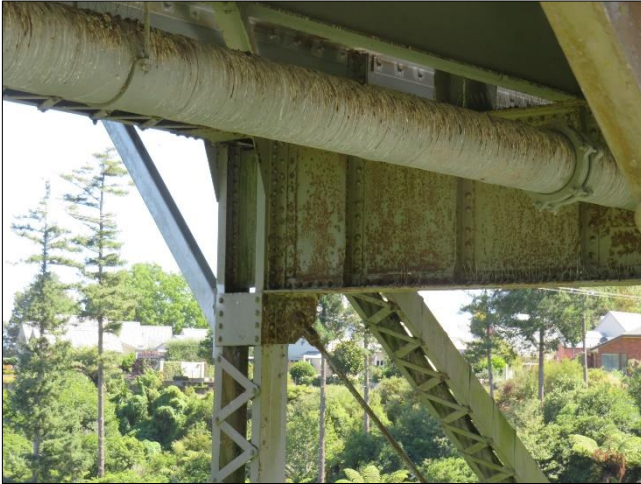
Figure 4-3 - Widespread corrosion spots were observed on transom UT09-DT09.

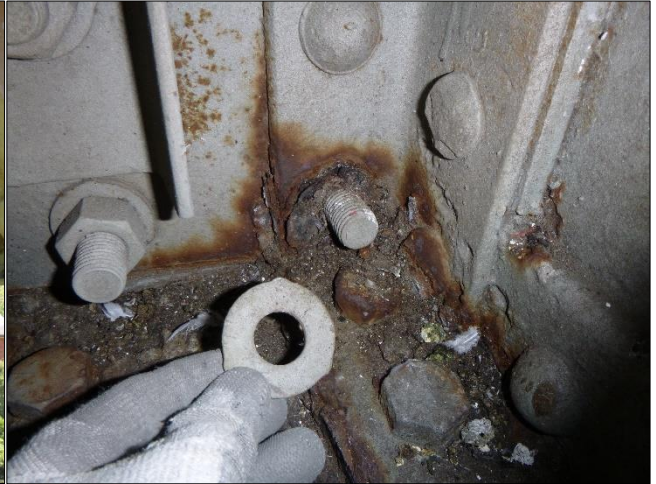
Figure 4-4 - Nut missing on transom at T10.

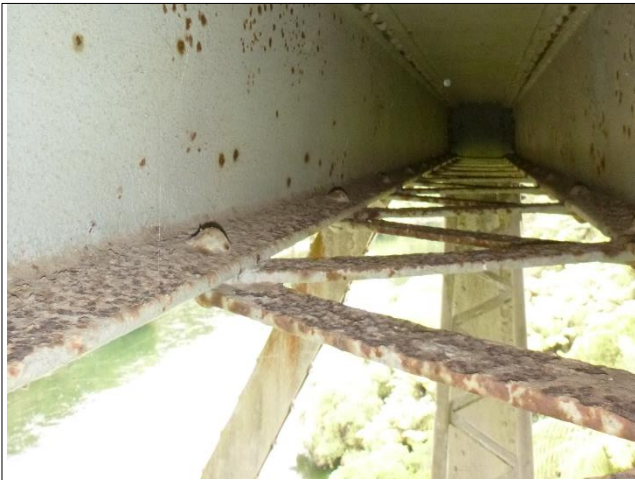
Figure 4-5 - Corrosion to lacing of Transom UT01-DT01

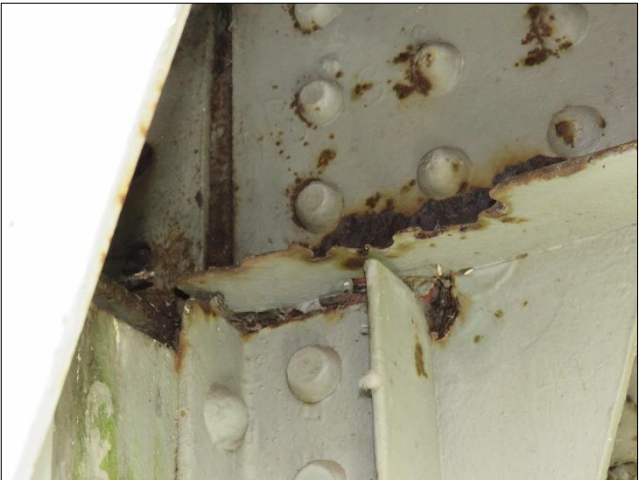
Figure 4-6 - Section loss to bottom flange of Transom UT07-DT07

Specific Defects of note are shown below. Due to the location at the support no structural maintenance is proposed for the section loss on UT07-DT07 other than corrosion remediation.

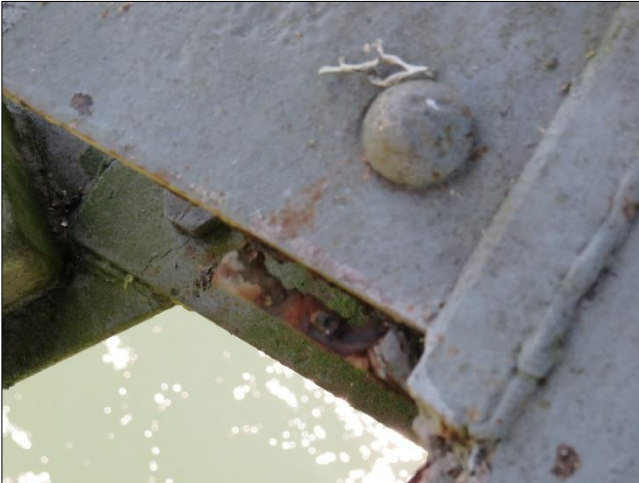
Figure 4-7 - Full penetration corrosion at UB11

Specific Defects of note are shown below, the corrosion in these locations should be remediated during the painting works, in some cases this may require new plates to be added where section loss has formed. This is to be agreed with the engineer on site. At one of the nodes a bent plate was observed, this should be investigated by an engineer when access is provided as part of the painting works.

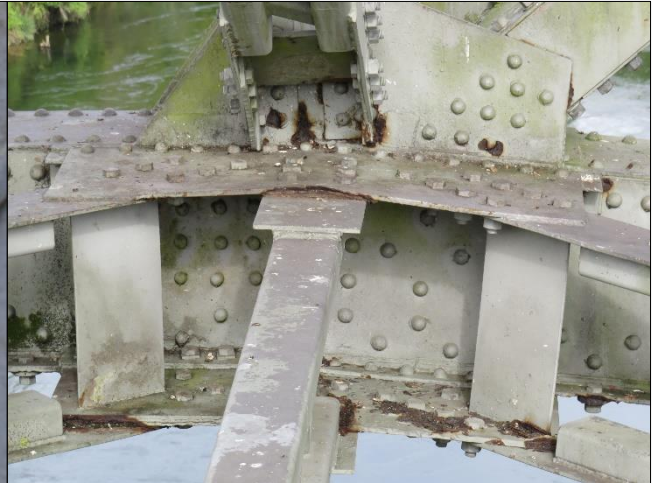
Figure 4-8 - Plate is bent with corrosion present on underside at UT6/DT6.

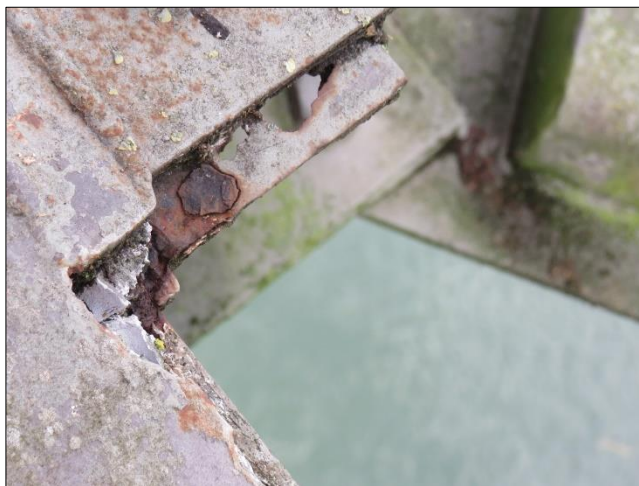
Figure 4-9 Full penetration corrosion at UB03

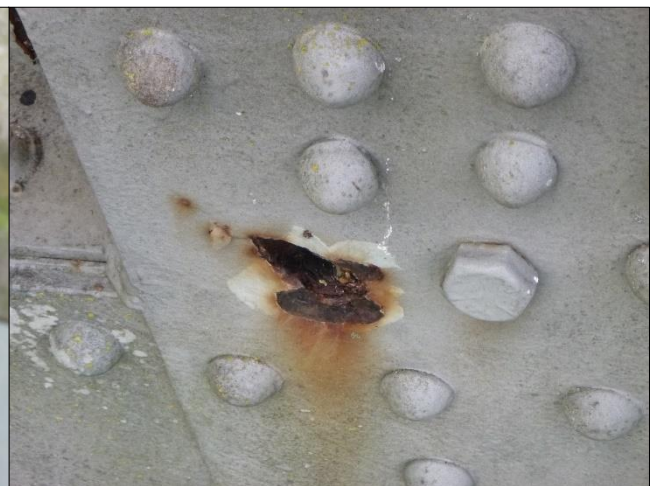
Figure 4-10 - Deep corrosion at UB08

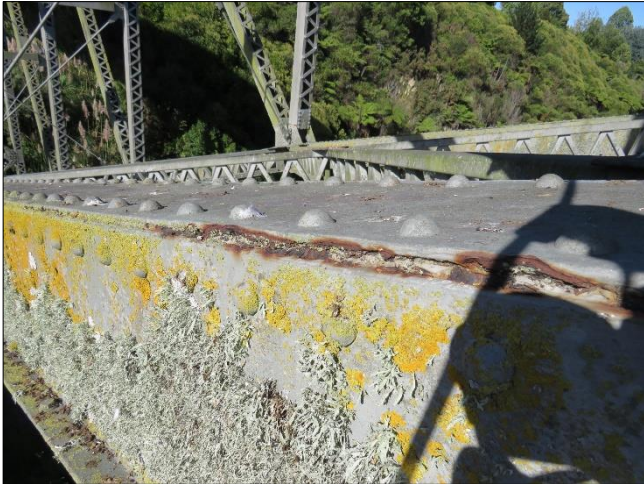
Figure 4-11 - Crevice corrosion in arch chords along top flange to web joint UB09-UB10.

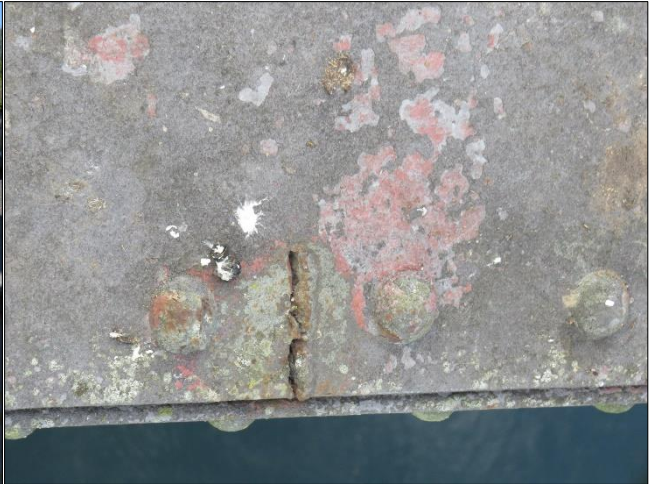
Figure 4-12 - Steel crack in arch chord UB05-UB06, likely historic, monitor.

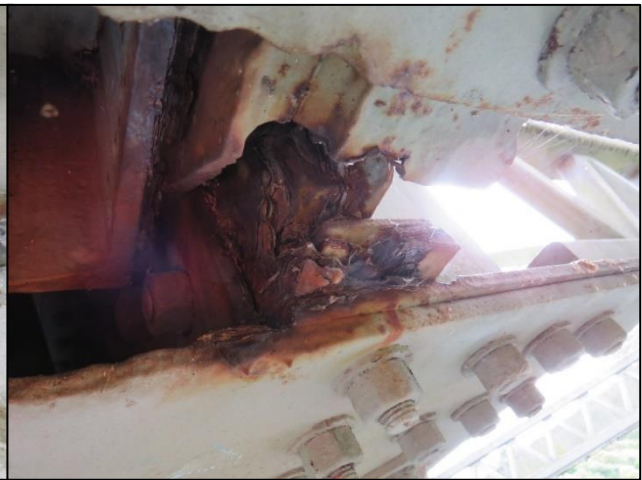
There are six pins on the structure, these are critical elements that must be treated with extreme care as there are no alternative load paths in the event of their failure. All six pins are showing signs of metal loss with the two centre pins more affected. A combination of pitting and crevice corrosion is prevalent on the welded joint where the side and top panels of the steel arch meet. Previous attempts of a maintenance applied joint sealant at this connection point is failing and the added occurrence of fungal growth has accelerated this due to dirt entrapment and prolonged wetness of the area. Corrosion is present on the arch pins themselves at the ground level pins.

Figure 4-15 - Evidence of significant metal loss at central pins

The structural integrity of these elements requires further investigation. Several components showed section loss and a breakdown of the protective coating system with moderate to severe corrosion. Other elements were in significantly better condition. Following the first issue of this report, Waipa DC have advised that the strengthening works carried out in 1999 included significant work to the pins and may have made redundant the elements that are seriously deteriorated. Records of the 1999 works state *"The detailed strengthening is intended to improve the bearing situation and provide some assurance that should the Original bearing surfaces eventually corrode completely away that the loads can still be transferred across the pin without catastrophic failure occurring."* The level of the assurance mentioned above is not quite clear. It is not known if the strengthening of the pins made the corroded areas redundant or if the strengthened pins still rely on some capacity from these elements. It is recommended that the designer (Tony Mans of BBO) is approached for comment and for any information they may have on file. Regardless of the outcome of these inquiries, further investigation is recommended including a detailed review prior to works commencing on site, inspection of the pins by a structural engineer, and ultrasound testing of the elements once the scaffolding is in place.

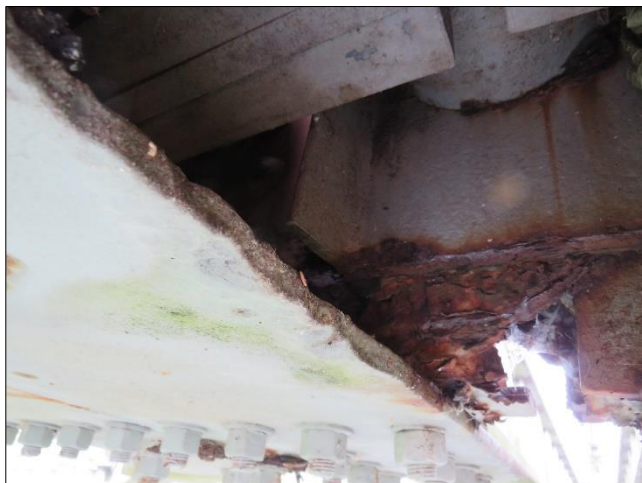
Figure 4-16- Corrosion in steelwork around central pins.

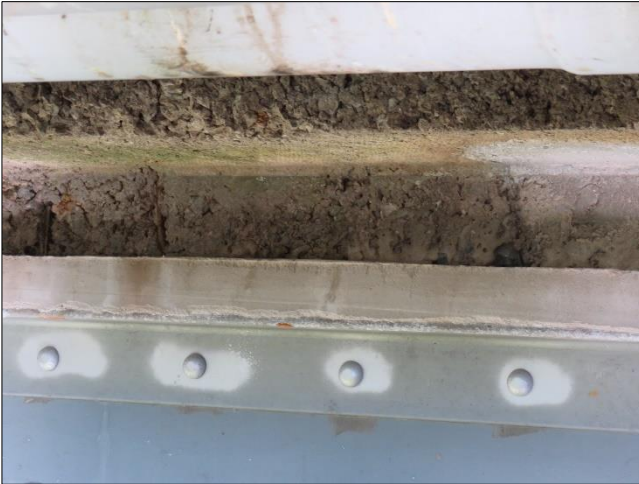
Figure 4-18 - Honeycombing and exposed reinforcement in deck

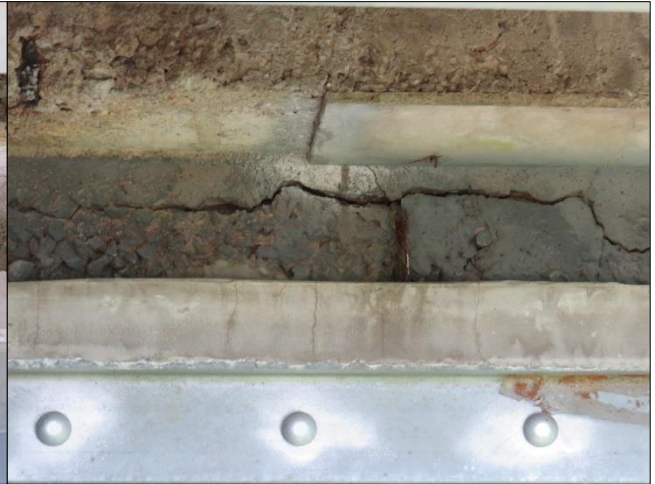
Figure 4-19 - Horizontal cracking in concrete. May be longitudinal shear issue at UP Span 1-2.

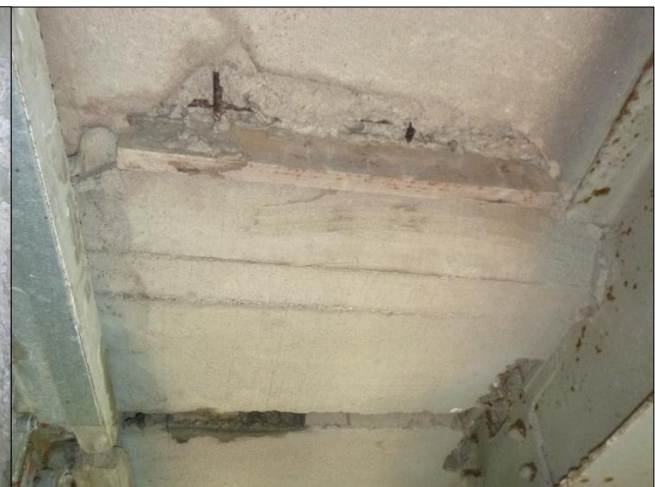
Figure 4-21 - Spalls adjacent to expansion joints at UP Span 6-7 T2-3.

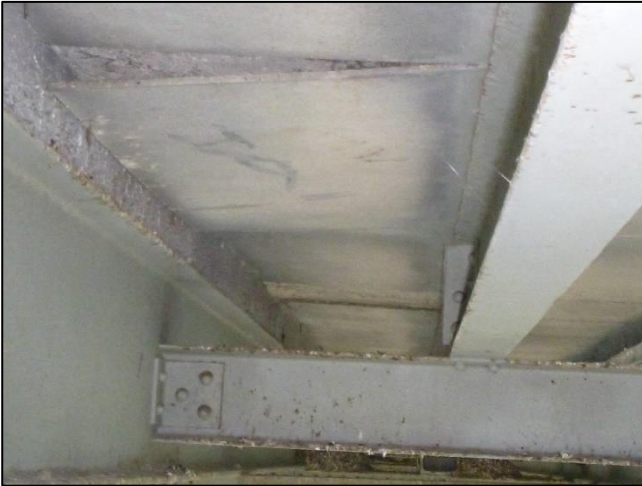
Figure 4-22 Loose, broken and missing asbestos panels observed on all bays at UP Span 5-6 T2-3.

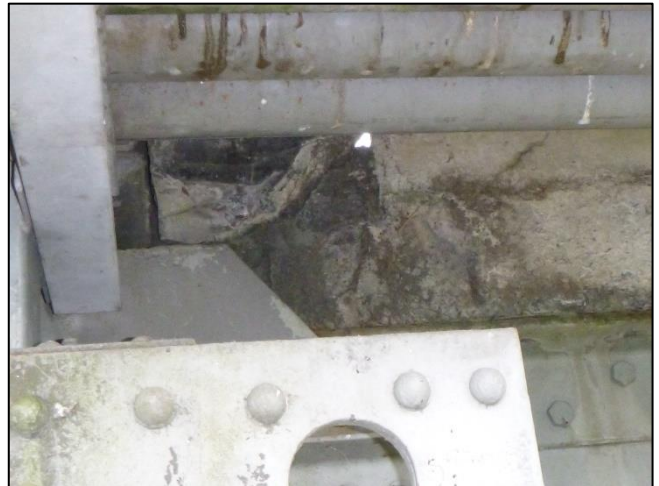
Figure 4-23 – Void in kerb allowing water to drain onto steelwork at Span DE.

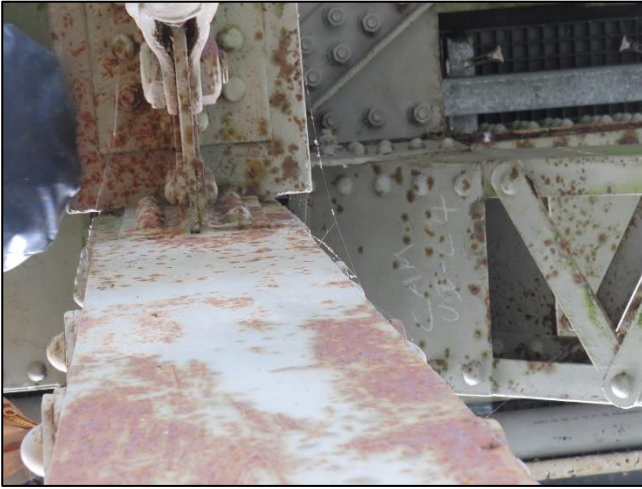
Figure 6-1 General corrosion and loss of paint

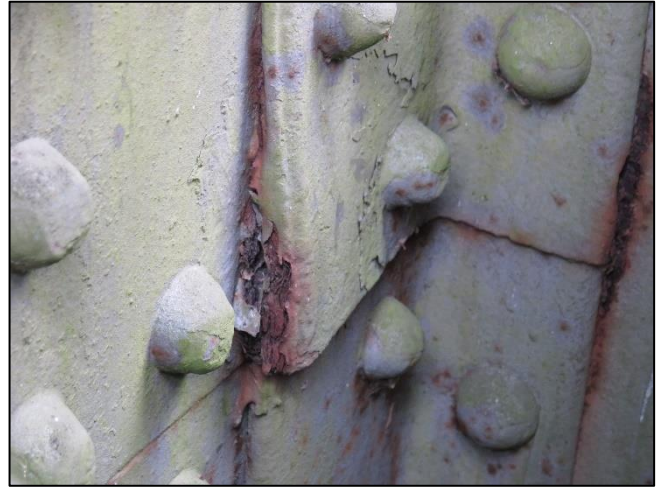
Figure 6-2 Crevice corrosion on edges of elements

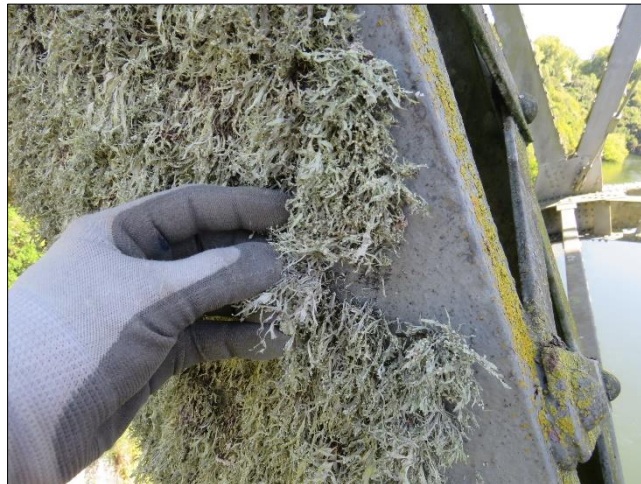
Fungal growth was observed on both the upstream and downstream faces of the bridge. Bird excretion is widespread on the bridge including many bird nests despite the presence of bird spikes. Both have negative effects on the coating systems and increase rates of corrosion.

Figure 6-3 - Example of Fungal Growth

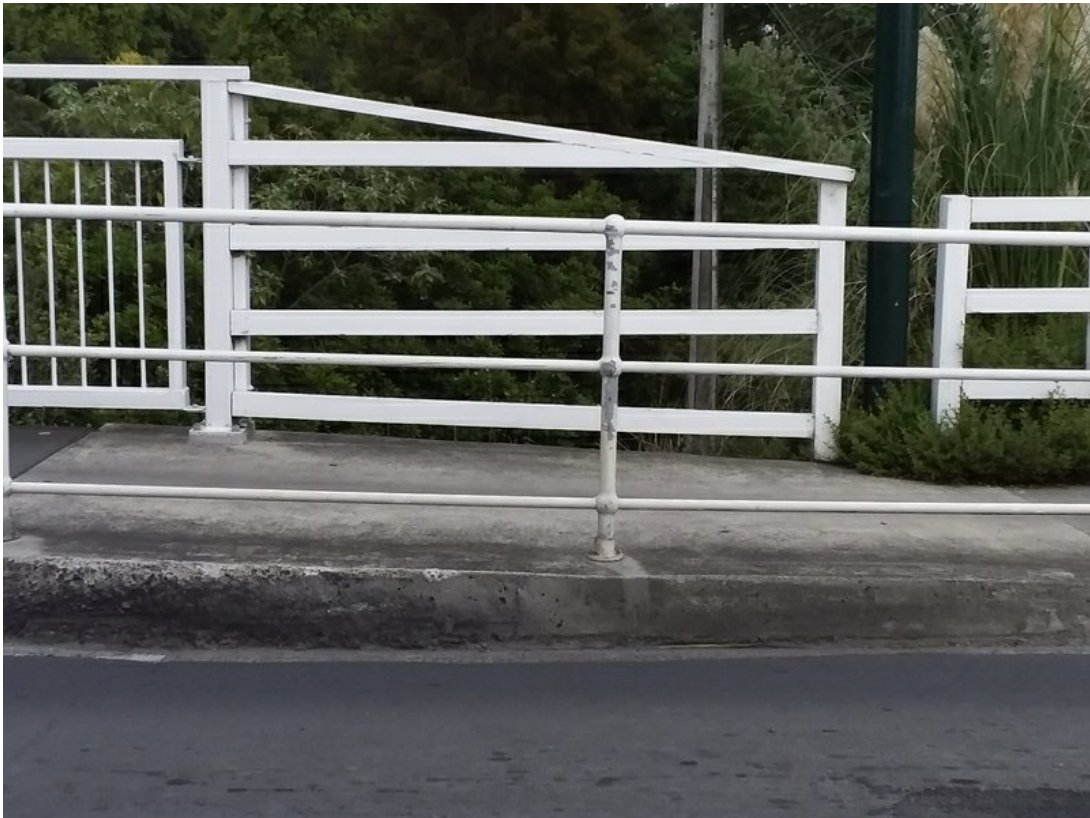
Approach Rails / Barriers / Walls (Element 35): Minor loss of coating on approach barriers. Downstream of Cambridge approach.

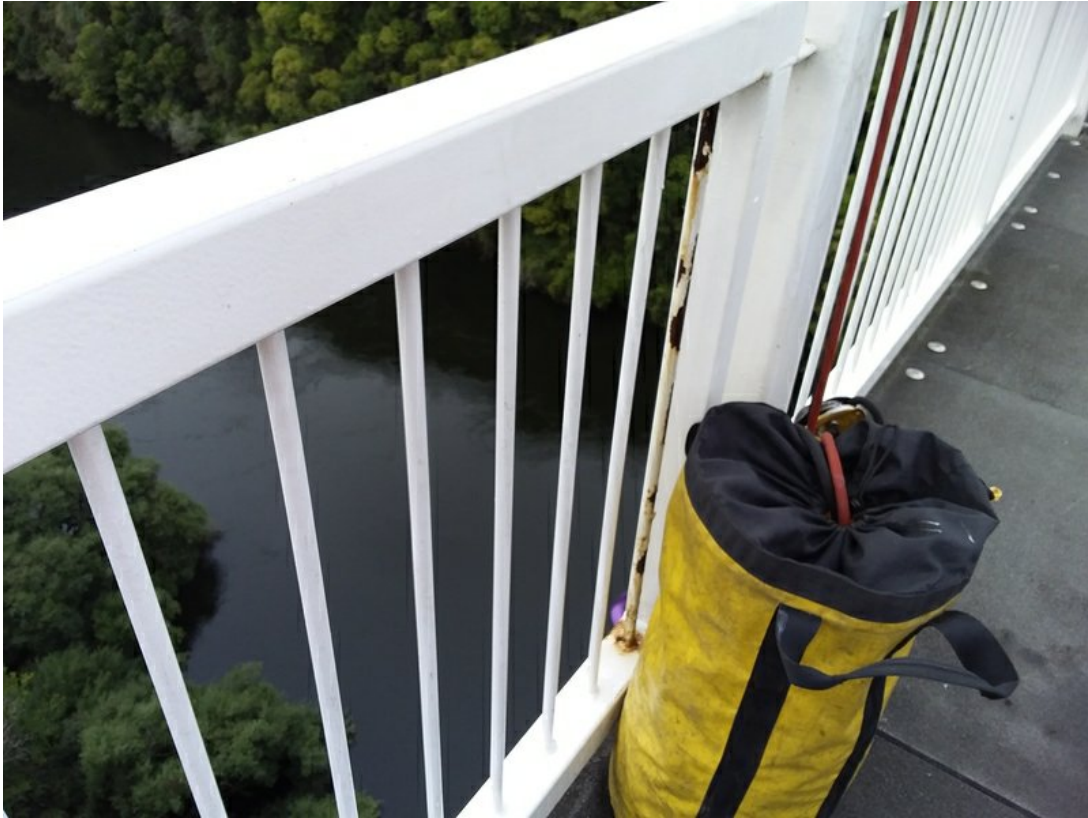
Painting: Barriers / Guardrails (Element 20): Loss of coating on footpath handrail. Upstream at L/5 from Cambridge end.

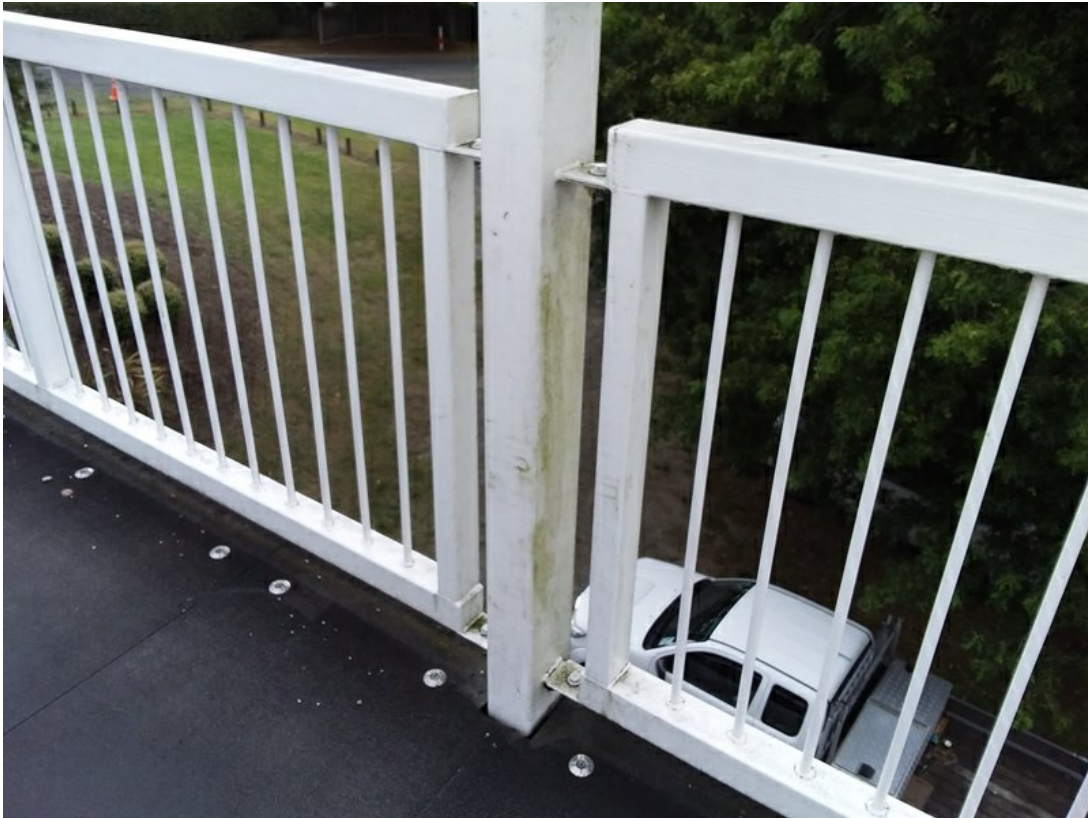
Painting: Barriers / Guardrails (Element 20): Moss growth on footpath handrail posts. Worst over the land spans.

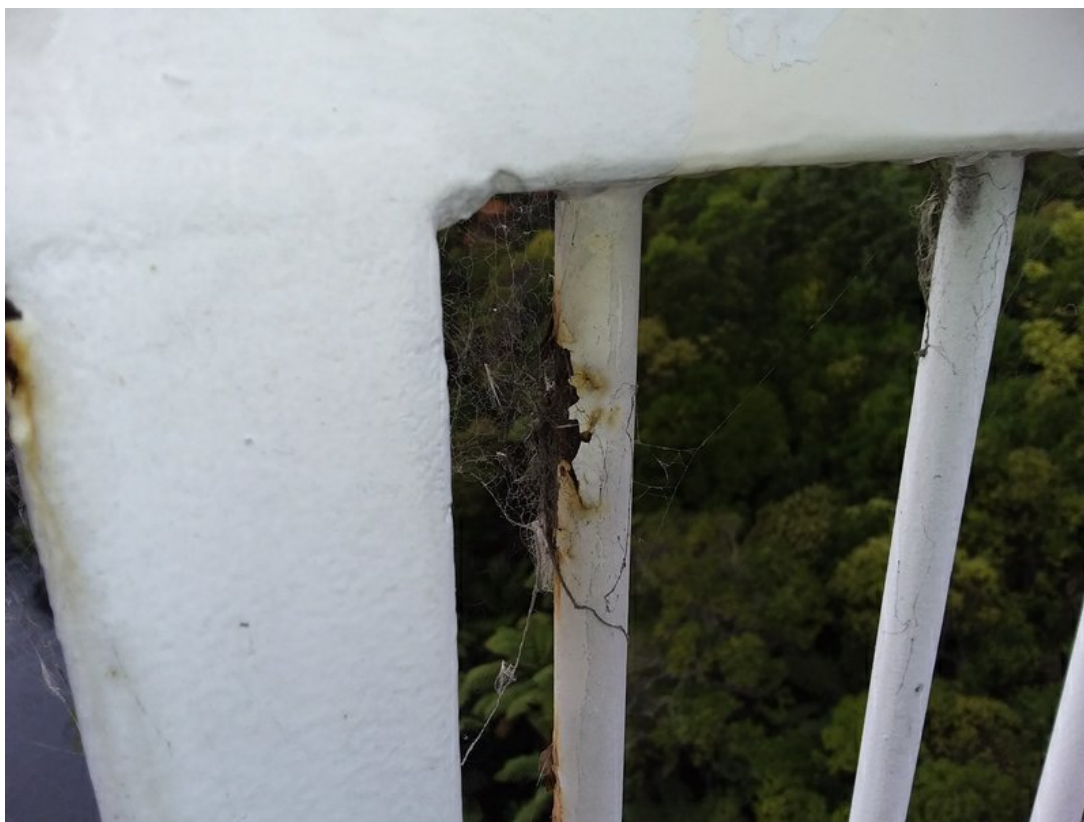
Painting: Barriers / Guardrails (Element 20): Loss of coating on footpath handrail. Upstream at L/5 from Leamington end.

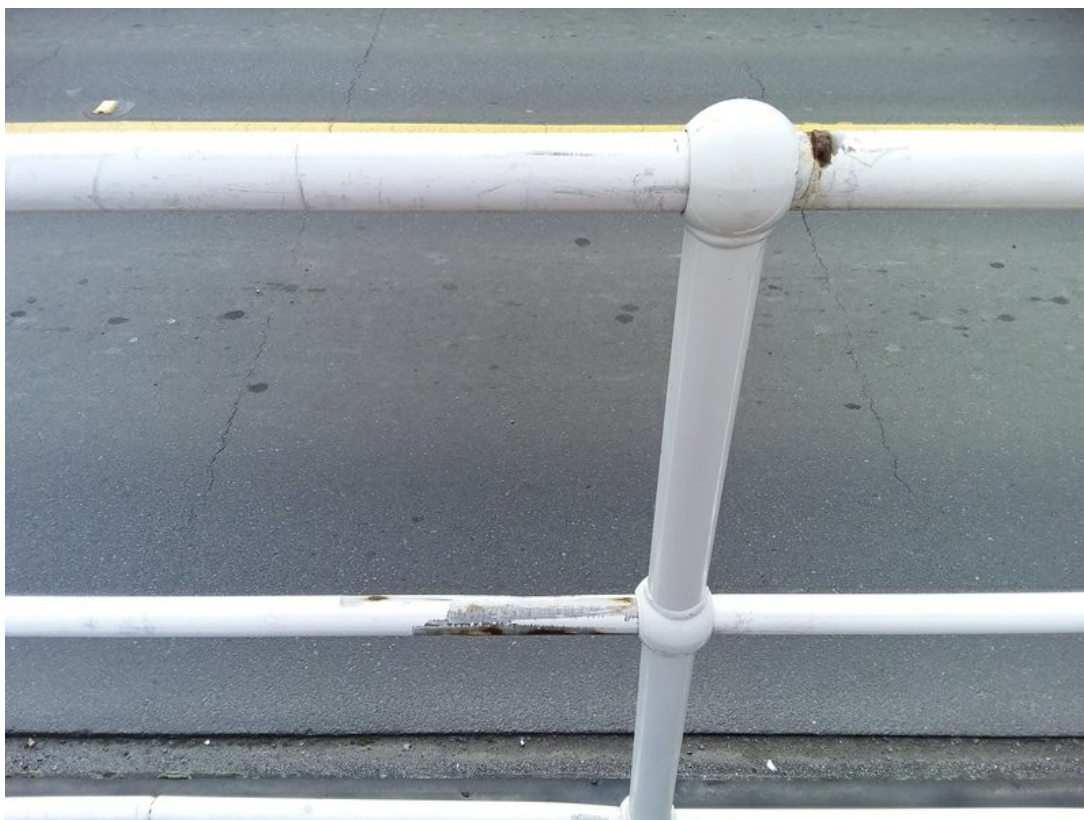
Painting: Barriers / Guardrails (Element 20): Loss of coating on traffic barrier. Upstream at L/4 from Cambridge end.

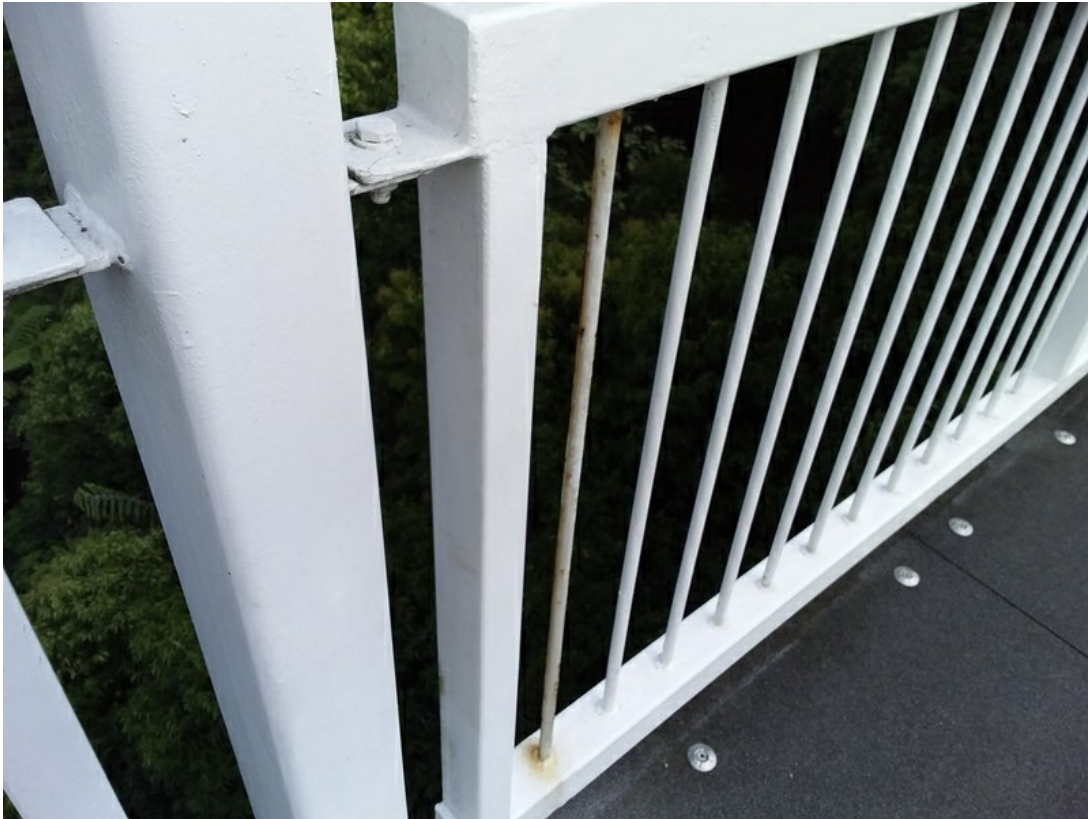
Painting: Barriers / Guardrails (Element 20): Loss of coating on traffic barrier. Downstream at L/6 from Cambridge end.

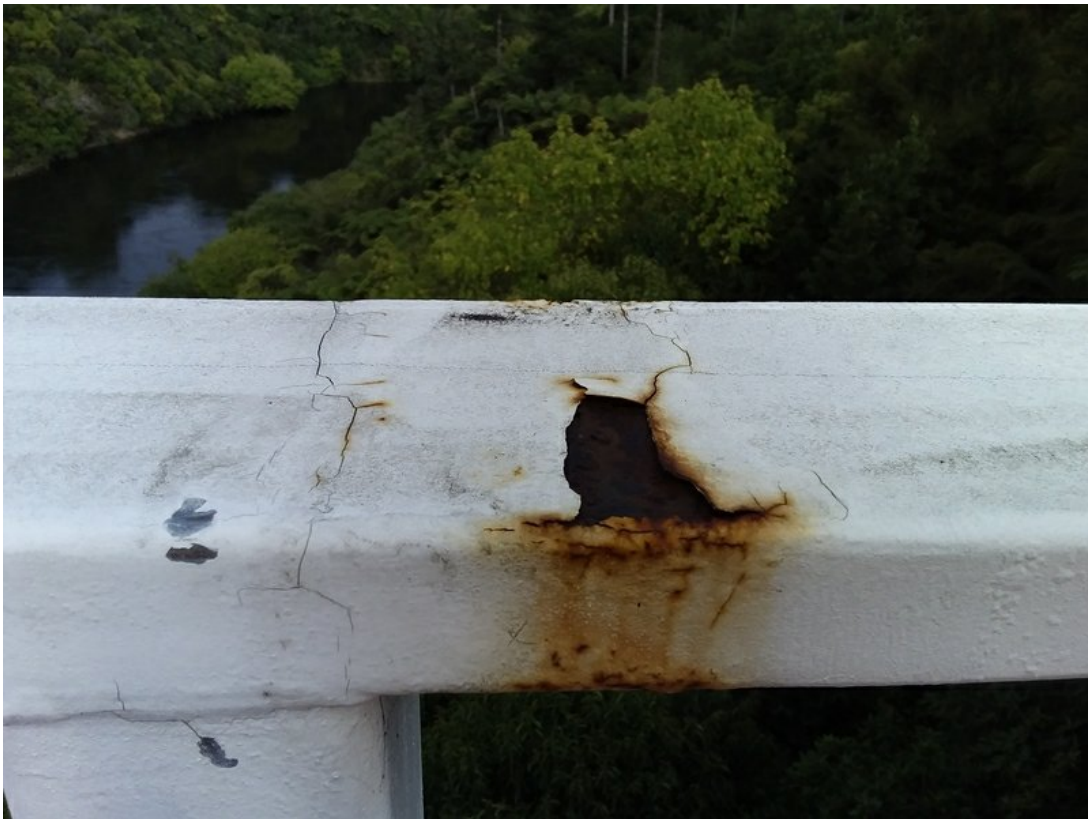
Painting: Barriers / Guardrails (Element 20): Loss of coating on top of footpath horizontal capping rail. Downstream at L/10 from Cambridge end.

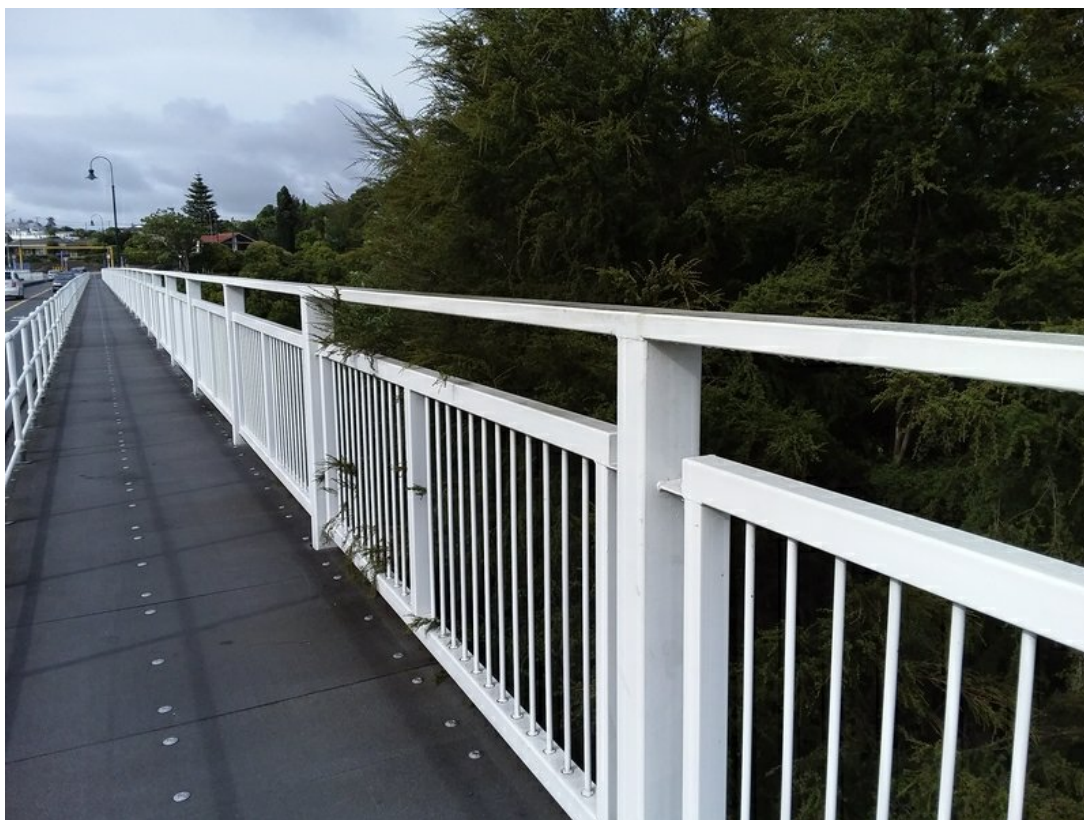
Guardrail / Handrail / Safety Fences (Element 22): Overgrown vegetation at footpath handrail. Downstream at L/10 from Cambridge end.

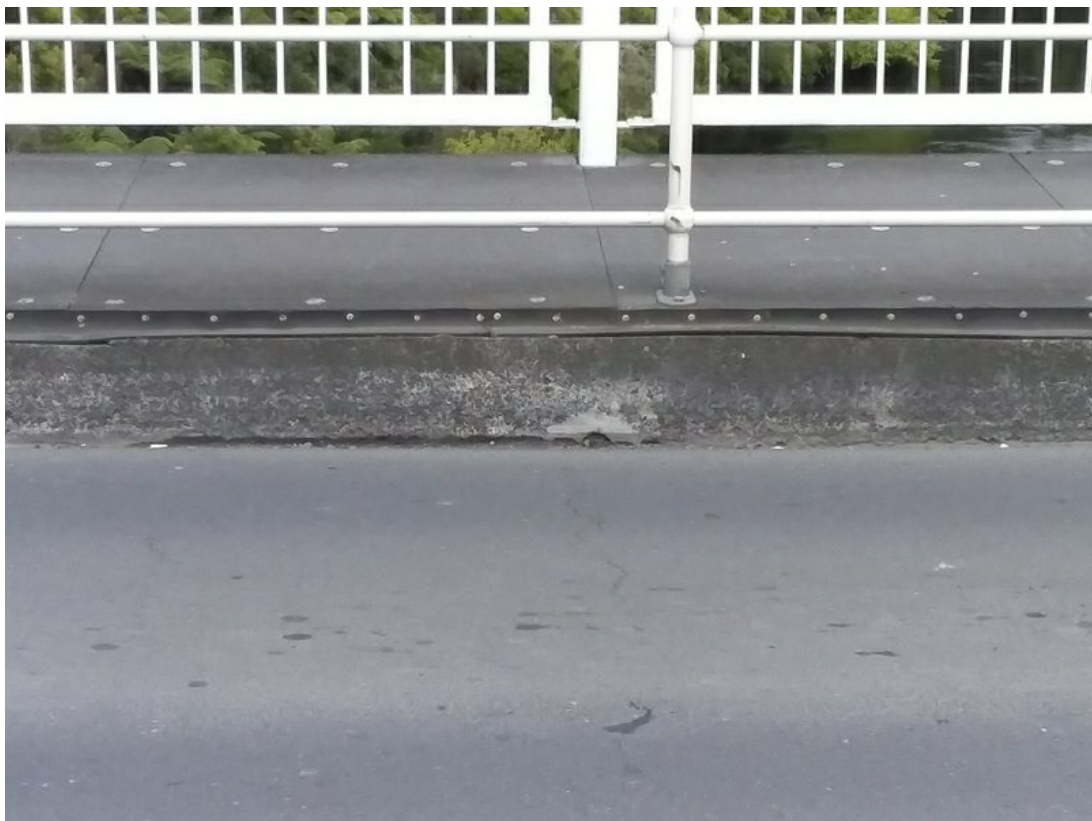
Superstructure Drainage (Element 15): Blocked drain hole on kerb.

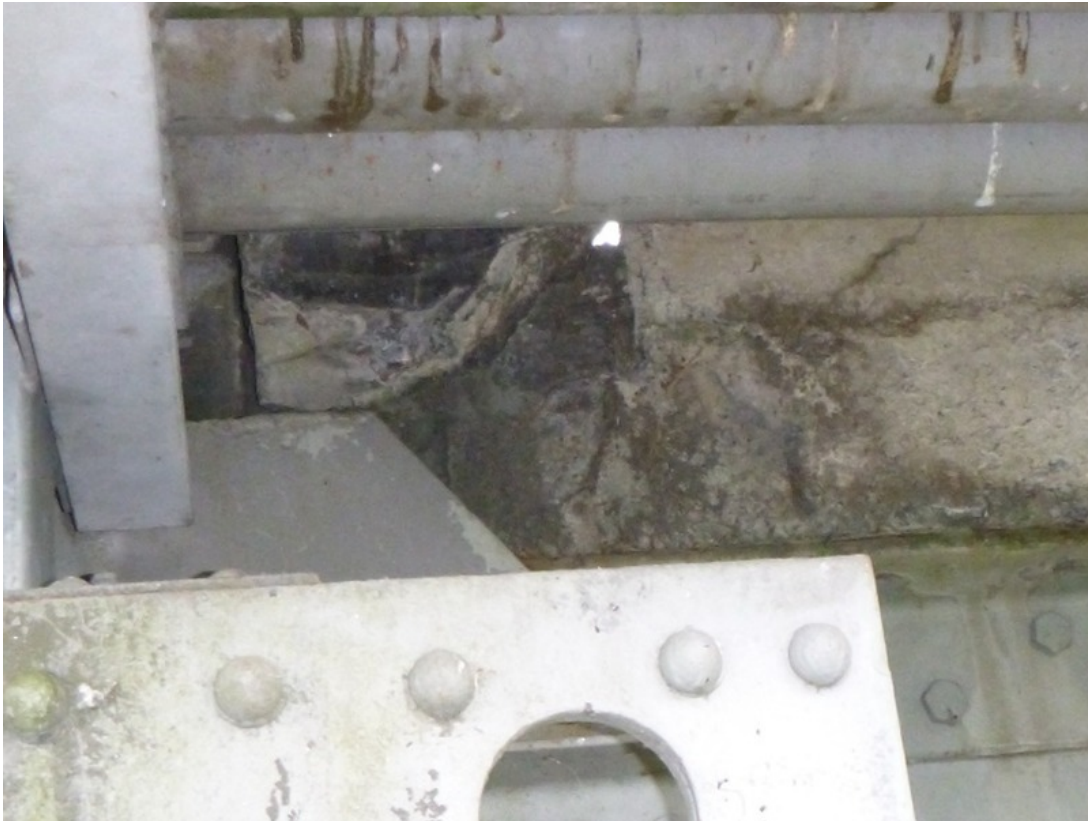
Superstructure Drainage (Element 15): Void in kerb allowing water to drain onto steelwork at Span DE.

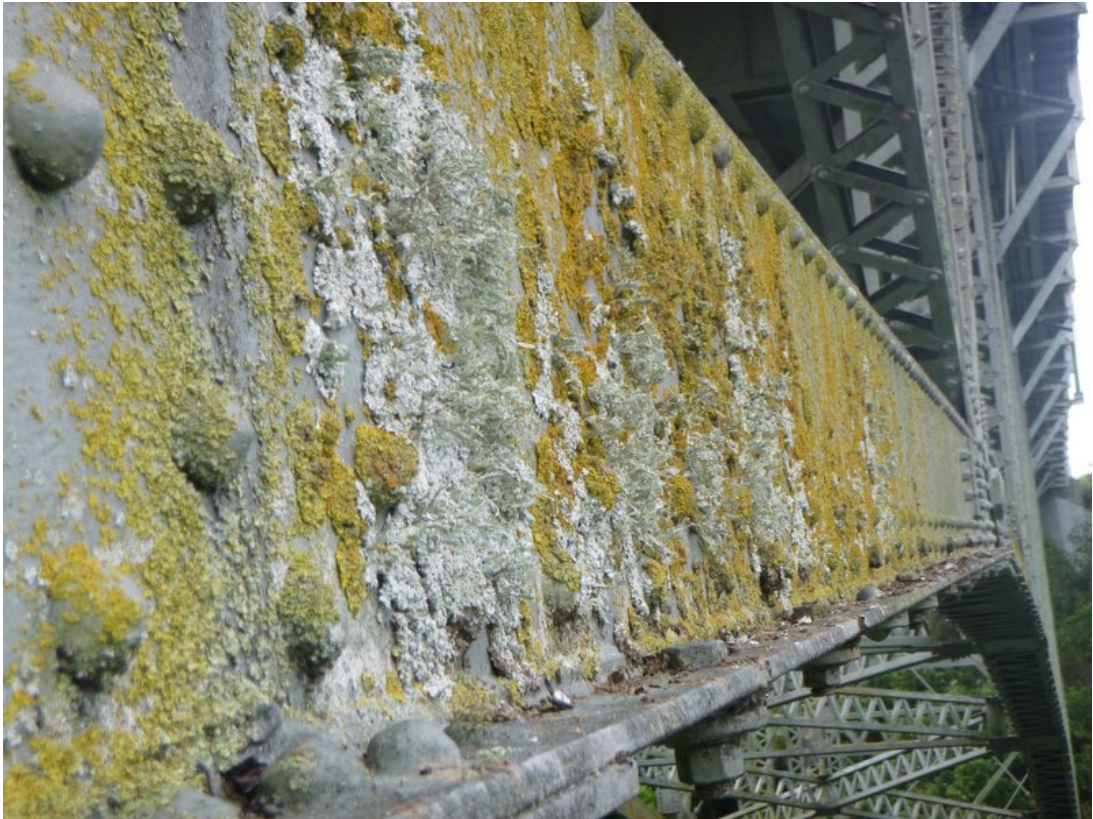
Primary Load Carrying Element (Element 1) : Fungal growth on arch bottom chord at UB07-UB08.

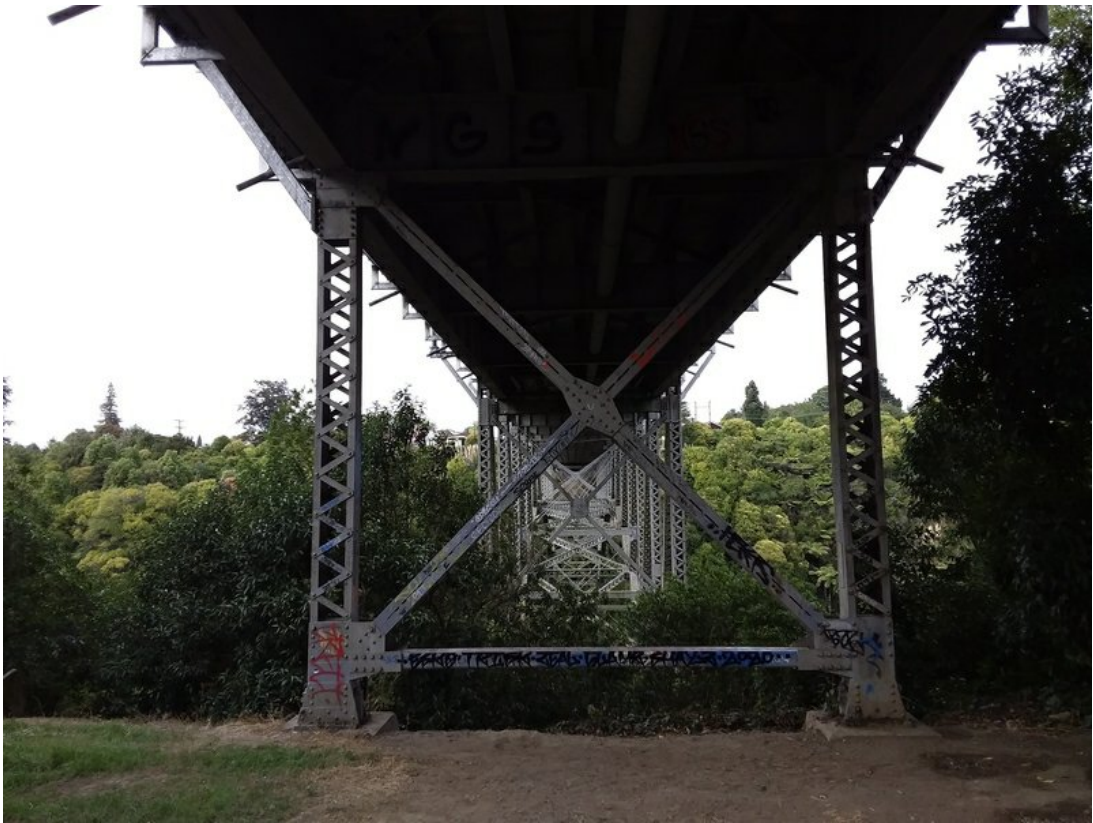
Painting: Substructure Elements (Element 19): Graffiti on A side of Pier B.

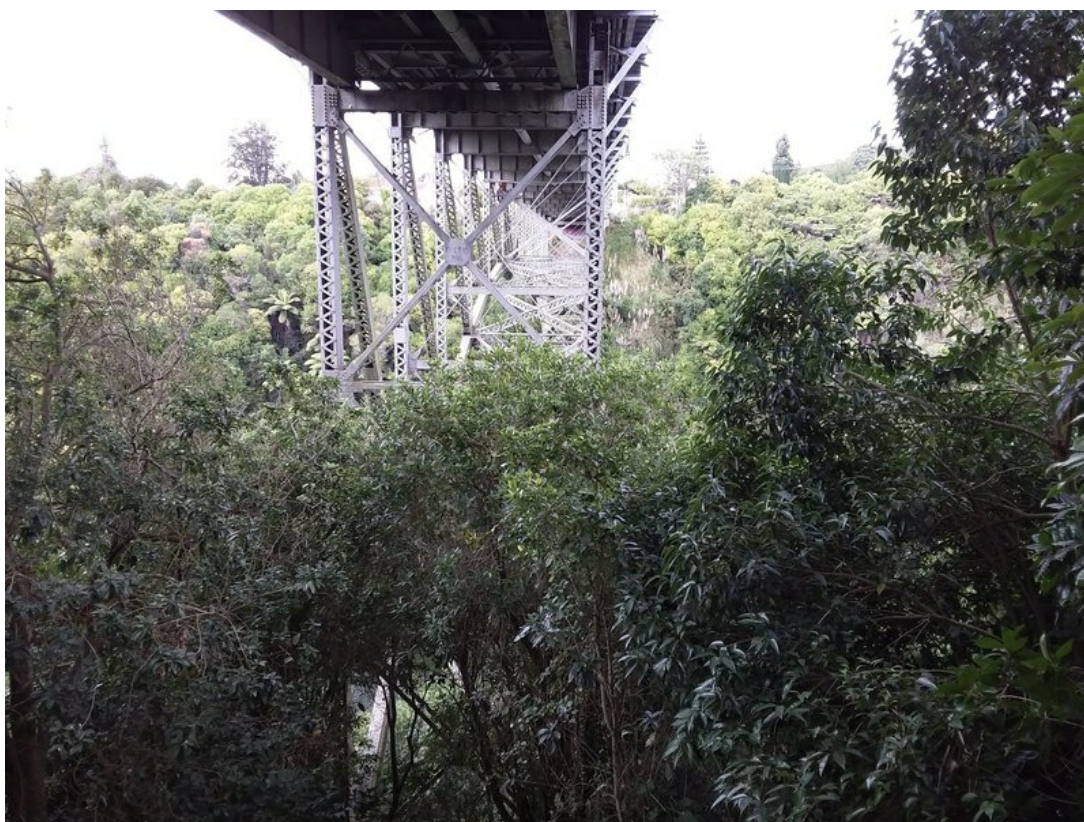
Invert / River Bed (Element 25): Could not access due to steep banks and dense vegetation.

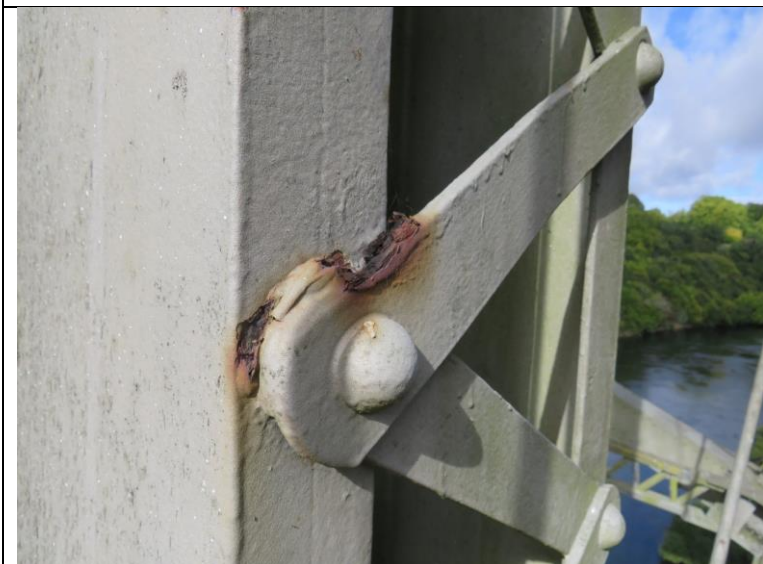
CREVICE CORROSION OF LACE PLATE ON COLUMN

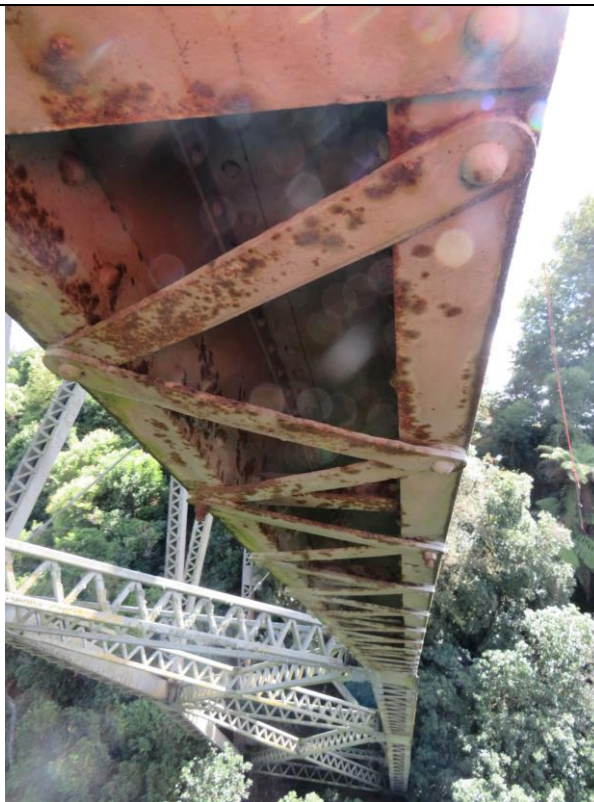
The underside of the bridge arches have widespread corrosion and the connection ends of the laced plates are showing consistent signs of crevice corrosion, some degree of metal loss and coating degradation.

GENERAL CORROSION ON UDESIDE FACE OF BOTTOM ARCH

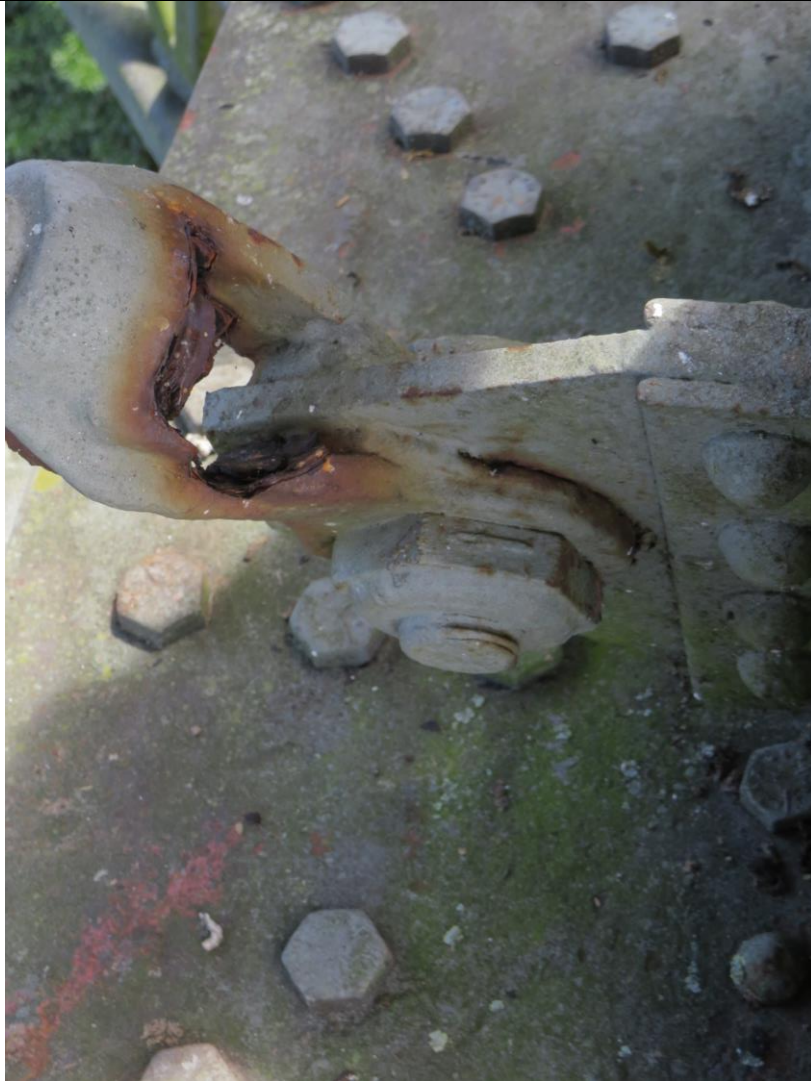
METAL LOSS AT TENSION STIFFENER CONNECTION END

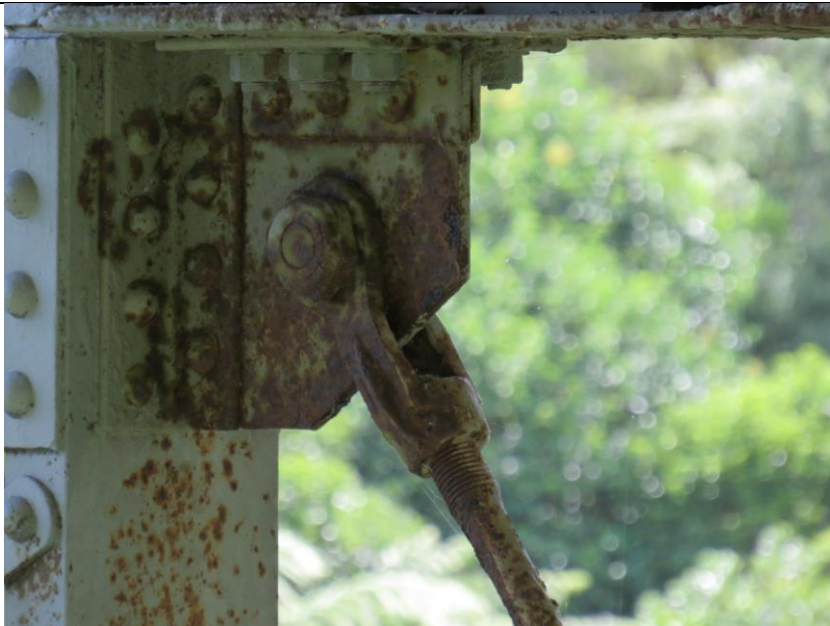
GENERAL COROSION WITH METAL LOSS AT TENSION STIFFENER CONEECTION
