# Victoria Street Bridge (Cambridge) Condition Assessment Report

Prepared for Waipa District Council

Prepared by Beca Limited

10 August 2020

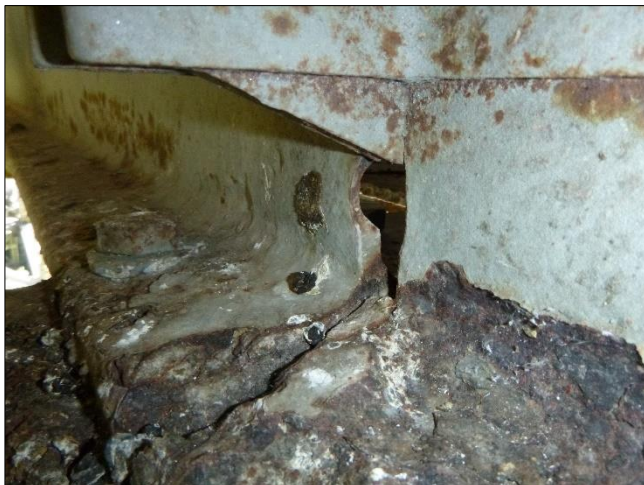
Figure 4-13 - Web may be deformed investigate during painting at T10.

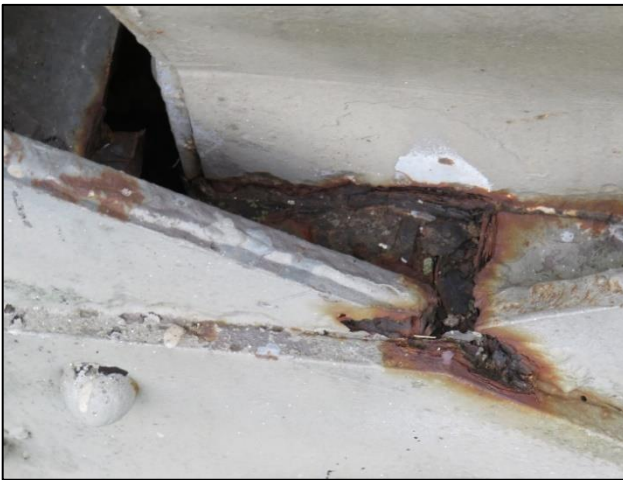
There are six pins on the structure, these are critical elements that must be treated with extreme care as there are no alternative load paths in the event of their failure. All six pins are showing signs of metal loss with the two centre pins more affected. A combination of pitting and crevice corrosion is prevalent on the welded joint where the side and top panels of the steel arch meet. Previous attempts of a maintenance applied joint sealant at this connection point is failing and the added occurrence of fungal growth has accelerated this due to dirt entrapment and prolonged wetness of the area. Corrosion is present on the arch pins themselves at the ground level pins.

Figure 4-14 - Pitting and crevice corrosion at central pin

The structural integrity of these elements requires further investigation. Several components showed section loss and a breakdown of the protective coating system with moderate to severe corrosion. Other elements were in significantly better condition. Following the first issue of this report, Waipa DC have advised that the strengthening works carried out in 1999 included significant work to the pins and may have made redundant the elements that are seriously deteriorated. Records of the 1999 works state *"The detailed strengthening is intended to improve the bearing situation and provide some assurance that should the Original bearing surfaces eventually corrode completely away that the loads can still be transferred across the pin without catastrophic failure occurring."* The level of the assurance mentioned above is not quite clear. It is not known if the strengthening of the pins made the corroded areas redundant or if the strengthened pins still rely on some capacity from these elements. It is recommended that the designer (Tony Mans of BBO) is approached for comment and for any information they may have on file. Regardless of the outcome of these inquiries, further investigation is recommended including a detailed review prior to works commencing on site, inspection of the pins by a structural engineer, and ultrasound testing of the elements once the scaffolding is in place.

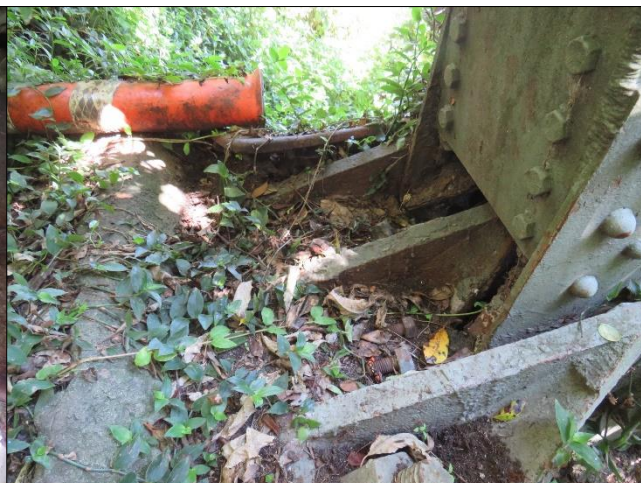
Figure 4-17 - Vegetation build-up at ground level Pins

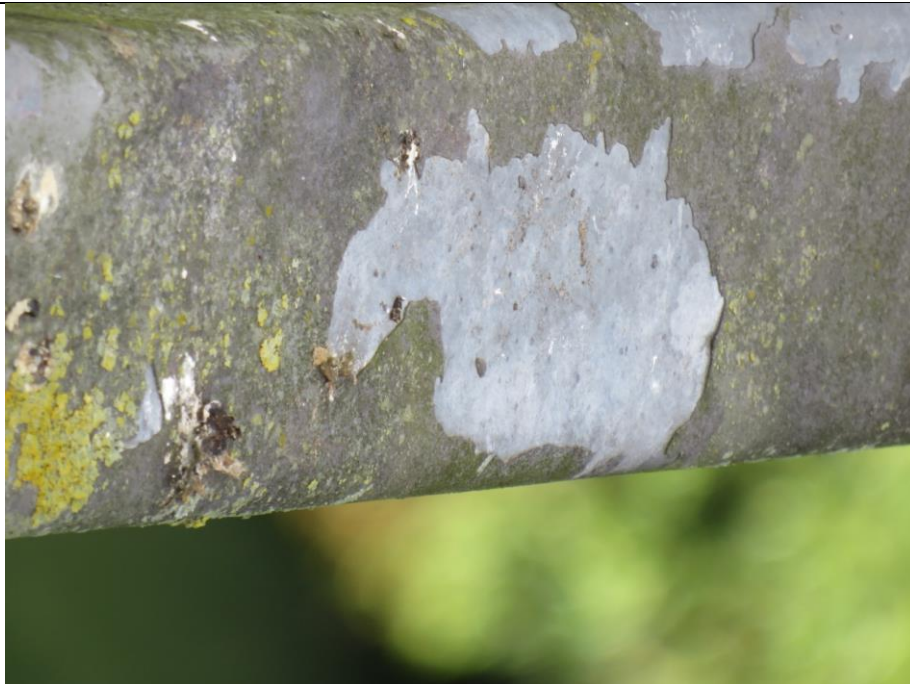
There are multiple areas where mechanical damage of the coatings has occurred, mostly around sharp edges and on plates of the laced columns. Coating delamination is occurring on localised parts of the bridge, mostly on and around the steel transoms, some spliced connection ends of vertical cross braces and on previous replaced horizontal cross bracing between the bottom arch sections.

COATING DELAMINATION

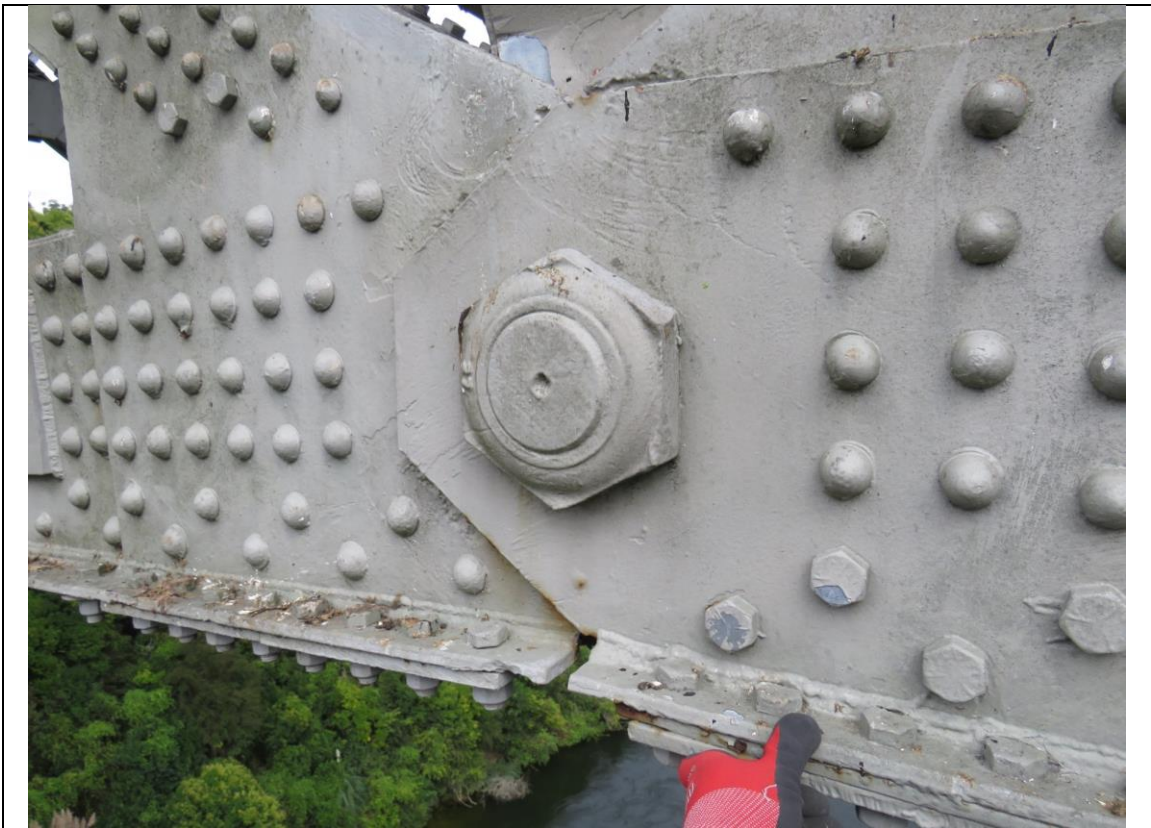
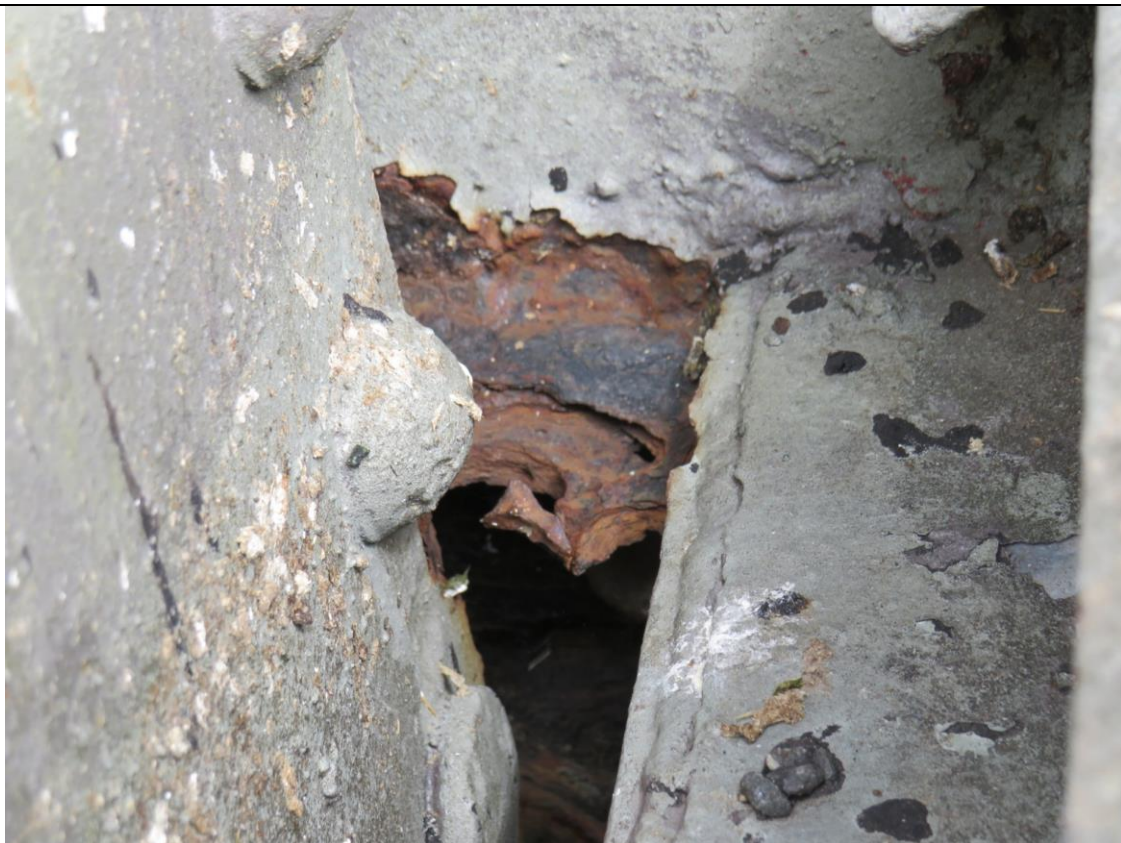
CENTRE PIN - UPSTREAM

All six major connection points or “pins” are showing signs of metal loss with the two centre pins more affected (around positioning plates of pins) . A combination of pitting and crevice corrosion is prevalent on the welded joint where the side and top panels of the steel arch meet. Previous attempts of a maintenance applied joint sealant at this connection point is failing and the added occurrence of fungal growth has accelerated this due to dirt entrapment and prolonged wetness of the area.

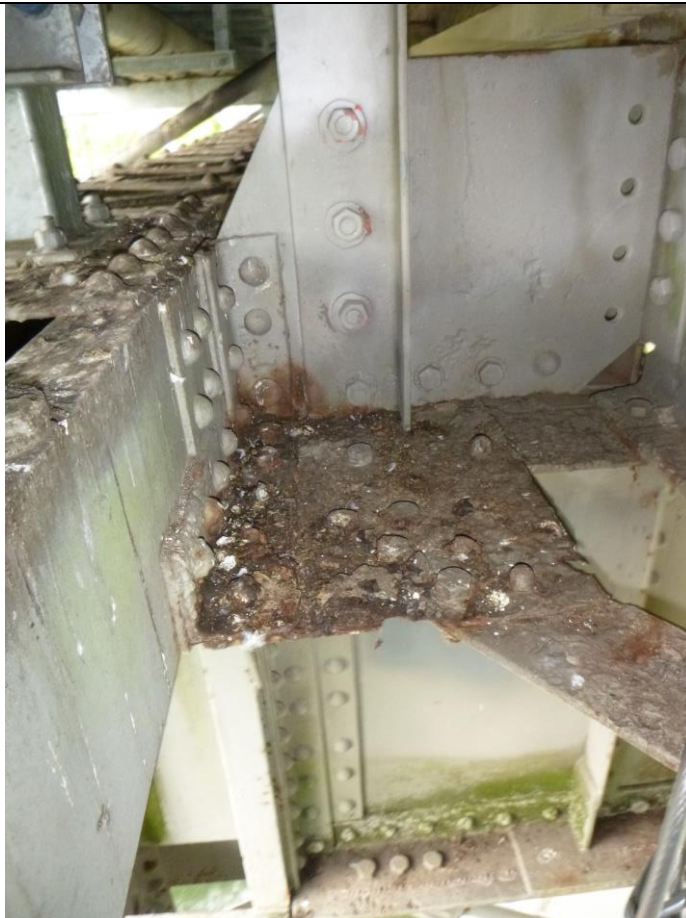
CROSS BRACE AND TRANSOM CONNECTION
